# CAN WE LEARN FROM THE HERITAGE LOST IN A FIRE?

*Experiences and practises on the fire protection  
of historic buildings  
in Finland, Norway and Sweden*

National Board of Antiquities, Department of Monuments and Sites, publication no 26  
(Museoviraston rakennushistorian osaston julkaisuja 26)

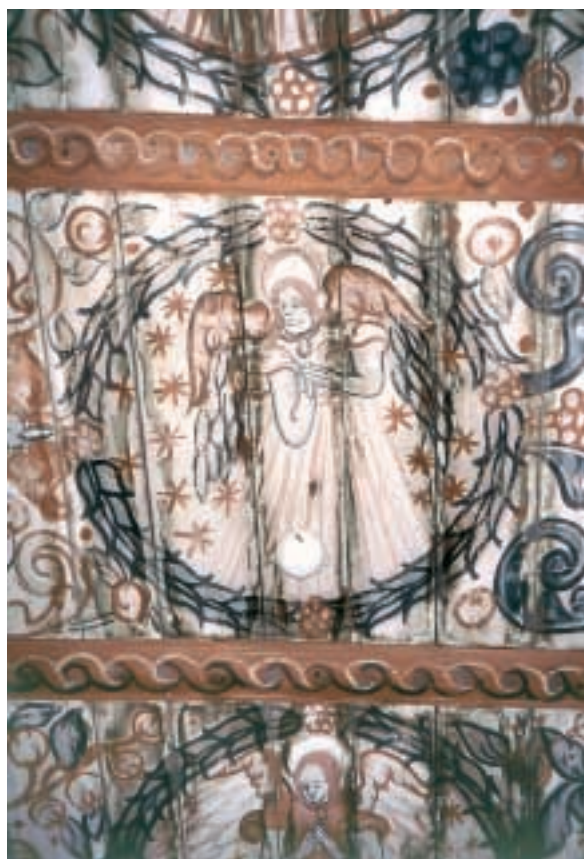
Sometimes the intention is good but something is missing.

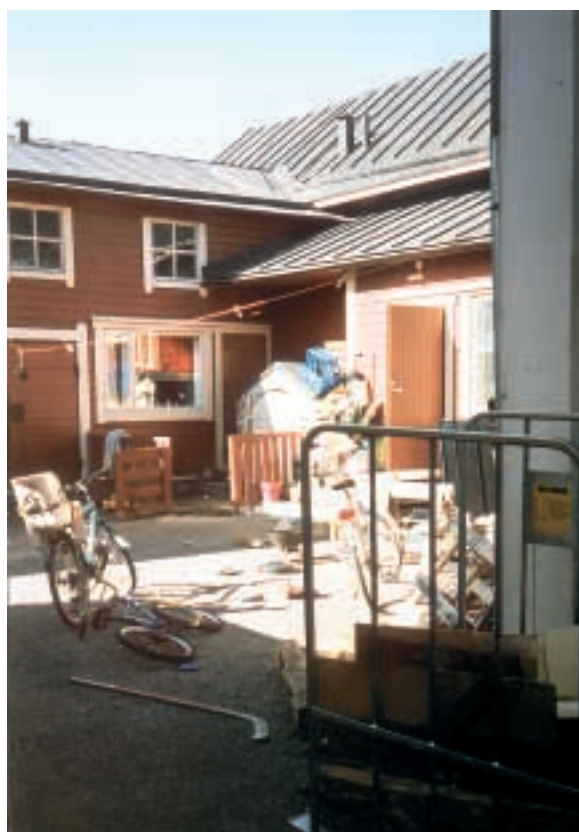
There is still too much combustible material in some of the courtyards in Rauma.

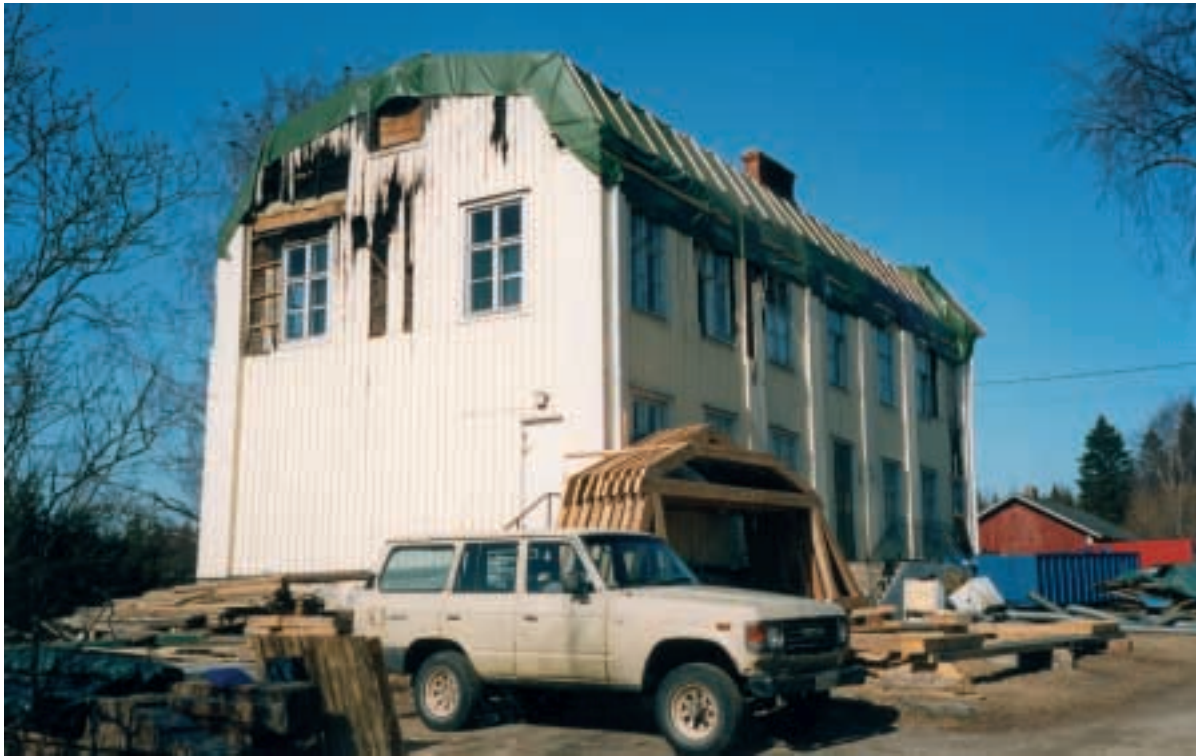
Åminneborg after the fire.

The fire broke out in the floor between the second living floor and the attic. The cause of the fire was a short circuit in an old electric wire, which resulted from condensation in the metal coating around the electric wires. It is interesting to note that the second living floor had been heated for only a few years.

The result of the fire was that all the roof structures and the attic were badly charred and the attic floor support beams were badly damaged. The ceiling, walls and the floor of the second living floor were badly damaged because of the amount of water used by fire fighters and there was also damage to the first floor.

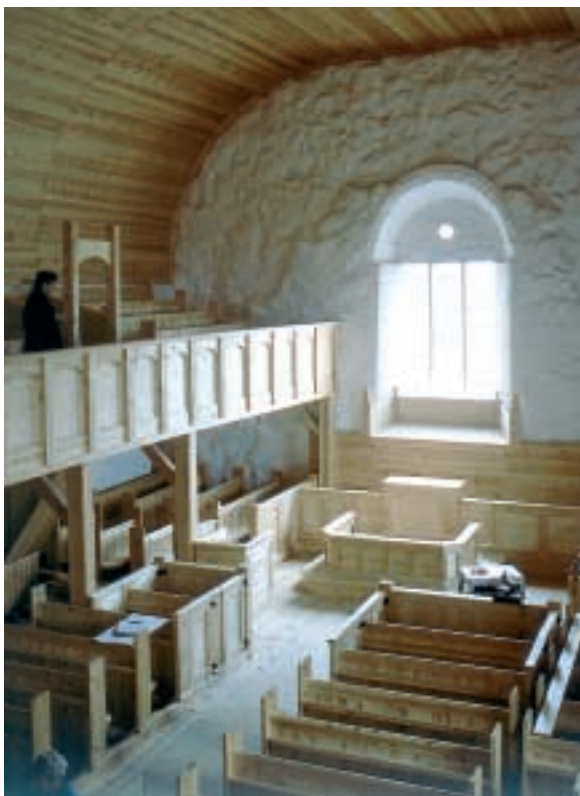
All wooden parts (roof, ceiling, doors, interior) burned down almost totally. Only one door remained, but it was badly charred. Some of the floor planks remained badly charred. The floor joists were still in good condition. Some other wooden parts survived. The walls, which were made of natural stones and bricks, remained but they had suffered from the heat. The plaster contained so much clay that it was fired and fell down during the next winter.

Interior of Tyrvää after rebuilding, without any paintings.

Because it was autumn and there was a danger of rain, work started by temporarily protecting the ruins with tarpaulin. Soon the congregation decided to build temporary scaffolding to protect the remaining walls. The scaffolding was made of corrugated steel plates. The door and window openings were sealed with boarding.

Despite difficulties, the roof was subsequently rebuilt as a training exercise and in accordance with the old model. The documentation was rather good but some details and dimensions were missing. The shingles were made by volunteers.

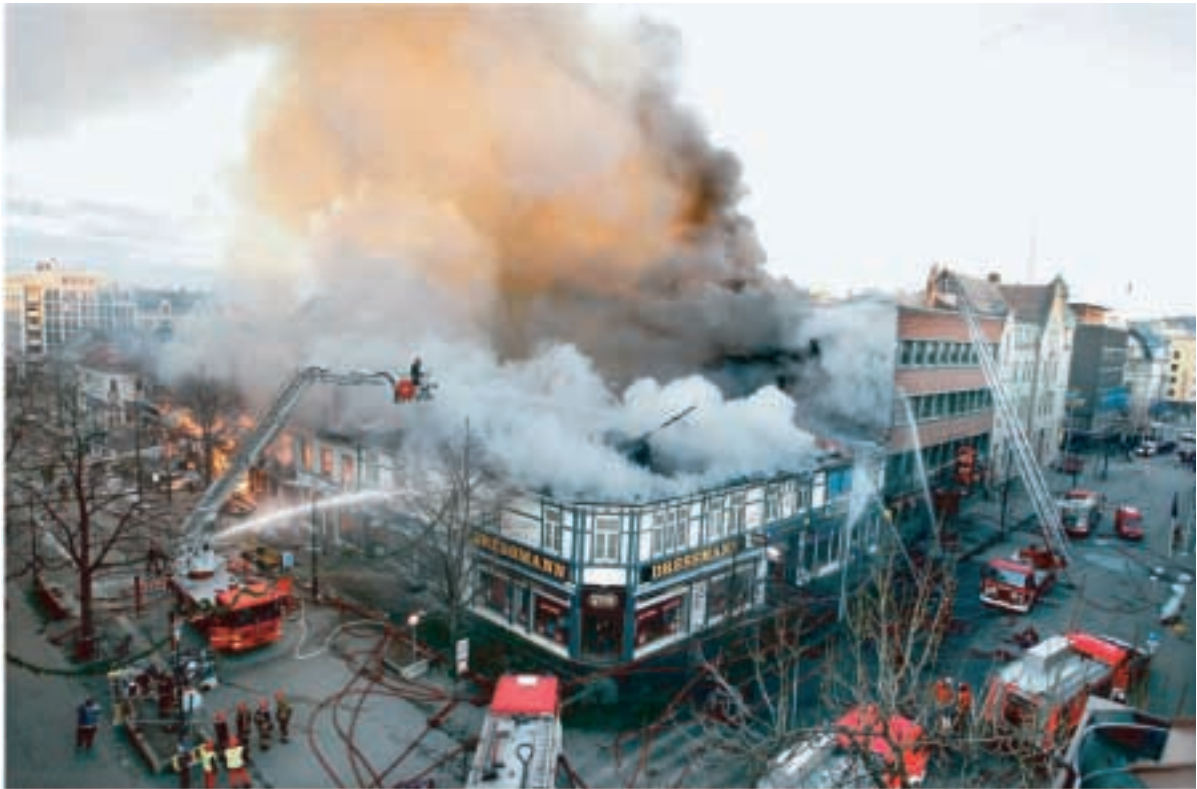
The fire started in a pan with hot cooking oil in a restaurant kitchen. Cooking oil is a frequent cause of fires. A couple of days before the fire, there were some indications of problems with the electrical installations in the restaurant. Fluctuations in the power supply might have caused a failure in the pan thermostat. The fire was reported to the fire brigade at 10.45. The cook had been trying to extinguish the fire without success. All available personnel from the fire brigade were on site before 11 o'clock. The Trondheim fire brigade also got assistance from fire brigades in the neighbouring municipalities and from the military.

There was an automatic fire detection system in the restaurant. According to the fire instructions, this was only in operation between 04.00 and 08.00 when there was nobody in the restaurant. There was also an automatic sprinkler system in the restaurant kitchen. The fire brigade turned off the sprinklers as they thought the fire was extinguished. The fire, however, had spread to the ventilation room in the floor above the restaurant. The fire spread from the ventilation room along the facades and through the lofts. There was a shared ventilation system with ventilation ducts in several of the buildings. Many of these buildings lacked firewalls between the lofts.

The fire in Trondheim.

It took the fire brigade hours to stop the fire spreading to the remaining part of the block. A wall of solid wood construction in one of the buildings stopped the spread of the fire. A large concrete building was also seriously damaged but the fire brigade managed to stop the fire there.

- The local authorities will carry out a risk analysis for fire protection.
- The fire brigade will be strengthened, particularly the department working with prevention.
- There will be improved routines for fire protection during the building planning process.
- There will be improved cooperation between fire-fighting personnel and fire officers.
- There will be improved routines for fire inspections.
- There will be a project for the fire protection of the historic centre of Trondheim, including a survey of all the properties.

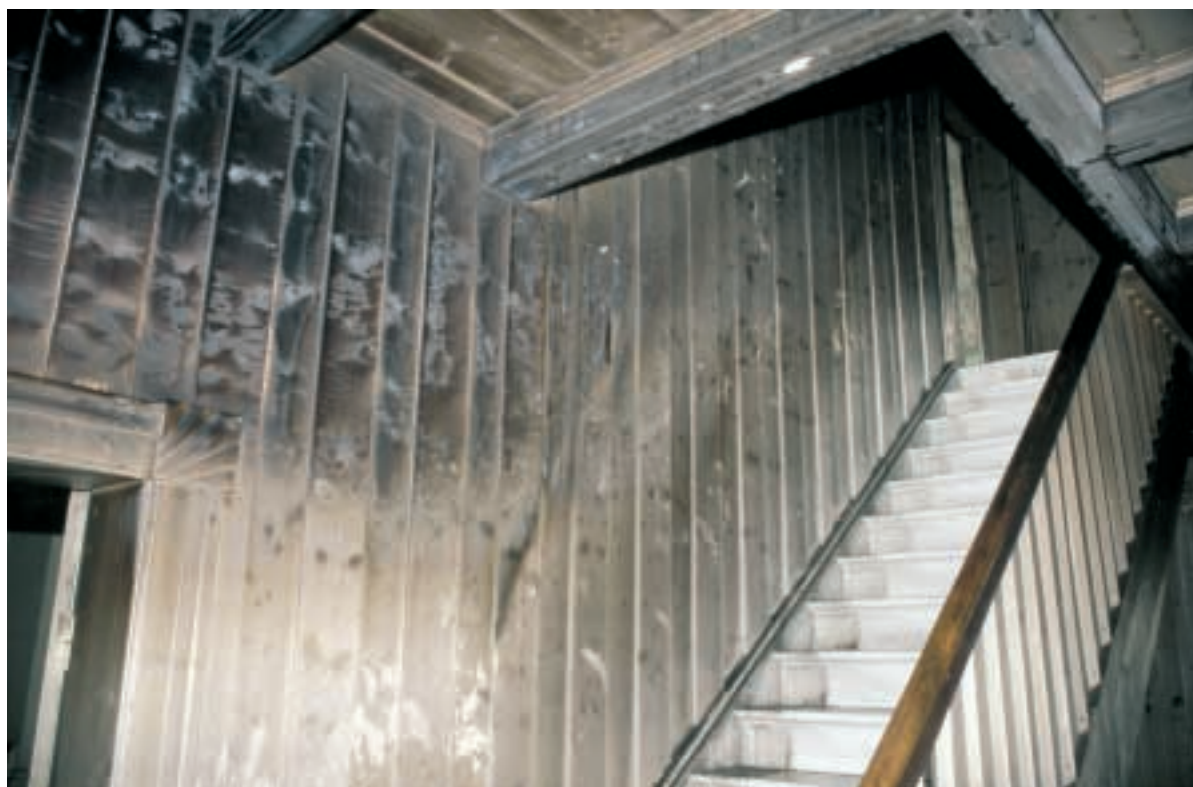
The fire was restricted to the part of the building used for living and more or less stayed out of

Interior of Ringnes just after the fire.

Dividing a building into different fire cells is important in order to prevent a fire from spreading. Even closed doors can effectively prevent a fire from spreading. An automatic fire alarm system connected to fire brigade saves a lot of time and it also works when there is nobody in the building. The early detection of a fire can substantially reduce the damage.

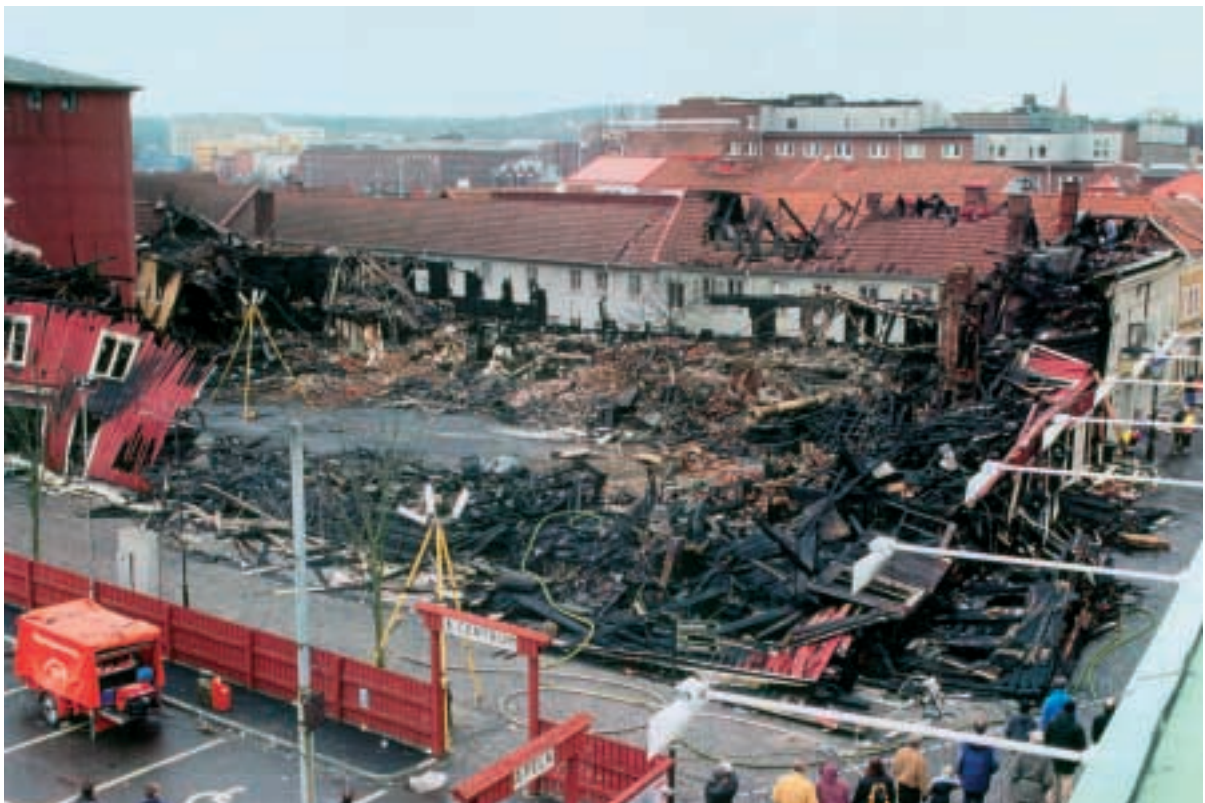
The block in Jönköping after the fire.

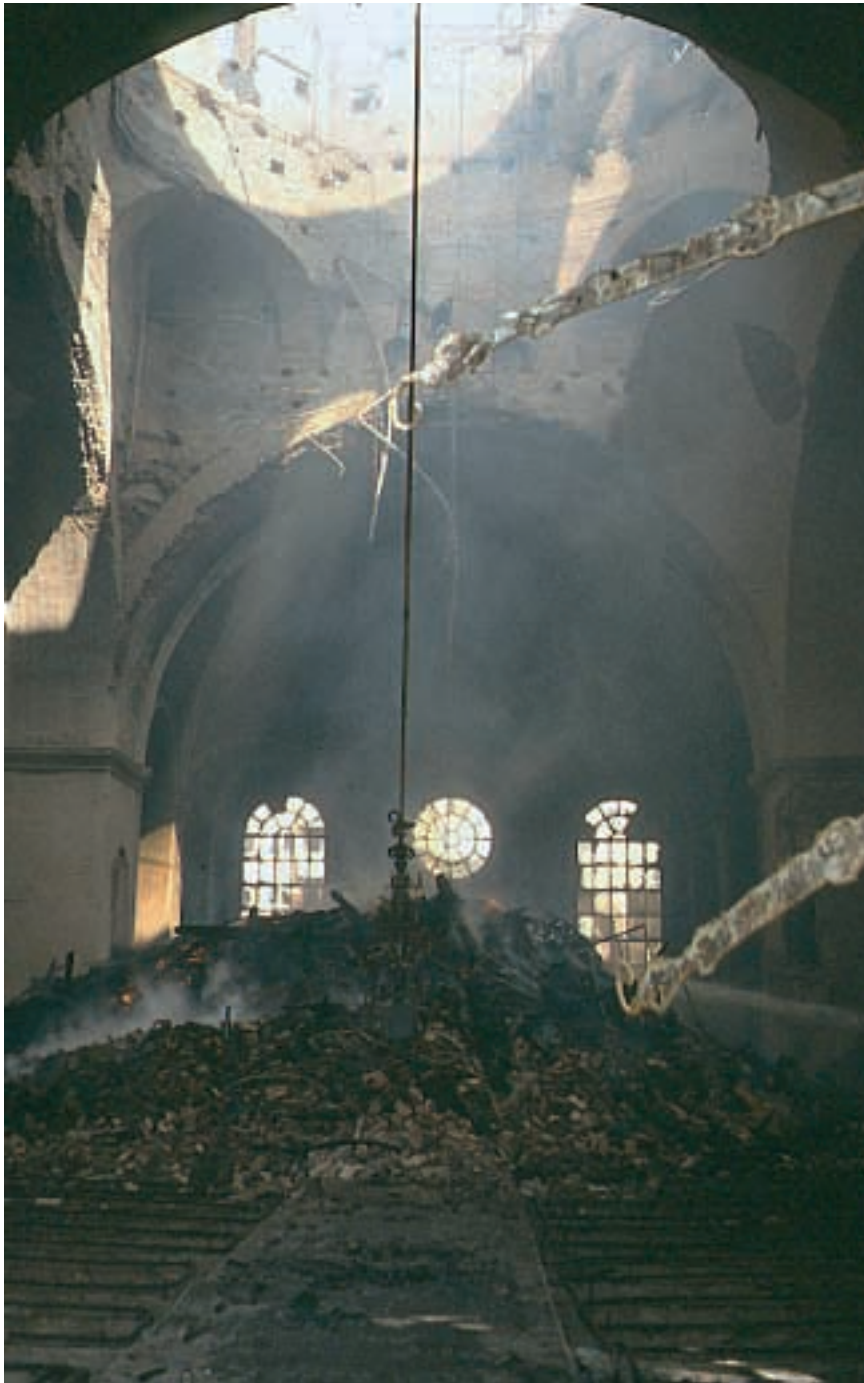
Katarina Church  
interior just after the fire.

The roof construction was a very interesting aspect in rebuilding. The architect proposed a traditional wooden construction while the church board wanted to use concrete. The matter was studied carefully by evaluating the use of laminated timber and steel structures but finally it was noted that the old technique with wood would be the quickest, easiest and cheapest way to rebuild the roof. So skilful carpenters were employed and all parts were made on the site in order to adjust them to the existing wall structures.

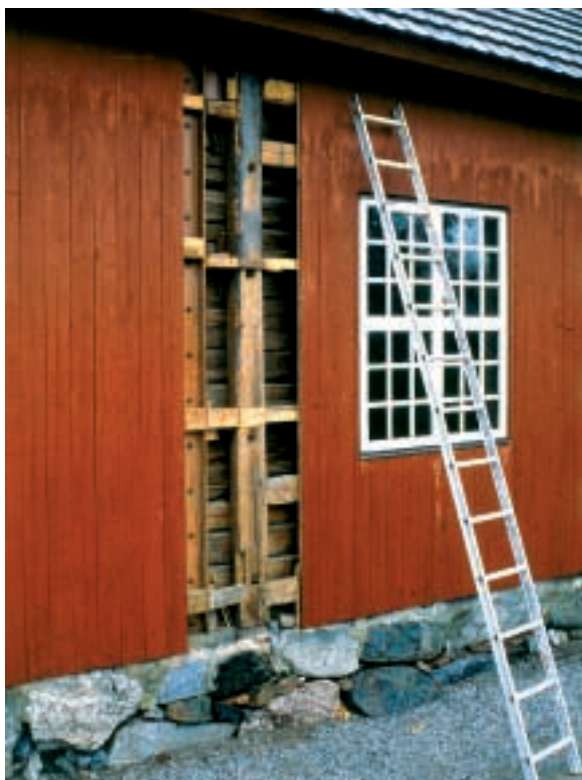
The windows were situated in the surface of the wooden boarding. There were no windows at all in the timber frame. This meant that the gap between the boarding and the frame was directly connected to the interior. This was again a serious fire risk. To prevent an arsonist from throwing something like a "Molotov Cocktail" through openings the existing glass windows were changed

The gap between the log wall and the exterior boarding.

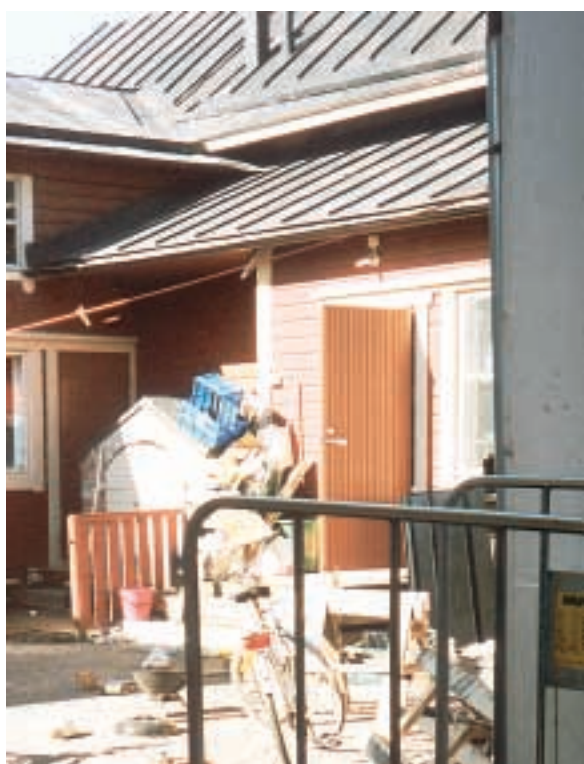
It is easy for an arsonist to set fire to an open bin full of rubbish in the vicinity of an historic building.

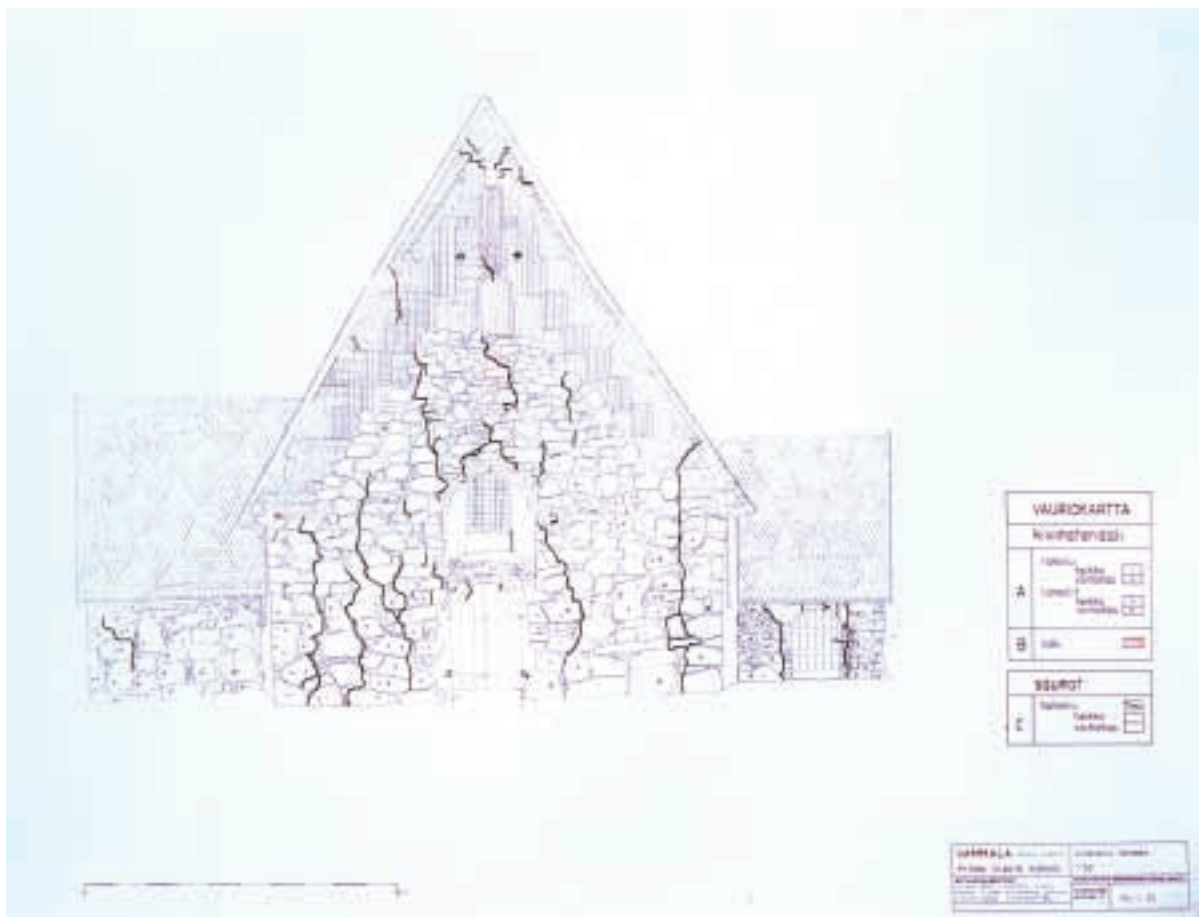
All cracks in the stonewalls were marked on the existing drawings of Tyrvää church.

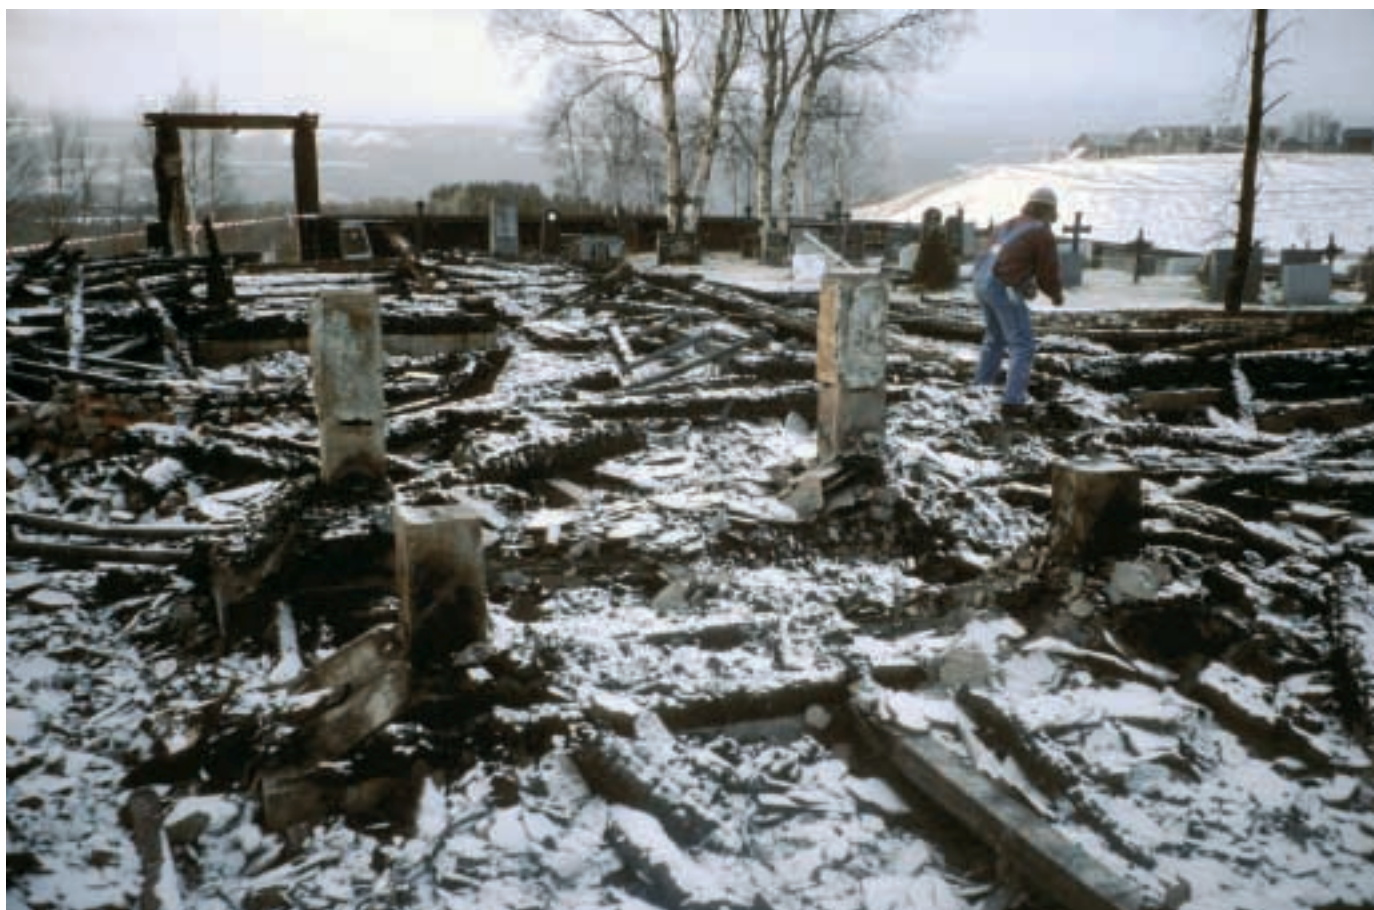
The starting point for investigations after a fire can be like this (Innset church, Norway).

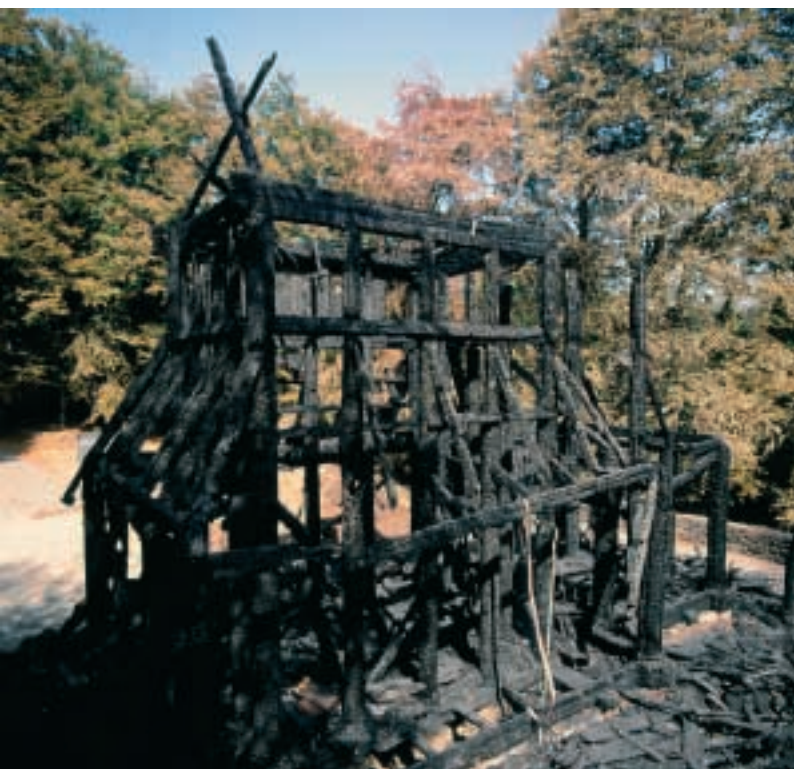
Fantoft just after the fire.
