A Research and Development Report from the Workshop

Removal of Damaging Conservation Treatments on Mural Paintings

November 2 & 3, 2007, Österbybruk, Uppland, Sweden

Author: Hélène Svahn Garreau

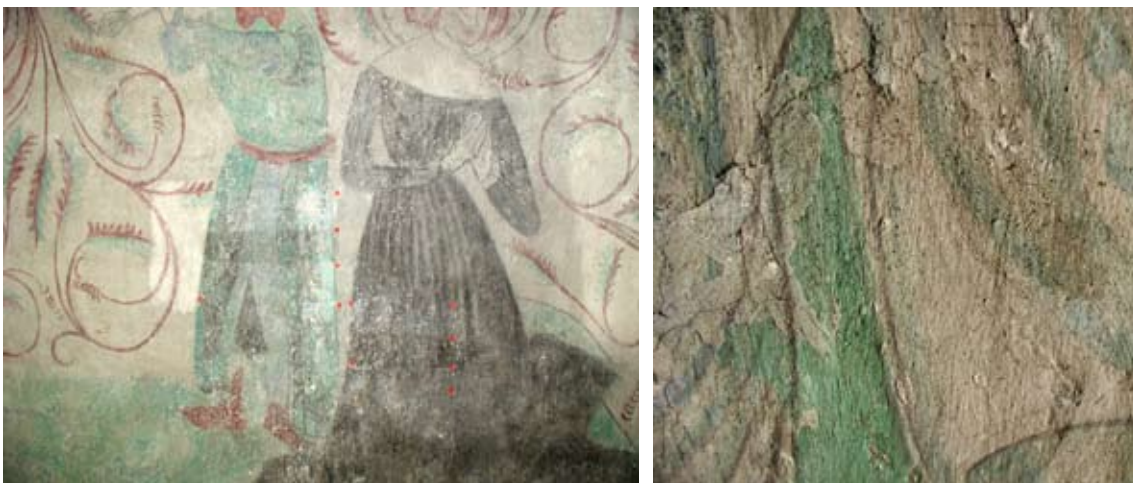
Figures 1 and 2. Tests in Vendel Church 2006. Photographs H el ene Svahn Garreau.

Another motivation for the workshop was that the Swedish National Heritage Board was working on the conservation of the medieval mural paintings in Vendel Church between 2005 and 2008. In 1930 the mural paintings were uncovered and treated with casein. The casein has become brittle and the paint layer is flaking severely. Thus, there are two problems to address: 1) *the reattachment of the paint layer* and 2) *the reduction of the casein*. The problem is quite difficult and one of the purposes of the workshop was to discuss the problem and share our experiences with the preinvestigation of the paintings.

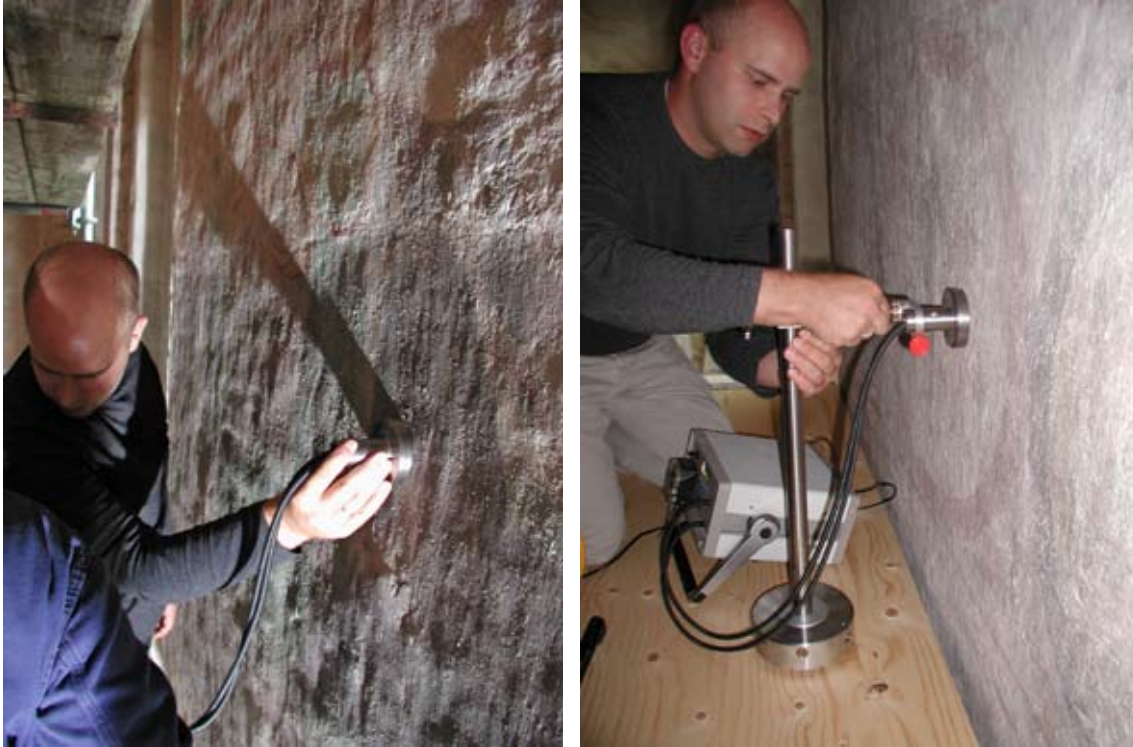
Figure 11 and 12. Dr. Beutel demonstrates the enzyme method in Vendel in 2003.
Photograph H el ene Svahn Garreau.

Dr. Beutel was invited to Sweden by the Swedish National Heritage Board in 2003 to demonstrate the enzyme method in Vendel Church. The method did not work since there were problems with the 2D fluorescence spectrophotometer device (see below). The sensor of the machine could not detect the casein on the wall. Thus, it was not possible to know if the casein was reduced.

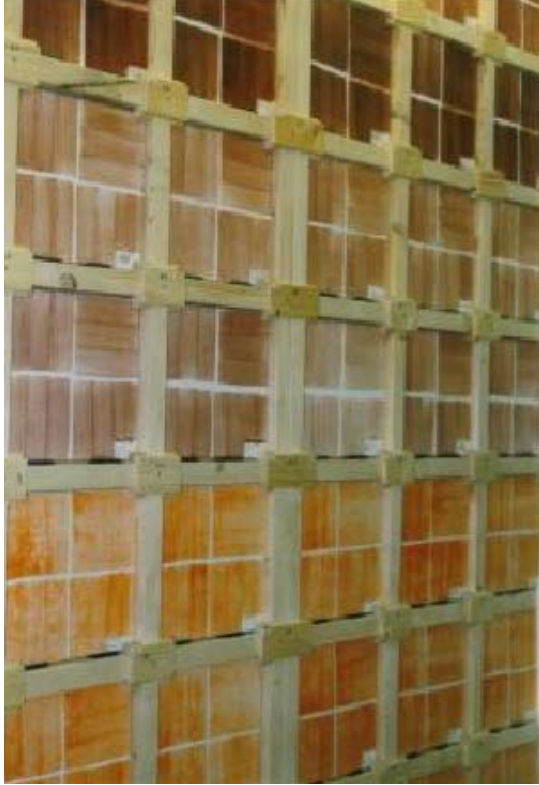
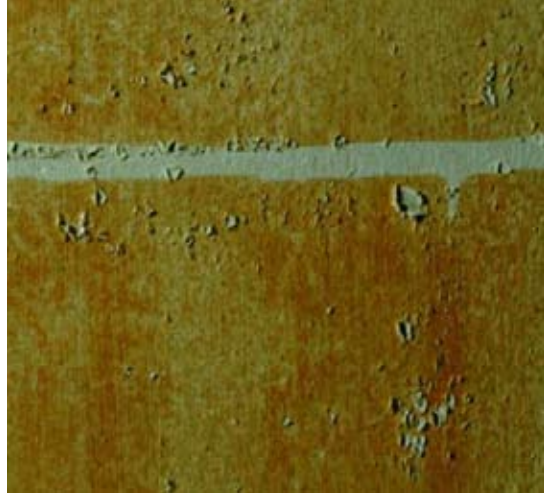
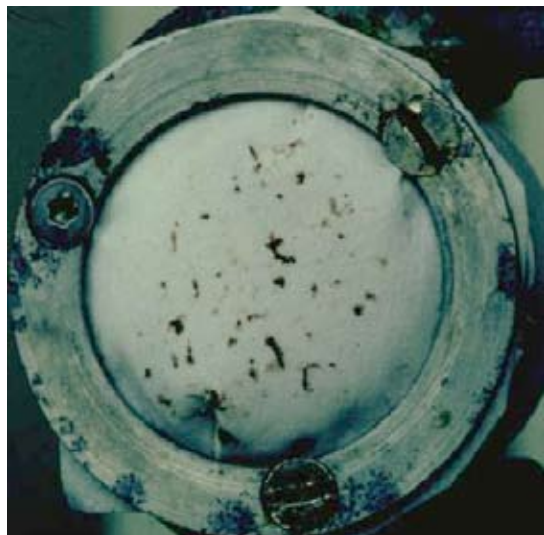
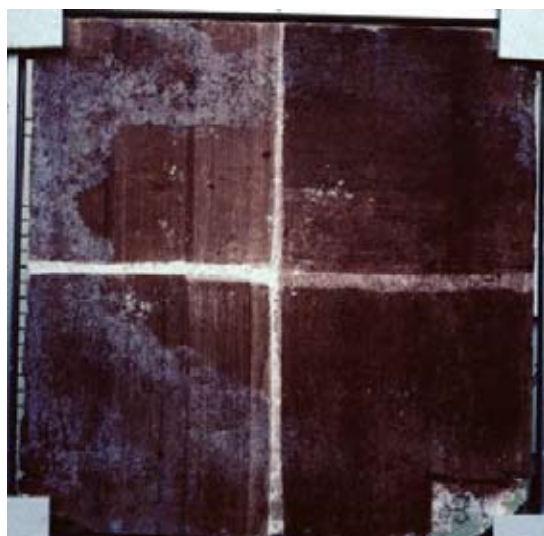
Figure 13. Test panels.

Figure 14. Test panel after ageing.

Figure 15. Test panels after salt damage has occurred.

Tests in the laboratory were made on test panels. Several test panels were coated with plaster, lime wash and different types of pigments. These combinations were used: 1) *lime wash*, 2) *lime wash and paratacamite*, 3) *lime wash and red lead*, 4) *lime wash wet in wet with red ochre*, 5) *lime wash wet in*

wet with red ochre and 6) *lime wash with casein bounded red ochre*. After this a layer of ammonium casein and lime casein was applied (on the left side once, on the right side twice) and the panels were impregnated on the back with $Mg(NO_3)_2$ and NaCl.

The test panels were aged to provoke degrading and flaking of the casein. The disintegrated pigments were consolidated and casein flakes reattached with Klucel E® (a cellulose derivate) and Plextol B 52® (an acrylic). Afterwards the test panels were treated with enzymes according to the Beutel method to remove the casein. The result was positive and no enzyme residues were left on the surface of the painting.

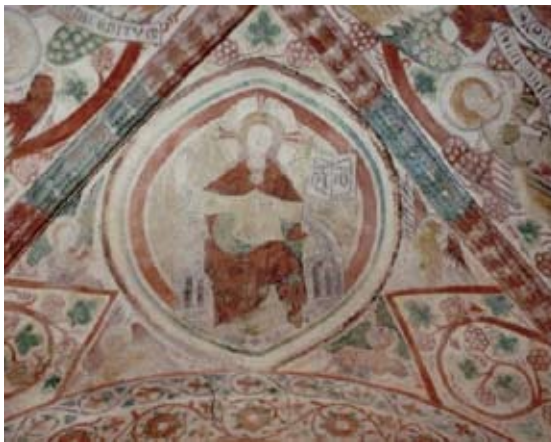
Figure 21. Flaking caused by casein.
Photographs Kerstin Klein.

The background of the project is that casein often has been used during the 20th century in wall painting conservation in Germany. Over time, problems provoked by the casein have occurred; for example darkening of paint layer, flaking and microbial infestation.

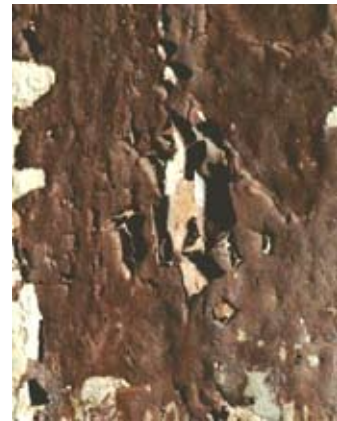
Figure 24. St. Alexandri Church paintings.
Figures 25 and 26. The flaking of colour, St. Alexandri Church paintings.
Figure 27. Before cleaning with enzymes.
Figure 28. After cleaning with enzymes.
Photographs Kerstin Klein.

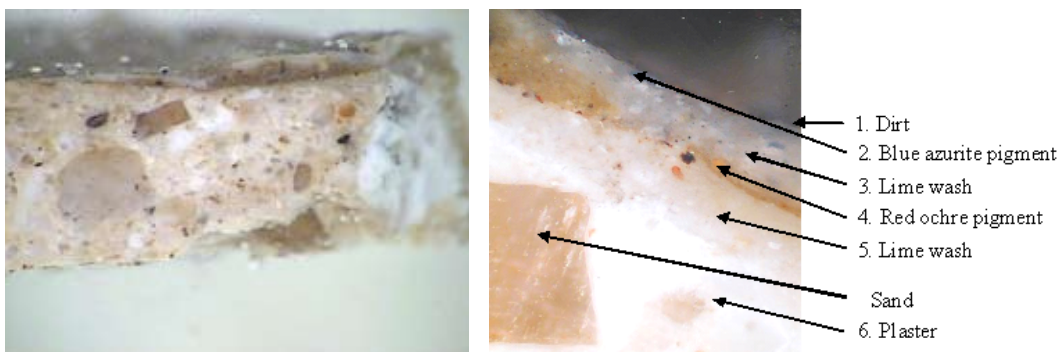
Figure 34. Cross section of the painting.

Figure 35. Cross section of the painting. Original scale 1:100.

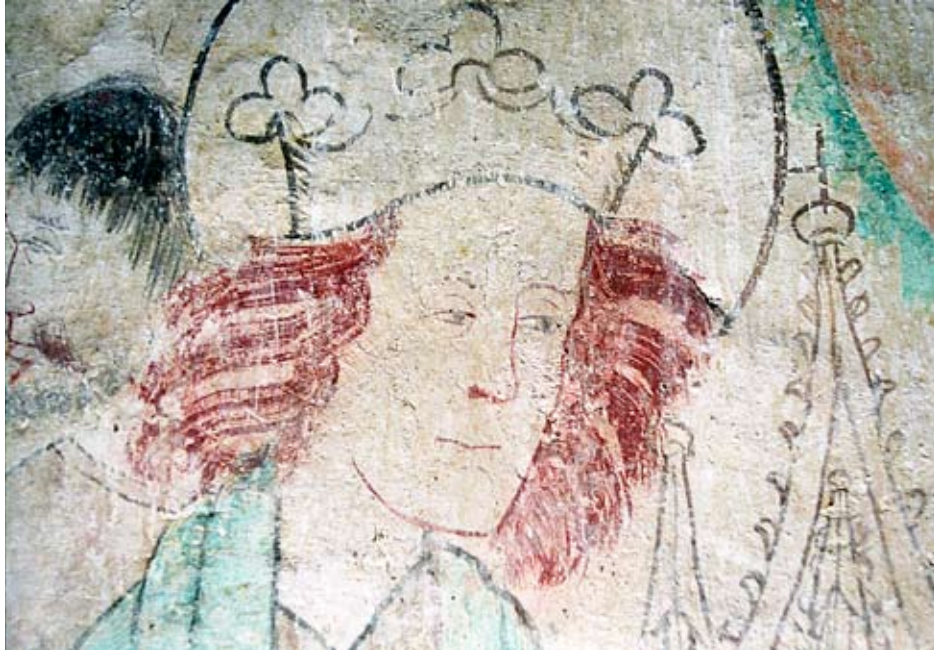
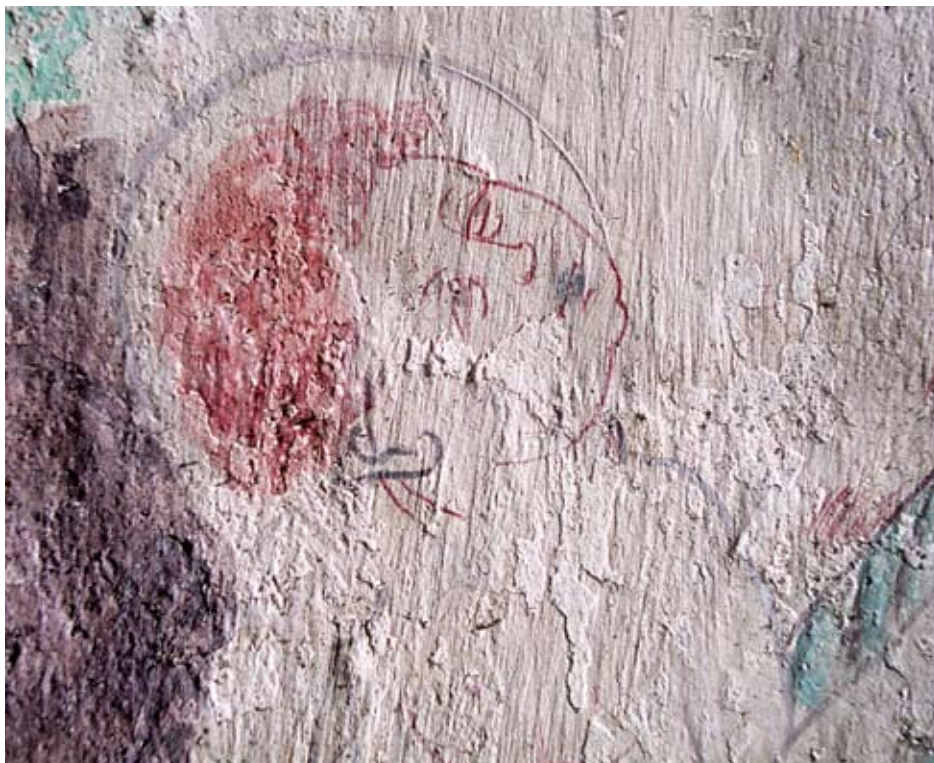
Figures 36 and 37. Figures from the northern wall in the chancel that demonstrate the medieval painting technique. The brush-marks and the brushes used by Ivan were varied according to purpose. Thin brushes for the contours and details and larger brushes for hair, and so forth. Photographs H el ene Svahn Garreau.

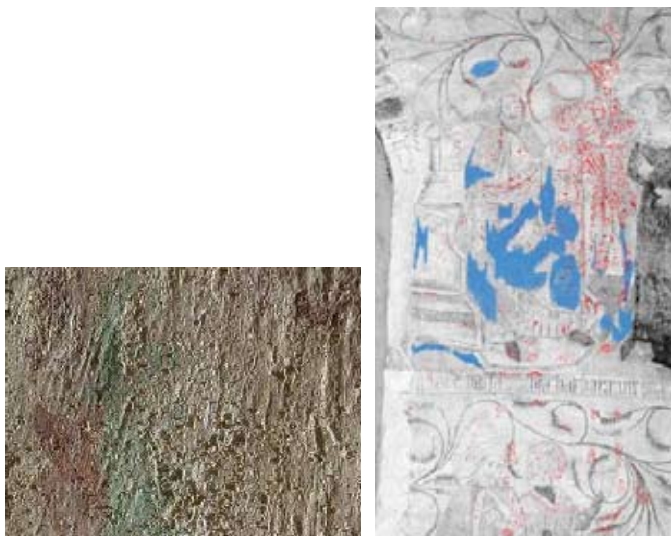
Figure 38. Flaking in the chancel.

Figure 39. Mapping of the flaking and glazed surface (blue).

The painting's main damage phenomenon was the severe flaking of the surface layer in the choir. Some areas were more and others less affected. Another problem was the climate that was too warm and dry in wintertime (probably causing more harm). In addition, a whitish powder and some dark areas were noted on the surface. These problems had to be addressed to establish the threats and causes of damage before conservation and restoration could start and the questions that needed to be answered were:

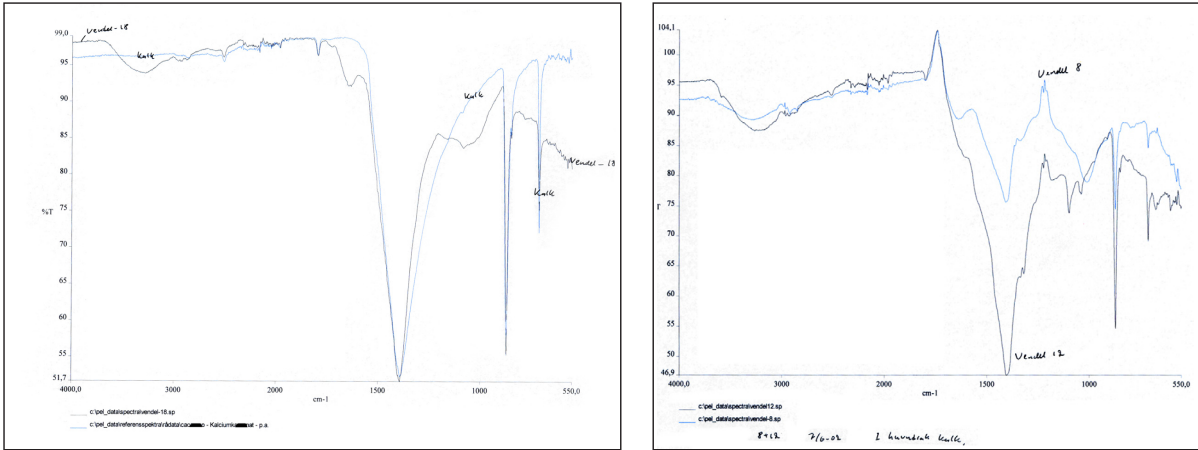
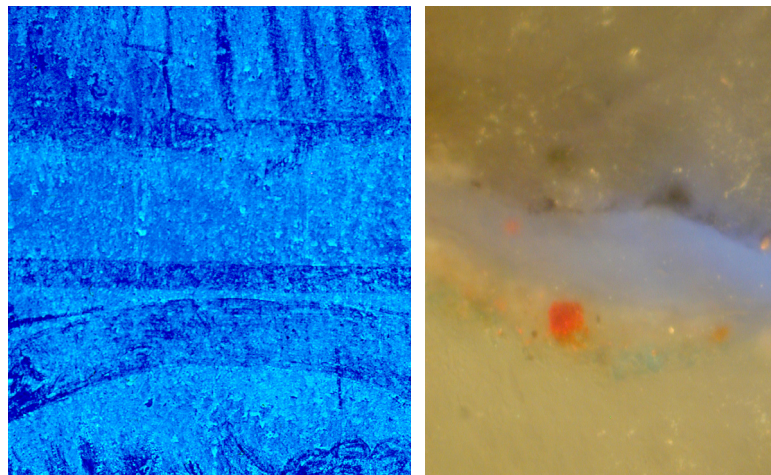
Figures 40 and 41. Results from FTIR from the Analytical Department at the Swedish National Heritage Board.

Figure 42. UV-light. Note the droplets. Photograph Gabriel Hildebrand.

Nilson used an unknown conservation treatment to “fix the weak paint layer” after uncovering the painting with hammers and knives. The treatment had, with time, become yellowish and the surface had a glazed appearance. The problem with the surface treatment was already discovered in 1979 and was investigated by the Swedish National Heritage Board with a microchemical Millon test (any protein containing tyrosine will give a positive answer). The result was positive and the protein was assumed to be casein. When reopening the problem in 2003 Svahn Garreau took samples of the treatment and sent them to the Analytical Department at the Swedish National Heritage Board. No proteins were found in FTIR – only calcium carbonate and a small amount of gypsum. Nevertheless, there was a yellowish coating on the surface. In UV-light it provoked a yellowish-whitish light phenomenon and underneath UV-light it was possible to see that the treatment had been spread rapidly and unevenly, which had caused it to flow down the wall leaving large droplets on the surface. It was reasonable to believe that it was casein (casein can give such a light phenomenon in UV-light). For some reason it was not detected by the FTIR. However, to be sure, further analysis was necessary, although it was not included in Svahn Garreau’s PhD work.

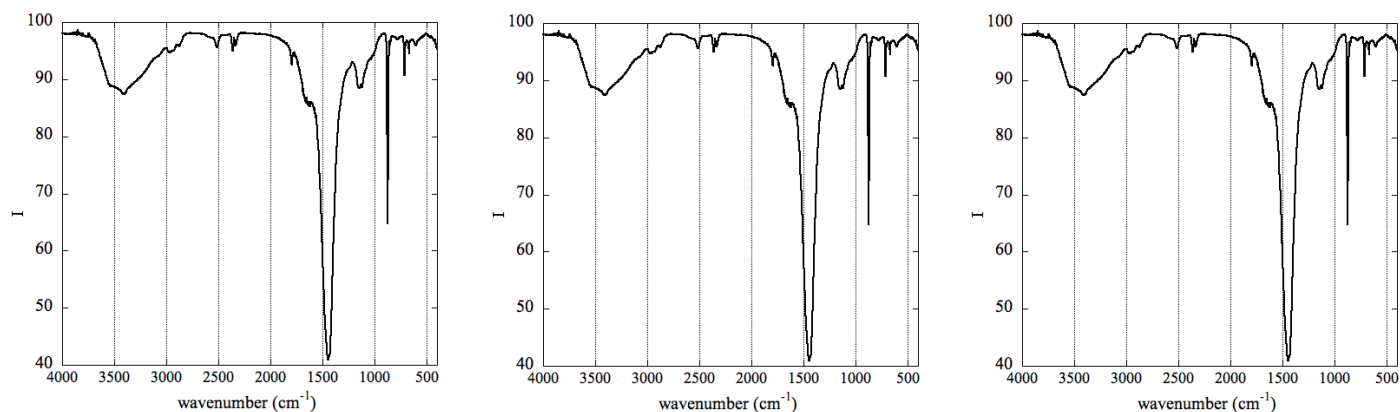
Figures 44 and 45. FTIR of the surface treatment sample from the Chemical Department at Florence University.

Figure 46. FTIR of surface treatment. Sample analyzed at the Chemical Department at Florence University.

In 2003 Conservator-Restorer Misa Asp at the Swedish National Heritage Board invited Dr. Sasha Beutel to test the enzyme method developed in Germany (see above). The portable 2D fluorescence Spectrophotometer was not able to detect the casein on the wall. More samples were sent to the microbiologist Dr. Karin Petersen at Hildesheim's Conservation School. With an ELIZA test she could establish that the surface treatment really was casein. In 2006 more samples were analyzed by Dr. Robert Corkery at the Institute for Surface Chemistry in Stockholm in FTIR and Professor Piero Baglioni at Florence University in FTIR. Both found protein that was assumed to be casein.

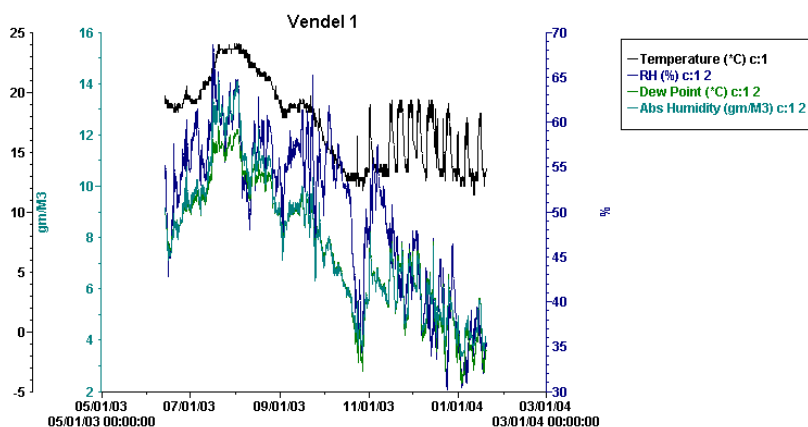
Figure 47. Climate measurement in the chancel with a data log (HOBO H80) between June 2003 and February 2004.

There were variations in humidity between 70% and 30% throughout the year and temperature, between a maximum of 24 °C (summer) and a minimum of 12 °C (winter). The RH changed from 50% in September to 30–35% in January. The result was evaluated by Tor Broström at Gotland University, who is an expert on climate in historic buildings. According to Dr. Broström the variation in RH was too big and the temperature too high in winter. The reason for the great variations in RH during wintertime was that the church was rapidly heated for mass on Sundays (the temperature changed from 13 °C on Friday to 19 °C on Sunday). Hence, Dr. Broström recommended changing the climate in order to achieve less variation in RH and a lower temperature in winter (18 °C maximum). For this purpose he suggested introducing a hygrostat that controls the RH instead of the temperature (between 40–60%).

The climate was measured with a data log (HOBO H80) twice in the chancel and once in the nave; between June 2003 and February 2004 and once between October 2006 and April 2007 (only in the chancel).

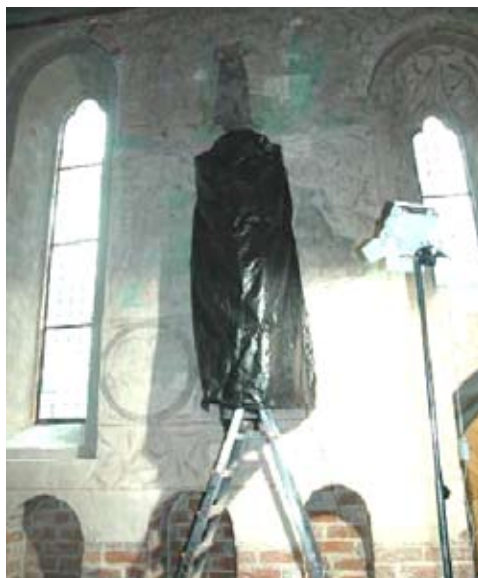
Figure 48. The “dark chamber” constructed for testing if the casein has been reduced in UV-light. Photograph Lena Östlund.

To control that the casein had been properly reduced a UV-lamp was used. A dark chamber (made of a box and a black garbage bag!) was constructed in order to be able to use the UV-lamp in daylight.

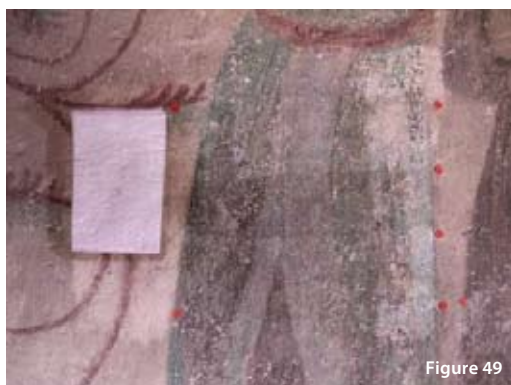
Figure 49

Figures 49, 50 and 51. Enzymatic cleaning.
Photographs H el ene Svahn Garreau and Ragnhild Cleasson.

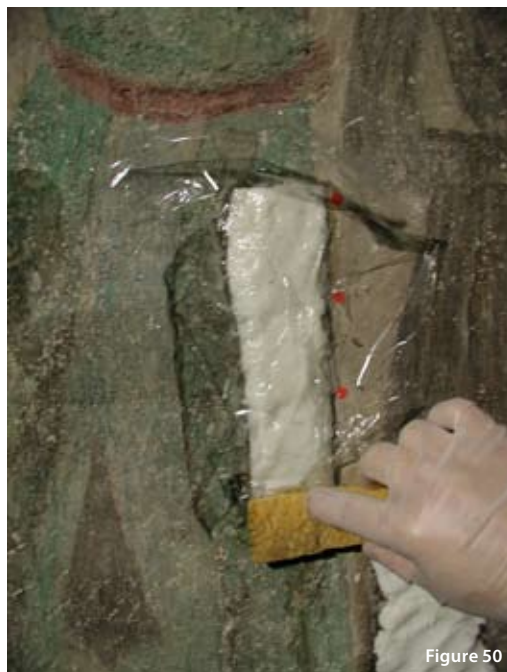
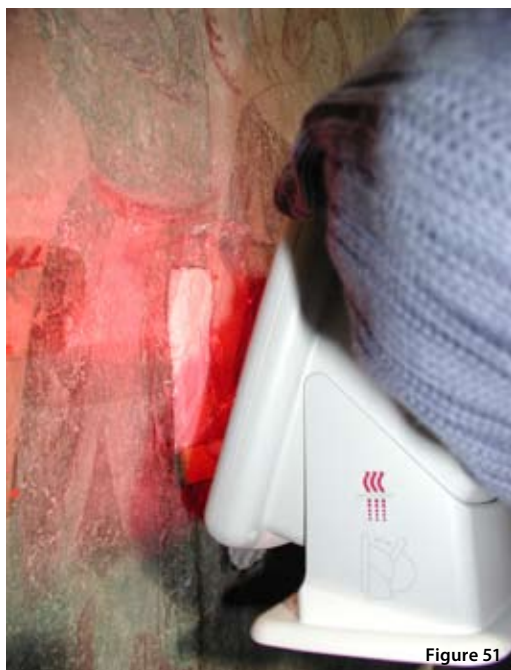
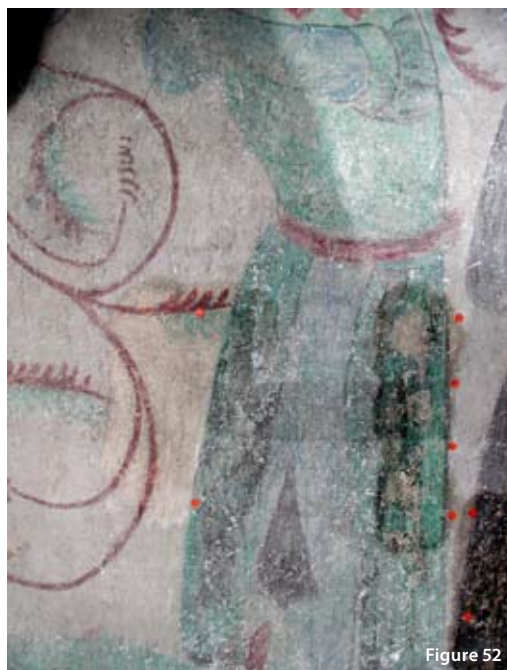
Figure 52. Tests with enzymes, ammonium carbonate and nanolime.
Photographs H el ene Svahn Garreau.

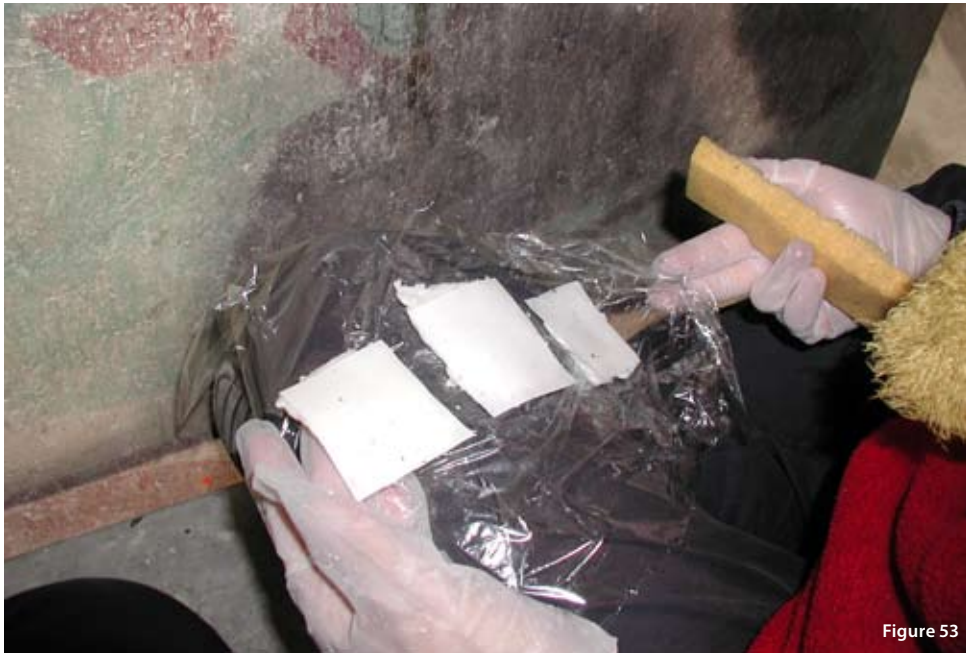
Figure 53

Figure 53. Tests with enzymes, ammonium carbonate and nanolime.
Photographs H el ene Svahn Garreau.

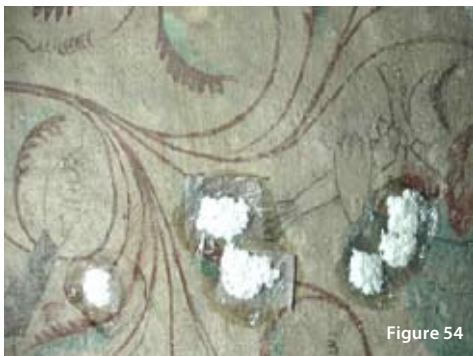
Figure 54

Figures 54 and 55. Tests with microemulsions and nanolime.
Photographs Lena  stlund.

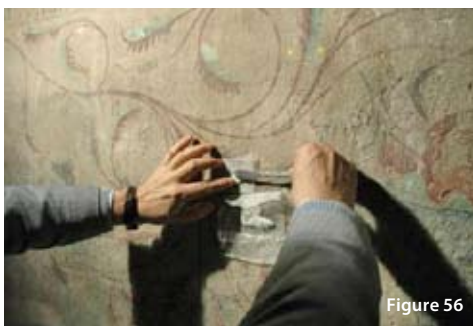
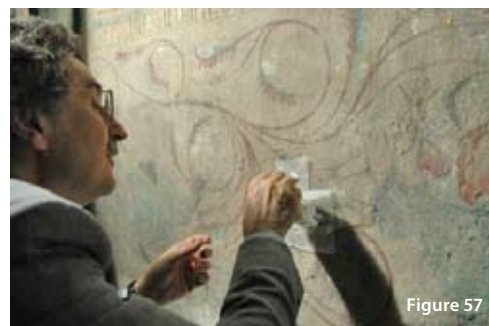
Figures 56 and 57. Tests with microemulsions and nanolime.
Photographs Lena  stlund.

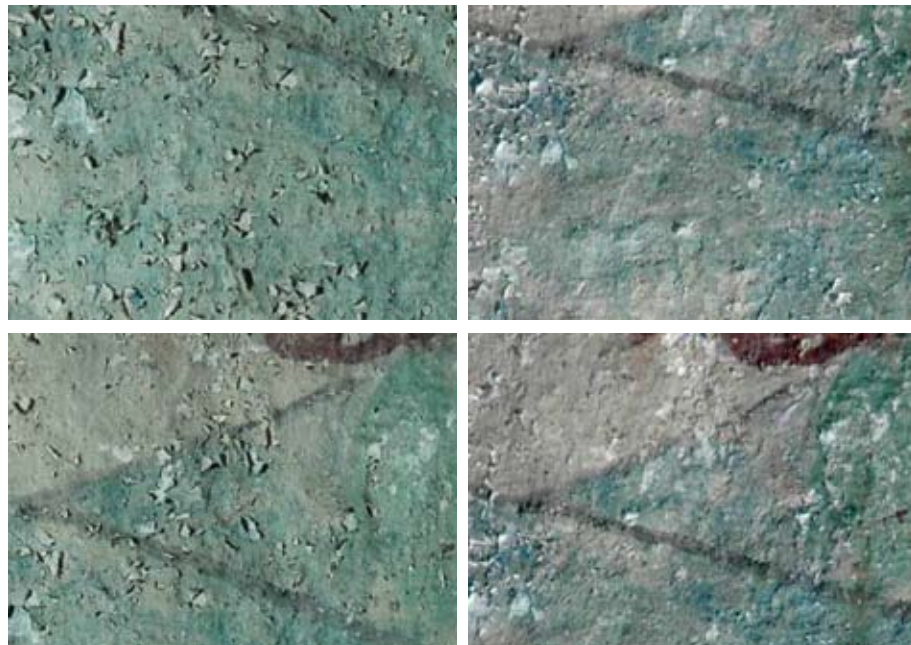
Figure 58. Before the nanolime/ME treatment (Sistema 3).

Figure 59. After the casein reduction with Sistema 3 and nanolime treatment.

New tests. Since none of the methods proved to be good enough, it was decided that more tests were required. Hence, new tests were made in 2006 with the Barium method, cleaning with gomma pane and attaching the flakes with Paraloid B 72®. The results with these methods were not satisfying. With the assistance of Professor Baglioni more tests were made with nanolime to attach the flakes and ME to reduce the casein. He proposed to reverse the methodology into a wet-in-wet system that first applies the ME and afterwards the nanolime. Finally, the results were good. The best results were achieved with nanolime and the oil-in-water ME (named Sistema 3 – see above). This system was effective, did not darken the painting, change the blue or green copper pigments, leave any salts, was easy to use, not too timeconsuming, available (professor Baglioni could provide the nanolime) and had a relatively low environmental and human risk. Moreover; the nanolime is completely compatible with the painting (it is same material). The only risk was if traces of the surfactant (Triton X 100) would remain in the painting. However, these traces would be removed with the washing compress.

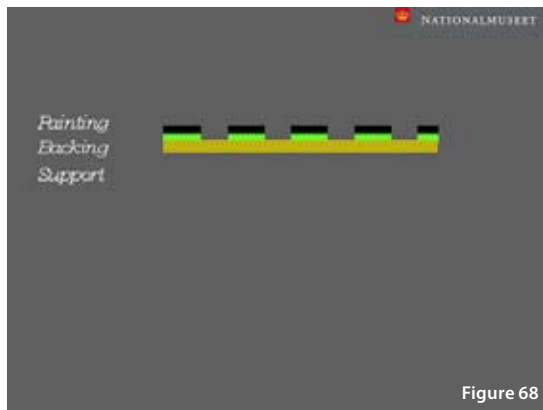
Figure 68

Figure 68. With the wrong technique, parts of the paint layer are lost when the facing is removed. Isabelle Brajer, Nationalmuseum, Denmark.

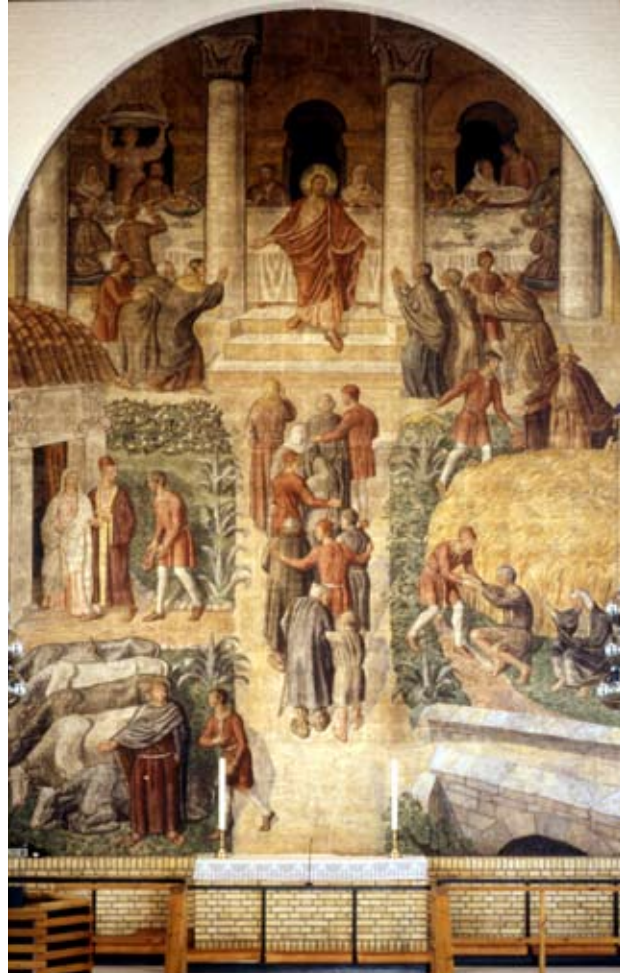
Figure 69. The strappo made by Steffanoni in Klaksvik Cathedral.
Photograph Isabelle Brajer, Nationalmuseum Denmark.

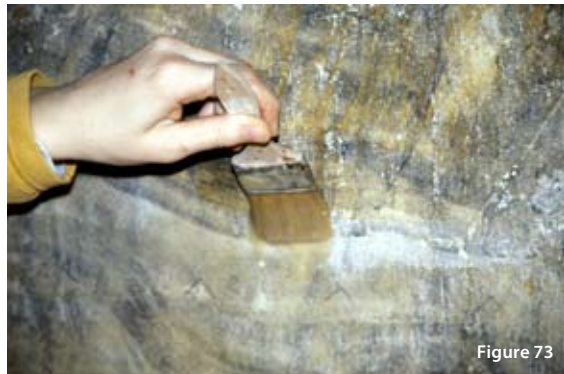
Figure 73

Figures 71 and 72. Viborg cathedral.
Figures 73, 74 and 75. Pictures of the preparation of the strappo in Viborg cathedral 1994.
Photographs Isabelle Brajer, Nationalmuseum Denmark.

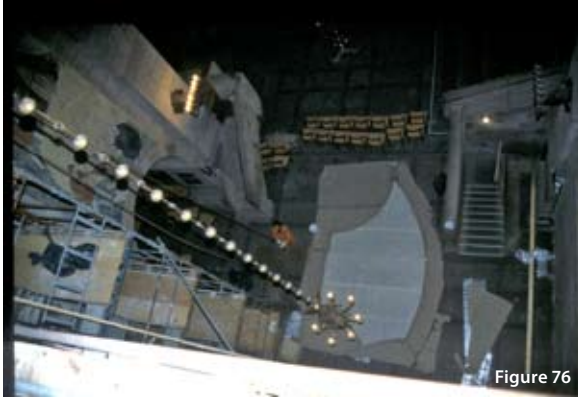
Figure 76

Figures 76, 77 and 78. The strappo made in Viborg cathedral in 1994. It is transported into the conservation laboratory at Nationalmuseum. **Figures 79 and 80.** The facing is removed from the detached murals in Viborg cathedral in 1994. Photographs Isabelle Brajer, Nationalmuseum Denmark.

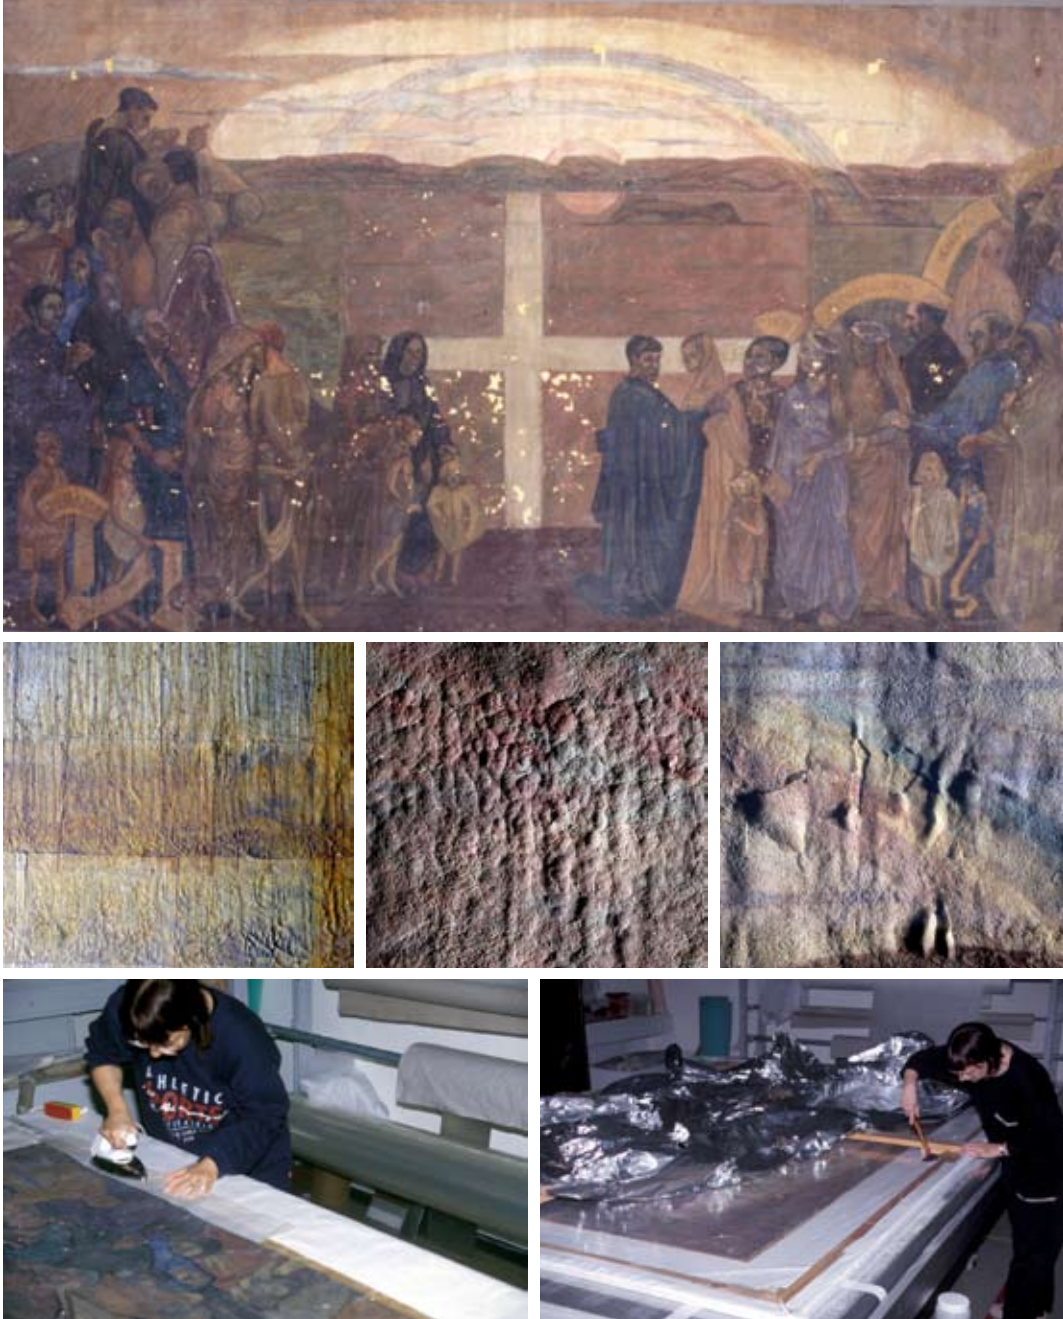
Figure 81. The strappo. Photograph Isabelle Brajer, Nationalmuseum Denmark.

Brajer also presented some other conservation work of strappos made by Risebye and his students, for example a transfer made by Leo Neuschwang and a mural moved by Sophie B Jensen in 1953, now found in Duborg Skole in Flensburg. The paintings suffered from deformation and flaking. Brajer developed a successful conservation methodology using a low pressure vacuum table. She removed as much as possible of the oil caseinate and the old canvas, used PVA in ethanol for the new facing and BEVA 371[®] to attach margins on the low pressure vacuum table. Afterwards the strappo was remounted using BEVA 371[®] onto rigid Honeycomb plates.

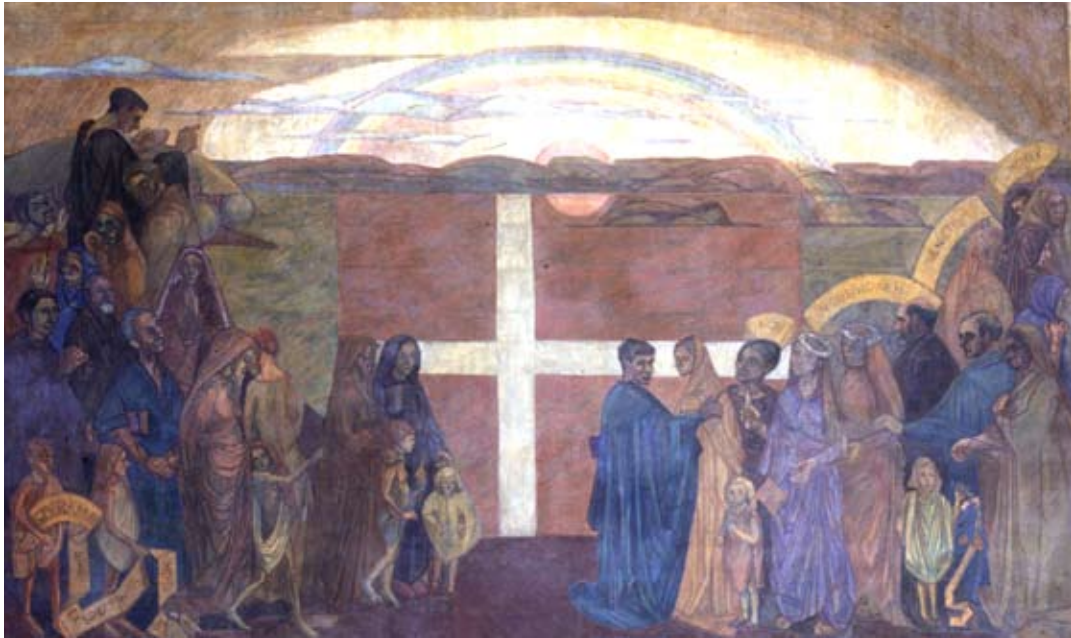
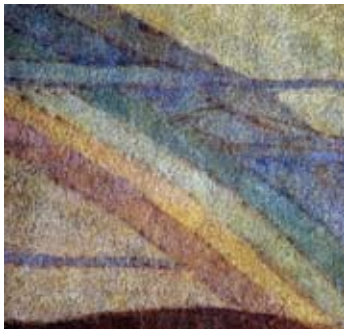
Figures 87 and 88. The final result. Photographs Roberto Fortuna, Nationalmuseum Denmark.

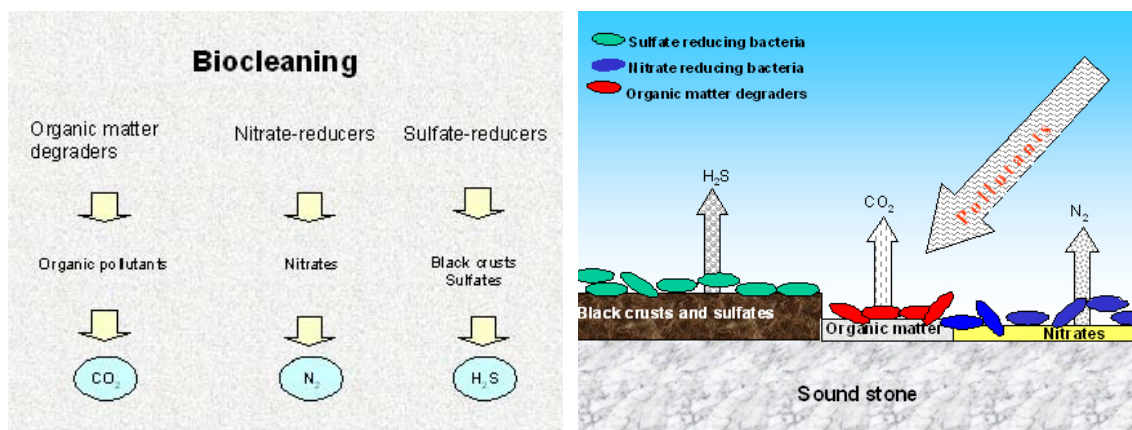
Figures 89 and 90. The biocleaning reduces organic matter, nitrate and sulfate products into volatile gases.
 Dr. Francesca Cappitelli, DISTAM, University of Milan

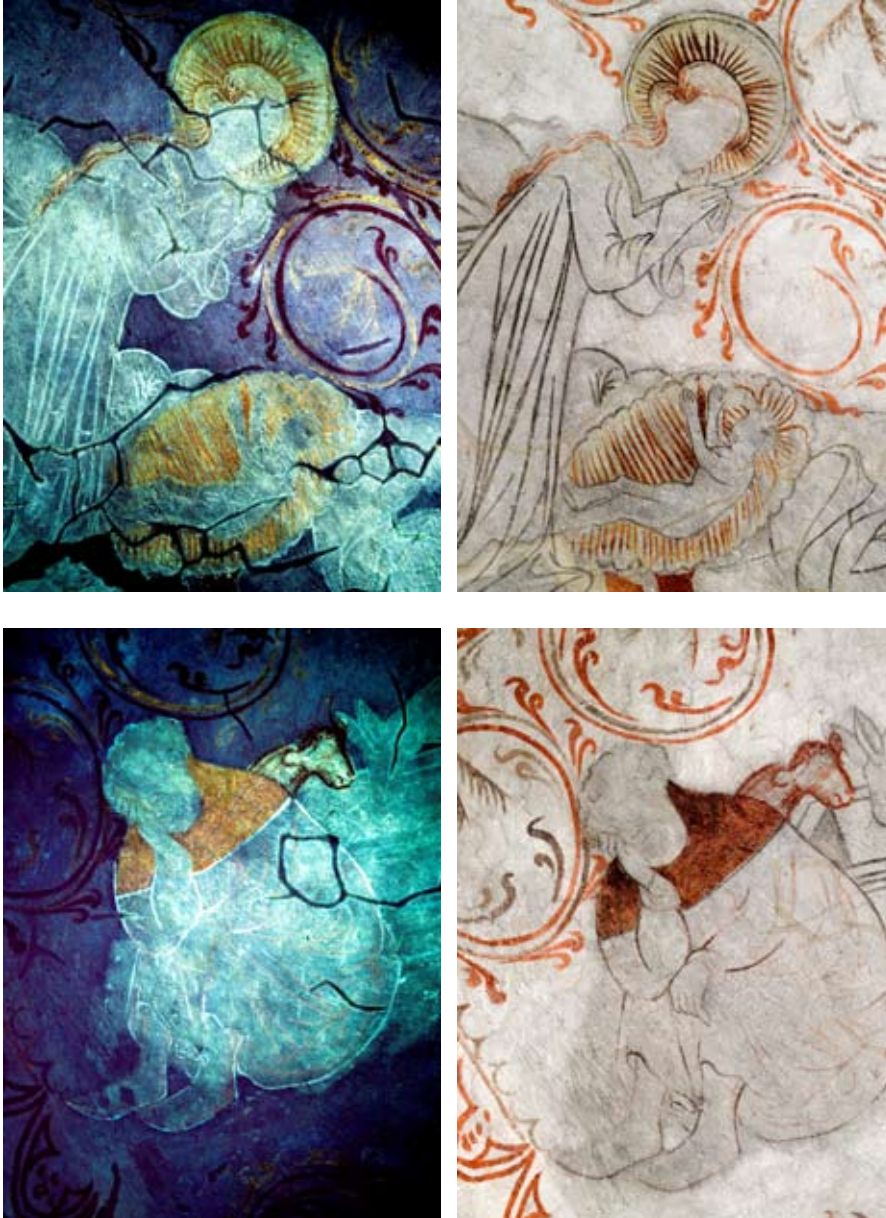
Figures 98 and 99. The murals in Undløse Church in UV-light and normal light. On the UV photograph, the yellowish-whitish areas are where the resin/oil has been used, and the luminous contours are where the Carlsberg Preparation (casein, poppy seed oil/colophony) has been used. Note that these areas are darker than the untreated areas in the normal light photograph. Photographs Roberto Fortuna, Nationalmuseum Denmark.

Figures 100 and 101. The murals in Undløse church in UV-light and normal light. In the UV-photo the area that fluoresces corresponds to the area that is dirty in the photograph taken in normal light. Photographs Roberto Fortuna, Nationalmuseum Denmark.

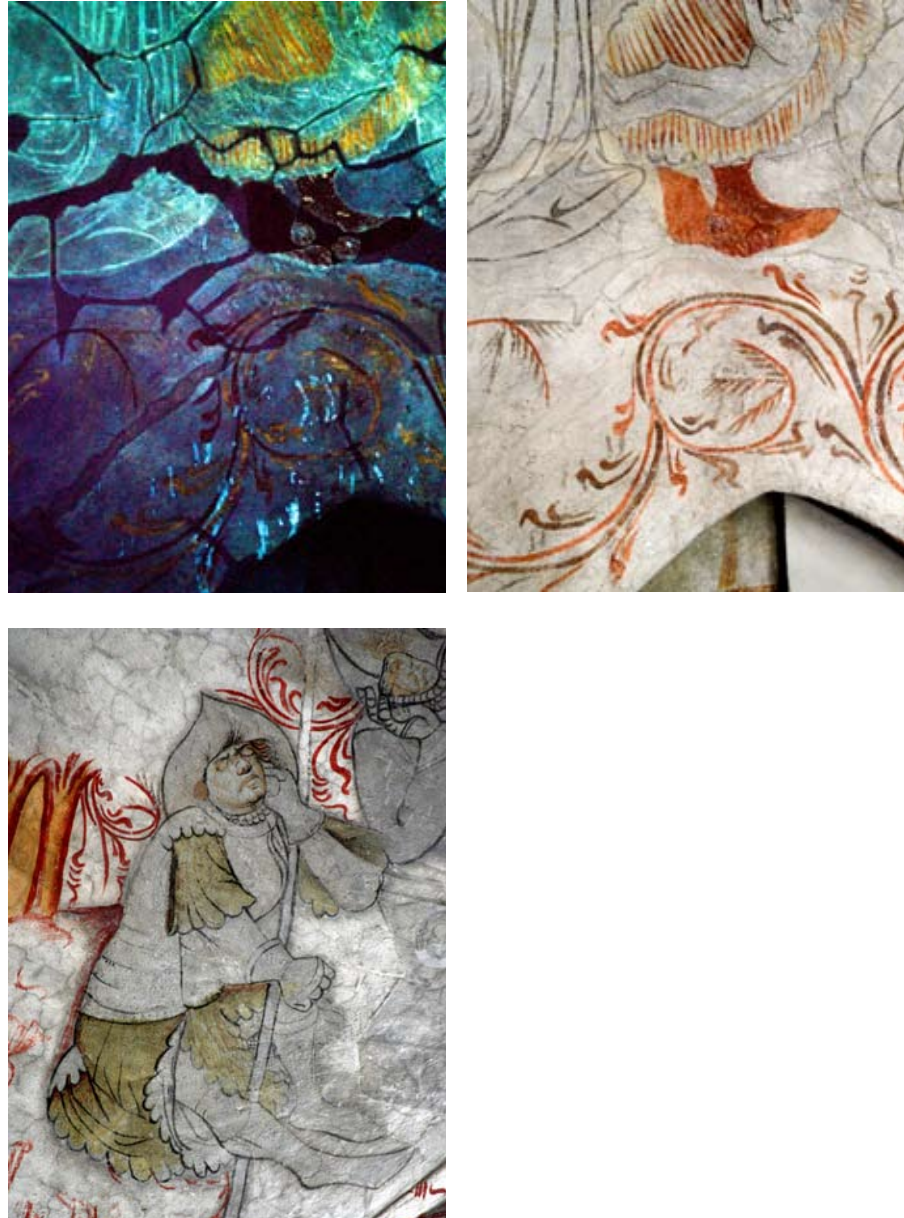
Figures 102 and 103. The murals in Undløse Church in UV-light and normal light. In the UV-photo small drips and splashes visible as strong white fluorescence have been identified as milk, which was used in the restoration of the wall paintings in 1956 in connection with the plaster repairs (black forms on the UV-light photograph). Photographs Roberto Fortuna, Nationalmuseum Denmark.

Figure 104. Mural painting in Undløse Church. The figures that have been treated with the Carlsberg preparation and oil/resin are darker than the surrounding areas because they attract dust. Photograph Roberto Fortuna, Nationalmuseum Denmark.

The production of the Carlsberg Preparation required laboratory equipment and was expensive, and therefore it was used sparingly. In Undløse Church Rothe used it only on the most important areas (the contours of the figures). The figures were treated with a simpler mixture of colophony and poppy seed oil, which the conservator probably mixed himself. The organic substances on the surface of the paintings have caused problems with time: the treated surfaces attract dirt. Consequently, the treated areas are darker than the surrounding areas, which disturb the enjoyment of
