KINROSS HOUSE
Kinross

Conservation Plan
Simpson & Brown Architects
November 2010

Contents	Page
1.0 Executive Summary	3
2.0 Introduction	4
2.1 Objectives of the Conservation Management Plan	4
2.2 Study Area	5
2.3 Heritage Designations	6
2.4 Structure of the Report	7

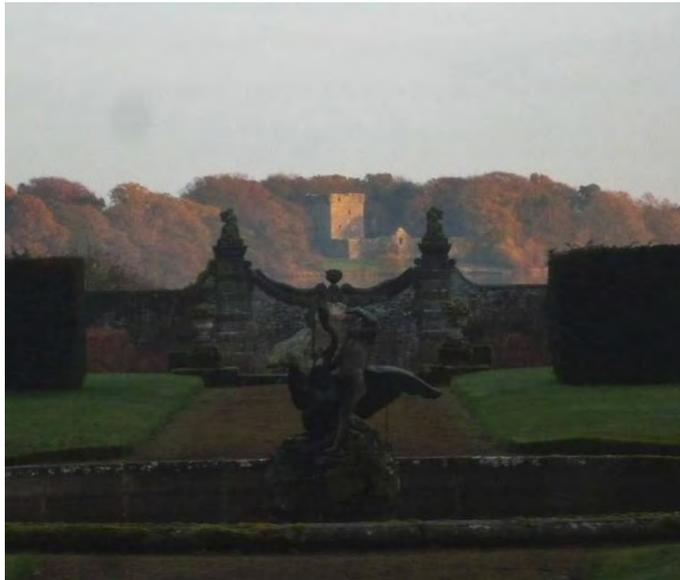
Figure 12 Loch Leven Castle from Kinross House S&B

The house that originally commanded the Kinross estate was Loch Leven Castle, a fortress with a long history, connected to many incidents involving the fate of several reigning Scottish monarchs in the medieval period, culminating with the imprisonment of Queen Mary I, known as Mary, Queen of Scots. The fact that the present estate is deliberately orientated on the castle suggests that it was imbued with some deeper significance than merely terminating a vista (Fig. 12).

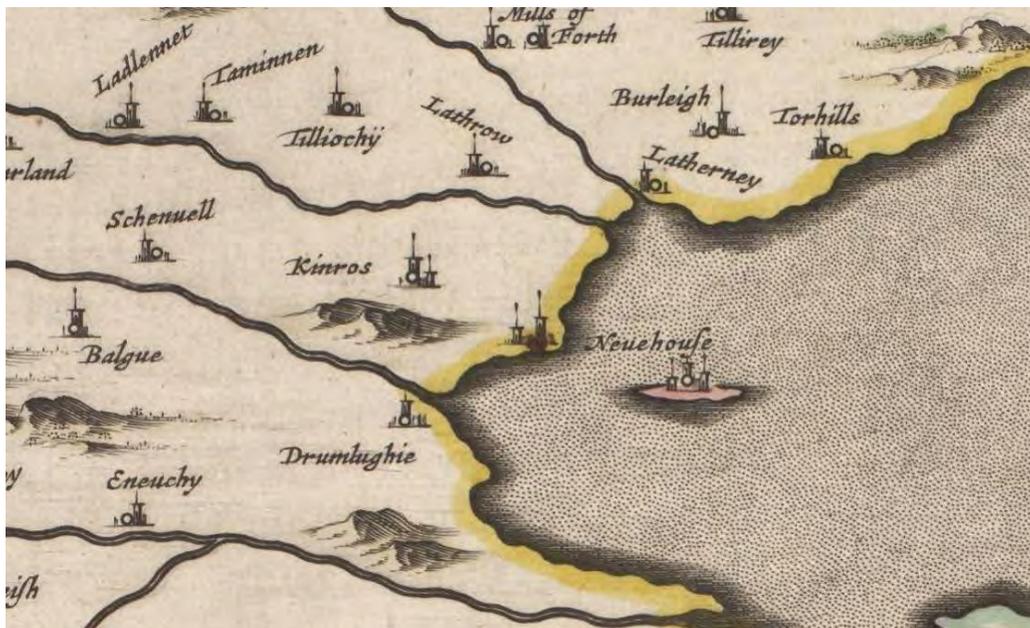
Figure 14 Detail *Blaeu Atlas*. Published 1654. NLS

Kinross is not featured in Timothy Pont's maps of Scotland from this period, surveyed and published in the 1580s and 90s. The estate first appears in the Blaeu Atlas, published 1654 (Fig. 14). This map, while little more than confirming that the estate existed in the first half of the seventeenth century, labels the two structures associated with the estate as "Neuehouse", and makes no distinction between Loch Leven Castle and Newhouse. The name "Kinros" only appears in relation to the town to the west of Loch Leven. There is no other cartographical evidence of the estate in this period before the laying out of the grounds by Bruce in the 1680s.

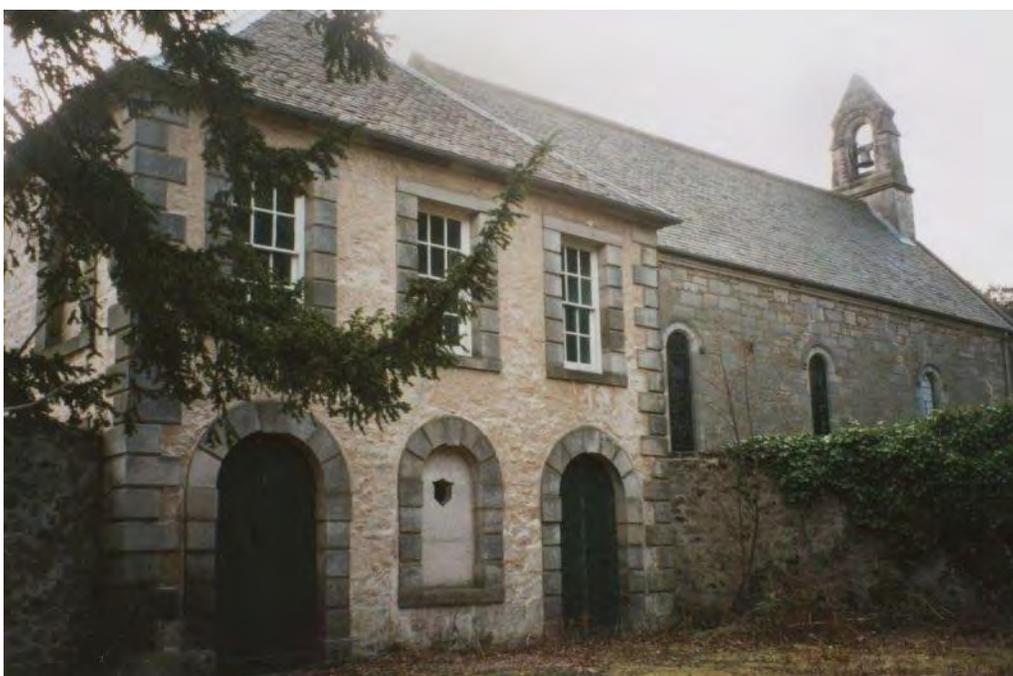
Figure 21 Hopetoun Aisle, Abercorn Kirk. RCAHMS

There is no other visual evidence of how the stables and coach house appeared, however they were probably similar to Bruce estate buildings at Pitmedden (Aberdeenshire) and Hopetoun (West Lothian), the Hopetoun Aisle at Abercorn Kirk, and the façades of the outbuildings illustrated on the Edward façade drawing, analysed subsequently in section 3.3.4 (Fig. 21).

These buildings have alternating header and stretcher rusticated quoins, and parallel-sided rusticated window and door margins. The structure of these secondary buildings would otherwise have been executed in random or coursed rubble, and would have been finished in lime plaster.⁵⁷ In these respects, they would have been similar to the extant pavilions terminating the quadrant links.

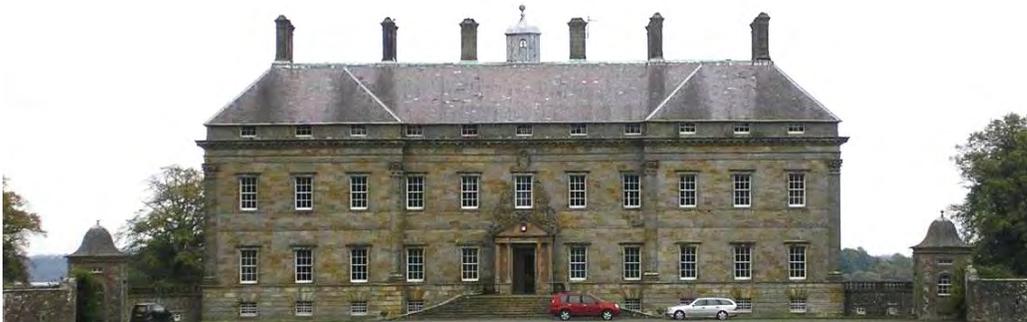
Figure 25 Kinross House. West façade. S&B

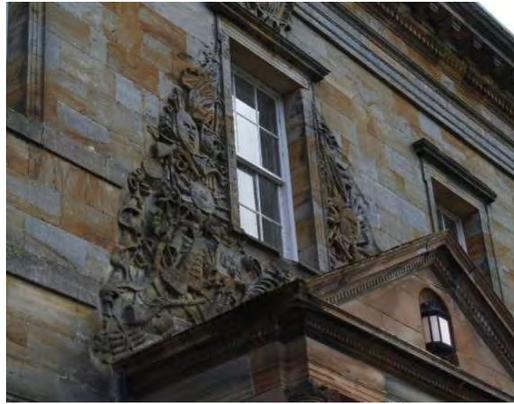
Figure 26 Kinross House. Carving on west elevation S&B

on the understanding that it is largely recessed into the plane of the wall. However, elements of the carving do stand clear of the wall plane, most obviously around the window margins, and the only reason for carving in may have been because insufficient stone had been left proud, or a mistake was made by the carver (Fig. 26). The pedimented doorcase and carving certainly appears on the *Vitruvius Scoticus* engraving and was re-created in the new porch at the turn of the twentieth century (see 3.5).

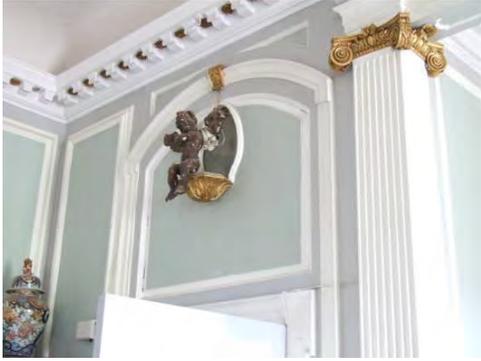
Figure 29 Kinross House. Mandorla-shaped lights over doors into south stair hall. *S&B*

large span of the Great Dining Room floor above. The building accounts for 1691 record work in the 'Ante Cham[ber] next Stair Case', labelled as 'r', the Waiting Room on the Edward plan. This arrangement of the ante rooms explains the arrangement of borrowed light for the back stair cases, originally only through the small mandorla-shape lights over the doors into the north and south halls (Fig. 29).

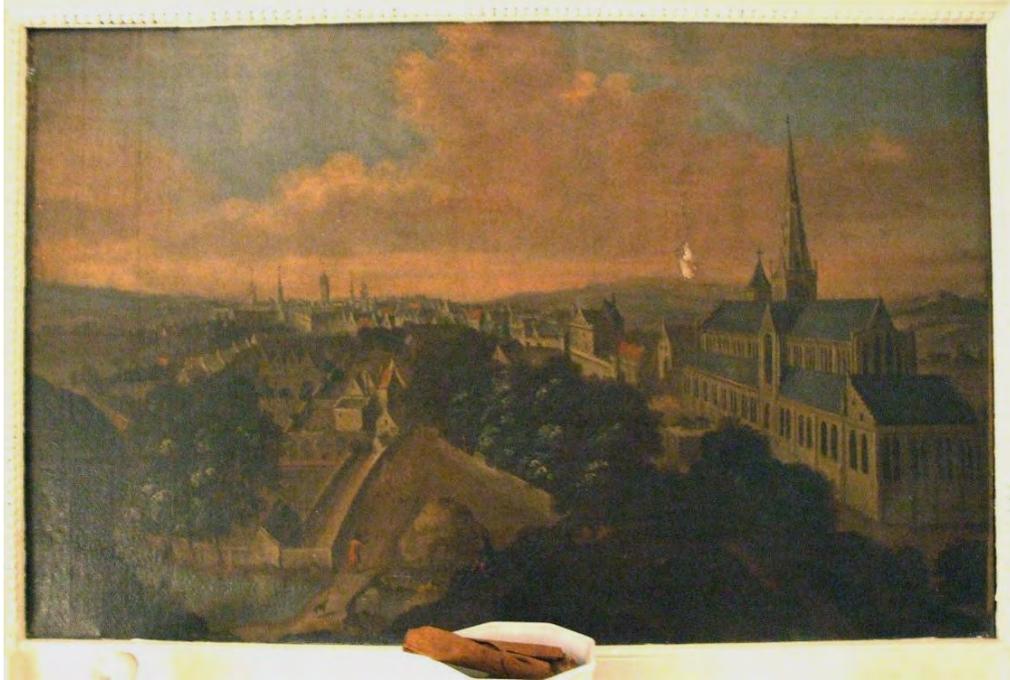
Figure 33 Kinross House. Over-mantle painting south east bed chamber, chamber storey. S&B

Paintings were also supplied to Bruce in 1692 and subsequently, and unlike the hangings, many survive in their original positions.⁶⁶ The best example is a set of over-door paintings in the manner of Dutch still-lives in the south east bed chamber on the entrance storey. Several over-mantle paintings remain *in situ* on the upper floors, the most significant being in the south east bedchamber on the chamber storey, a copy of *A prospect of Glasgow from the north east*, plate 17 of Slezer's *Theatrum Scotiae* published in 1693 (Figs. 33 & 34).

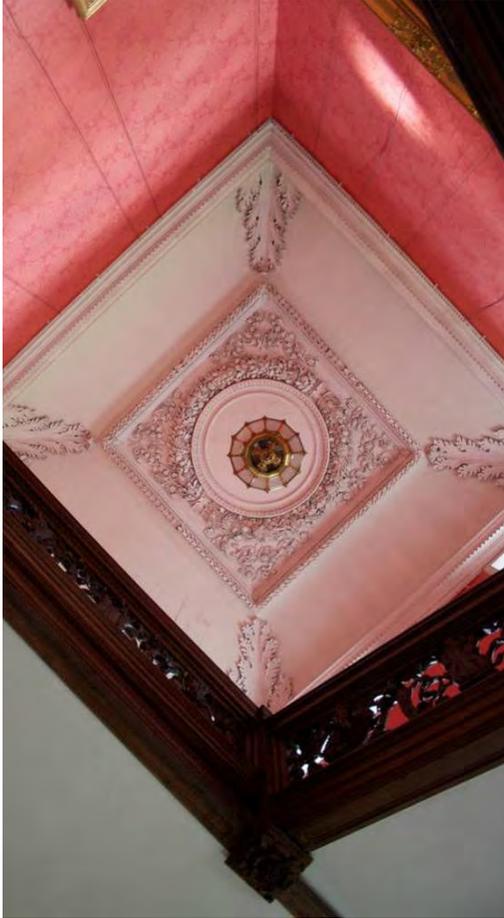
Figure 35 Kinross House. State stair ceiling. S&B

This space indicates the point at which the building of the house stalled. Though the entrance storey was fitted up with wall-hangings and paintings for occupation by the family, the state apartment on the principal storey was left incomplete, with only the most basic of interior fittings. The state stair ceiling is an indication of the elaborate nature of the ceilings that were to follow it in the rest of this level (Fig. 35). None of the plaster ceilings intended for the Great Dining Room, state withdrawing room, antechamber and state bedchambers were installed.⁶⁸ A comparison to Bruce's

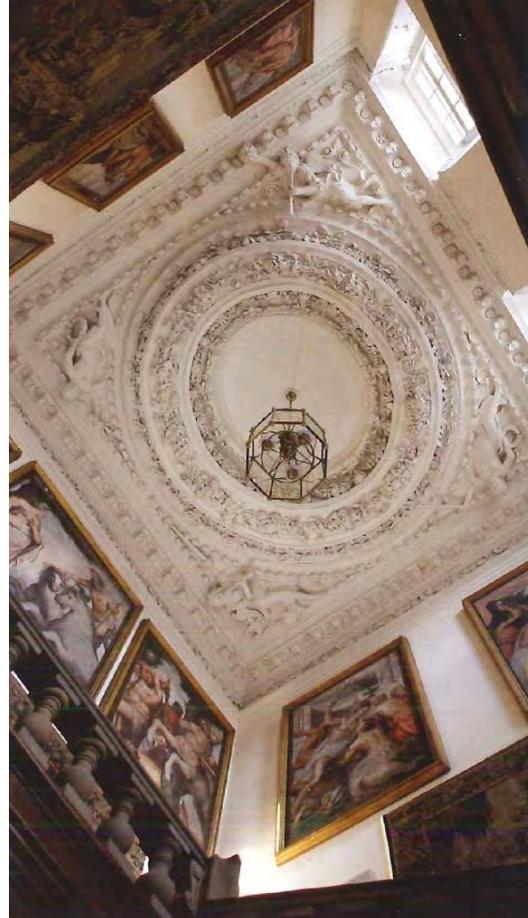
Figure 36 Palace of Holyroodhouse, state stair ceiling. *The Palace of Holyroodhouse: Official Souvenir Guide* (Royal Collections Enterprises, London: 2010)

contemporary interior schemes at the Palace of Holyroodhouse shows that though the state stair has an elaborate ceiling, those of the state apartments are even more elaborate, several with canvases depicting allegorical scenes fitted in their central roundels, and Bruce certainly intended the same effect at Kinross, and was intending to use the same craftsmen (Fig. 36).

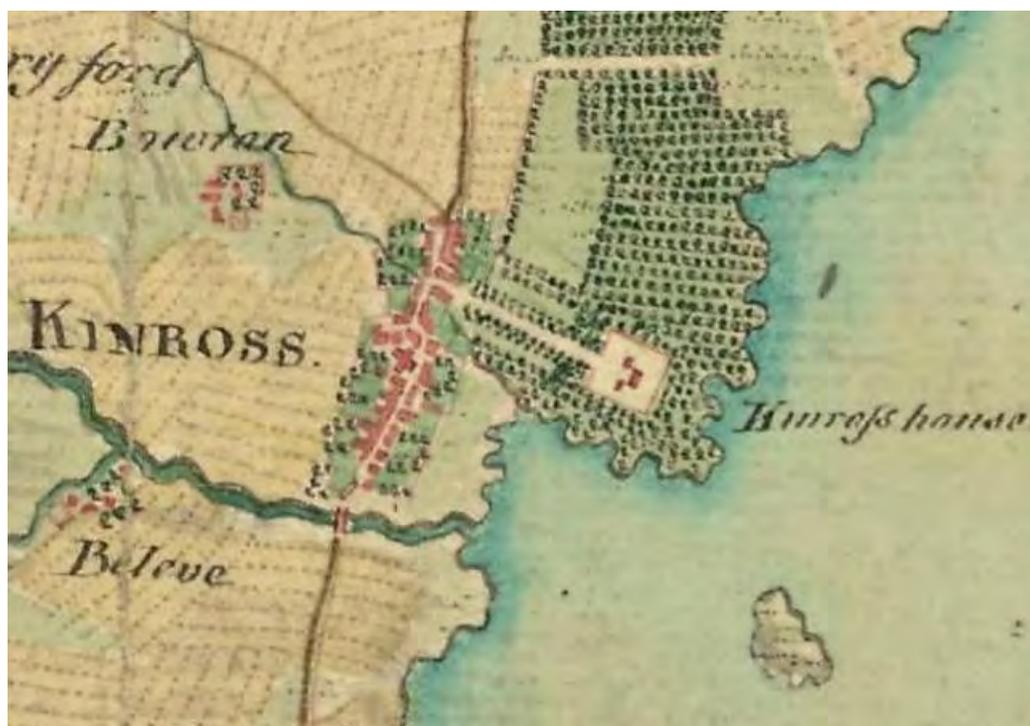
Figure 37 General Roy's military survey map c.1750 NLS

General Roy's Military Survey of Scotland (1747-1755) is not always an entirely reliable source for the layout estates and the sheet showing Kinross is no exception (Fig. 37). Though the footprint of the house is present, it is not accurate in detail, showing a rectilinear outline for the main block, instead of the advanced corners of the built design, connected to similarly rectilinear outbuildings by straight links, not curving quadrants. The house is shown in a square enclosure with no marked features, bordered by woodland and accessed by the tree-lined avenue. There is no indication of any stables, carriage sheds or indeed any estate buildings. Though the square enclosure relates to the Great Court marked on the Edward plan, the fact that there is no connection of the house and its enclosure to the loch side suggests that this plan is merely indicative, and is not a reliable source for the layout of the estate in the mid eighteenth century, nor for confirming the presence or absence of estate buildings.

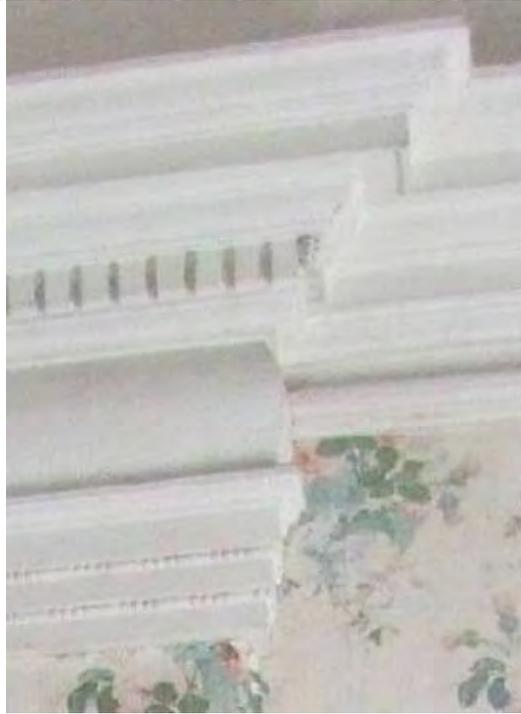
Figure 40 Kinross House. Detail of chimney cornice in state anteroom S&B

It is however in this period at the end of the eighteenth and the beginning of the nineteenth century that the inlaid marble chimneypieces in the state drawing and dining rooms were installed, probably replacing lesser quality timber chimneypieces. The chimneybreast plaster work in both rooms is of the Bruce period, being a full entablature with bead-and-reel architrave, pulvinated frieze and dentil cornice. Distinctively, each run of dentils is terminated at the corner with an inverted fir cone. As in other rooms, this entablature only adorns the chimneybreast, a simpler run cornice topping the other walls (Fig. 40). The two mantelpieces themselves are of inlaid white marble, of differing but similar propriety design, one with a carved plaque. Neither is consistent with the early or mid eighteenth-century function of the rooms as state rooms, and by the time they were installed, the rooms must have changed their function and been redecorated economically.

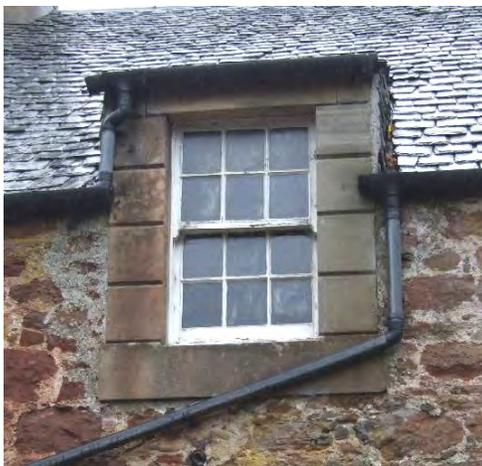
Figure 42 Kinross House, stable courtyard, east range. *S&B*

The only elements of dressed masonry of comparable quality to the Bruce-period garden wall piers, are the rusticated window margins on the wall-head dormer windows in the east range (Fig. 42).

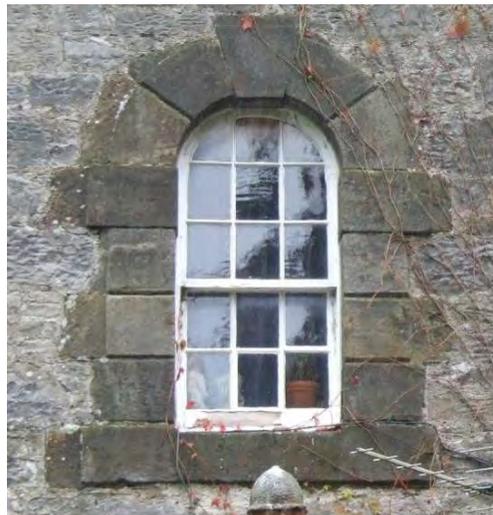
Figure 43 Kinross House stable courtyard, east pavilion. *S&B*

The round-headed windows of the south range, and some of the upper windows of the pavilions visible from the drive (Fig. 43) are not similar to the two round-headed windows of the Bruce period on the pavilions of the house (Fig. 44). They are not rusticated, only their key and springer stones stand proud of the rest of the margin, whereas those in the stable are fully rusticated.

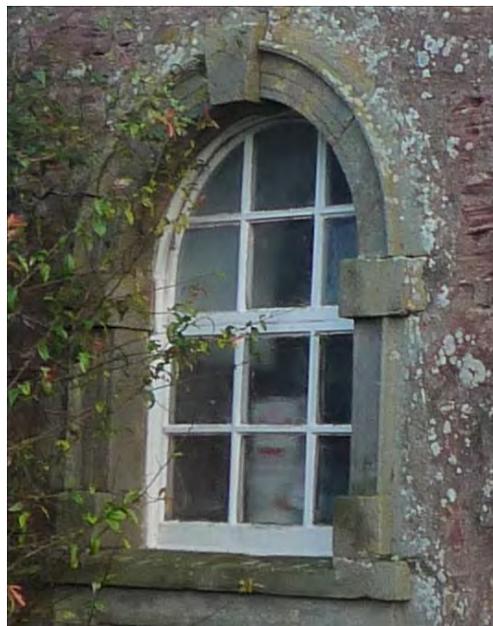
Figure 44 Kinross House, north pavilion. *S&B*

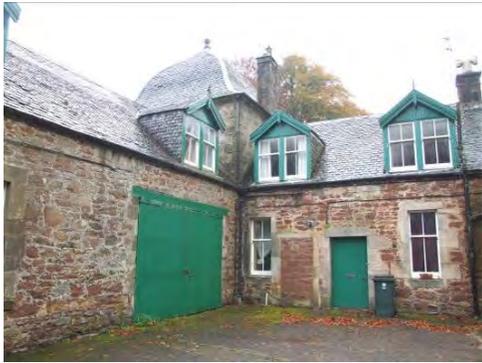
Figure 45 Kinross House stables, south east angle. *S&B*

The courtyard façades show a plethora of different window and door openings, with the barge-boarded dormers dating from the early twentieth century. There are also sills remaining in place from vanished wall-head dormers in all three facades (Fig. 45). Internally, one of the spaces originally intended as a stable, has hay niches in the wall supplied by chutes from the hayloft above, now cut by the later plaster ceiling. At three points in the south range, the wall was opened and a lintel inserted to create

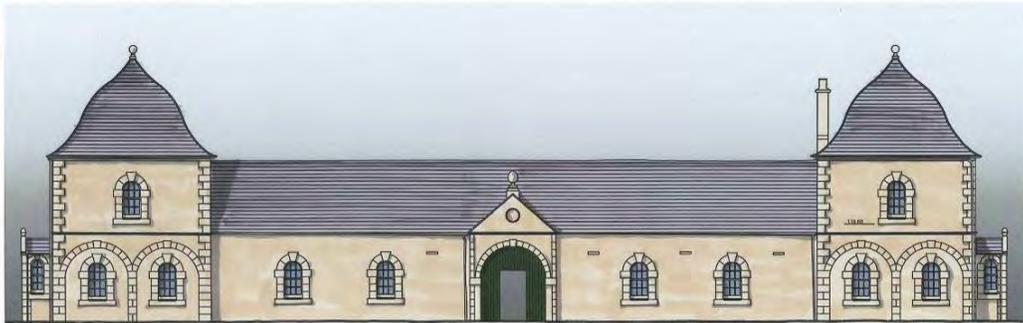
KINROSS HOUSE
Stable Block

Figure 46 Kinross House, stable courtyard, south façade as existing. *S&B*

These round-headed windows in the south range also date from different periods themselves, with those in the pavilions having been added subsequently. Gifford states that they are all insertions of the same period, however it is clear that they date from two phases.⁹⁰ When first built, this façade seems to have had no window openings, only sandstone ventilation slots. Subsequently, windows were introduced, perhaps in the mid eighteenth century, when the ground floors of the pavilions were converted for vehicular storage and had paired arched openings inserted, cutting some of the quoins (Fig. 46).

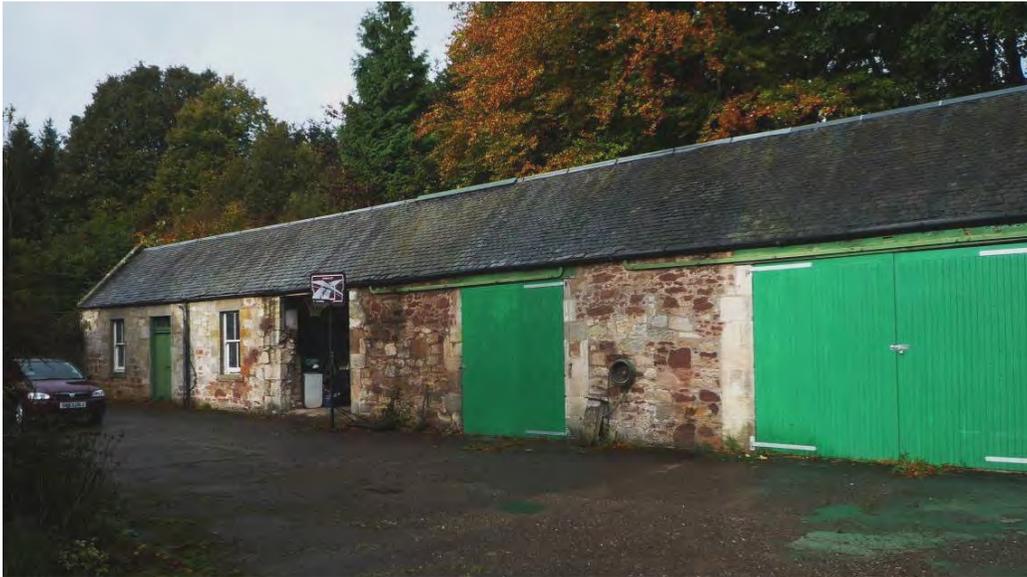
Figure 47 Kinross House stables, north range. *S&B*

The north range that stands apart from the others was extended between the 1798 estate plan, which records it as sited fairly symmetrically within the bounds of the other ranges of the U-plan, and the 1823 John Wood map. It differs from the other ranges as it is a single storey and apparently always intended for storage. There is a mix of masonry on all sides which indicates a considerable number of alterations. Further east, and not apparent in the extension, the range appears to have been fronted by three or five low arches, possibly serving as cart sheds (Fig. 47).

The lean-to section to the north is an addition, with most of the eaves supported on timber posts. This part of the building must have been designed to accommodate livestock housed in pens perhaps in the mid nineteenth century.

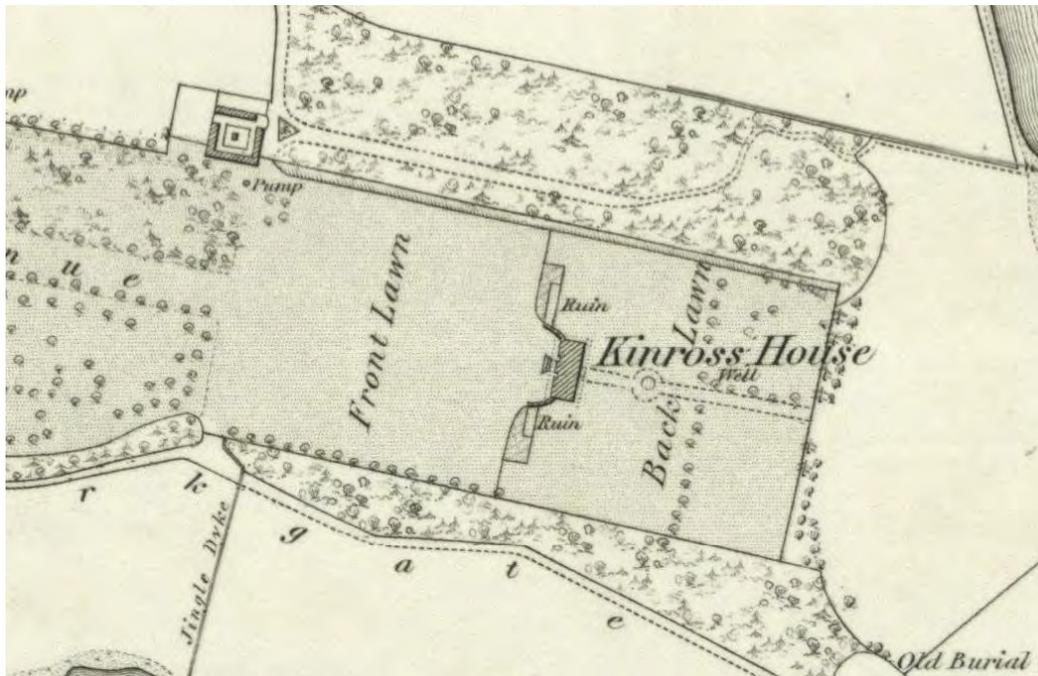
Figure 49 First edition Ordnance Survey map, 6 inches to the mile c.1854 NLS

Bruce's wings designed to house some of the domestic accommodation of the household away from the house itself, are recorded in John Wood's 1823 map. However, by the first Ordnance Survey map of around 1854, the wings are marked as ruins (Fig. 49). They were presumably taken down soon after 1854 because they would have cost more to repair, than to demolish and reuse the stone. Additionally, the functions that they had been designed to accommodate, had largely been absorbed into service areas within the house itself by the mid nineteenth century, and their existence would have been essentially superfluous.

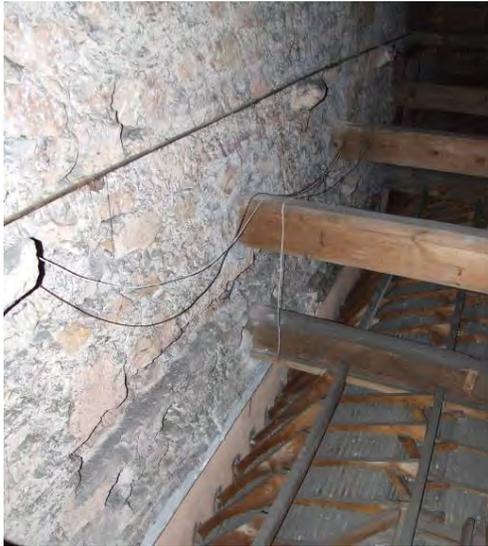
Figure 51 Kinross House above ballroom ceiling, west wall corbels. *S&B*

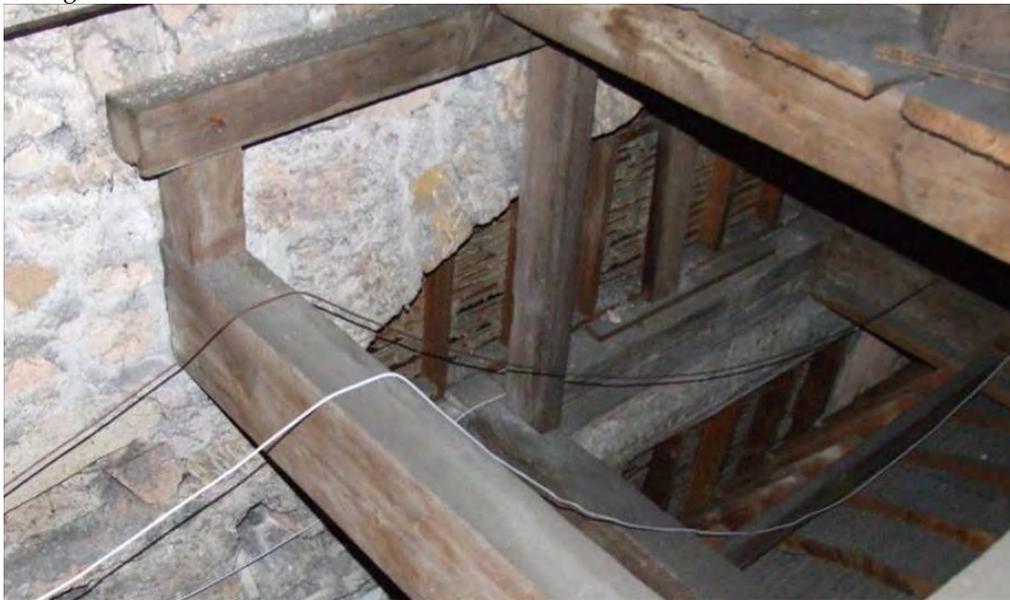
Figure 52 Kinross House above ballroom ceiling, west wall relieving arch over lintel of former musicians gallery. *S&B*

height of Bruce's Great Dining Room, fundamentally compromised its rationally proportioned volume of a double cube, that Bruce drew from Palladio (Fig. 53). It also seems likely that the removal of the musician's balcony in the east wall also dates from the 1869 re-roofing (Fig. 52). However, it is logical to assume that Sir Graham-Montgomery's maintenance would have been focussed on keeping the house wind and water-tight for the inheritance of one of his sons, and would not have been concerned with reinstating decorative features. Sir Graham died in 1901, and Stobo presumably passed to his eldest son, leaving Kinross to his second son, Sir Basil Templar Montgomery (1852-1928).⁹⁷

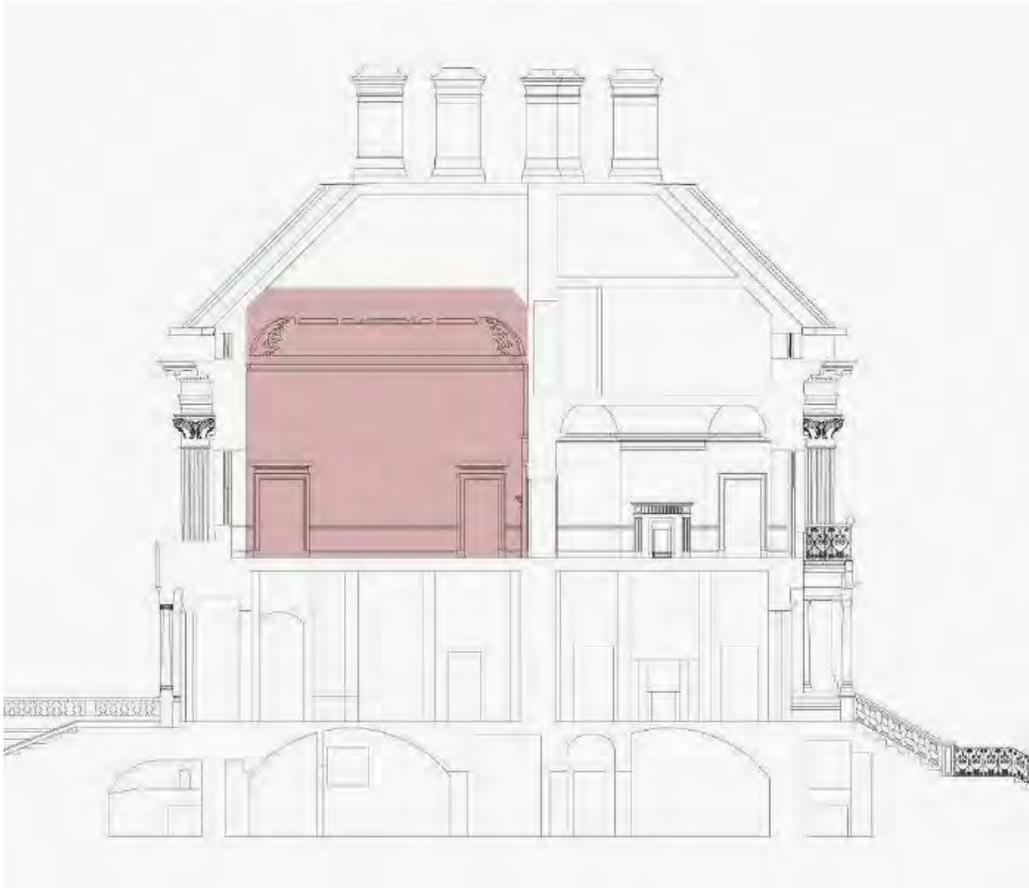
evidence all suggests significant alterations to the roof when it was replaced in the 1860s, indicating that structural problems leading to water ingress must have become critical. It seems that the platform height was lowered, the lead-lined masonry wall-head gutter course removed and replaced with cast-iron rhones supported by brackets at the eaves which concealed the enriched lintels of the windows. This would have meant that the pitch of the roof would have been steeper and, because the wall-head was higher, the eaves would have been higher than those on the present roof. The result of this lowering of the roof and consequently the ceiling

Figure 53 Kinross House section detail. Shaded area indicates cube volume height of Great Dining Room before reduction in 1860s *3D Reid/S&B*

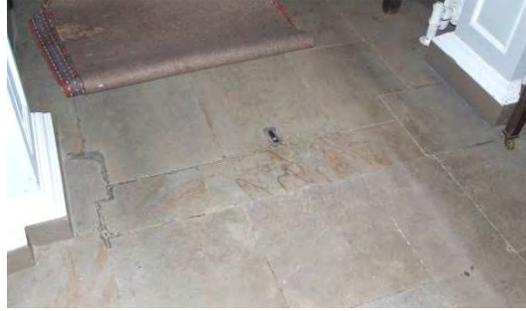
Whatever piers were in place between Bruce's Westhall and the two anterooms to north and south were replaced in this reworking. Examination of the paved floor shows that double doors existed between the hall and the anterooms (Fig. 57). The *Vitruvius Scoticus* plan shows the previous arrangement, indicating a substantial pier with paired entrances to the anterooms. However, as previously discussed in section 3.3, the accuracy of this plan is questionable.

Figure 57 Kinross House hall floor, north west entry to former anteroom showing metal door-bolt fitting. *S&B*

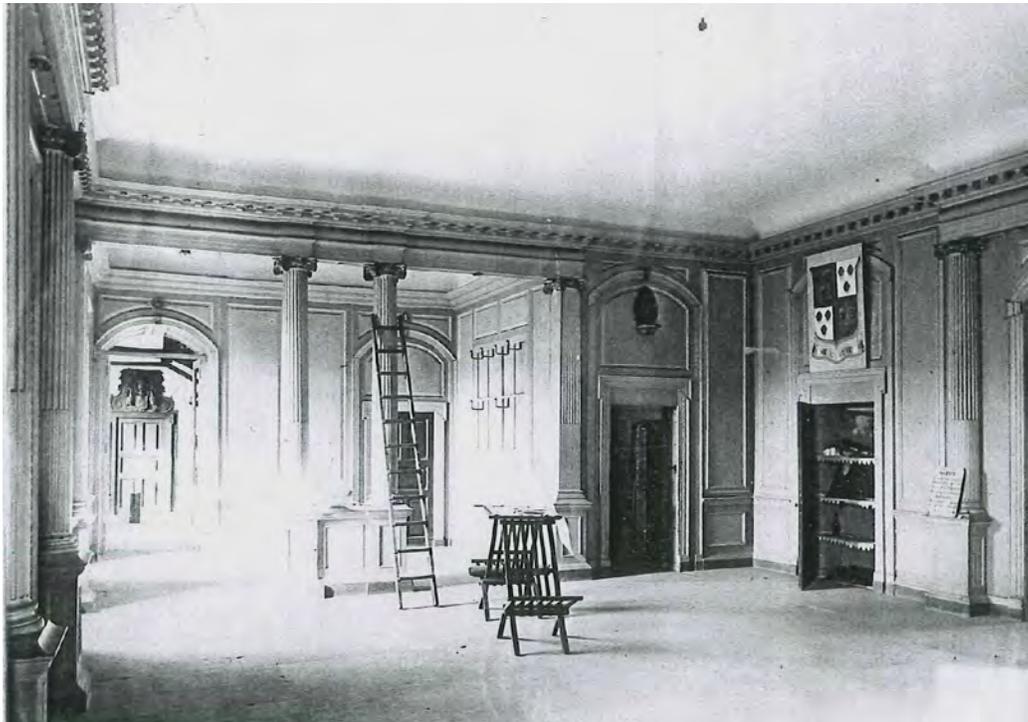
A lighting arrangement was introduced to light the pair of back stairs by borrowed light from the former anterooms of the now T-plan hall. As discussed in section 3.3, as the original hall was only the central square section of the plan, the only light for the stairs was through the small mandorla-shape lights over the doors into the stair halls. The Gillespie drawing shows that the intention was for paired windows with astragals, which was altered subsequently to the large pairs of single-pane lights now present (Fig. 58).

Figure 58 Kinross House hall, looking north. Following completion of Lorimer & Matthew panelling scheme. Note the light borrowing arrangement with fire-bucket brackets in front. *NMR*

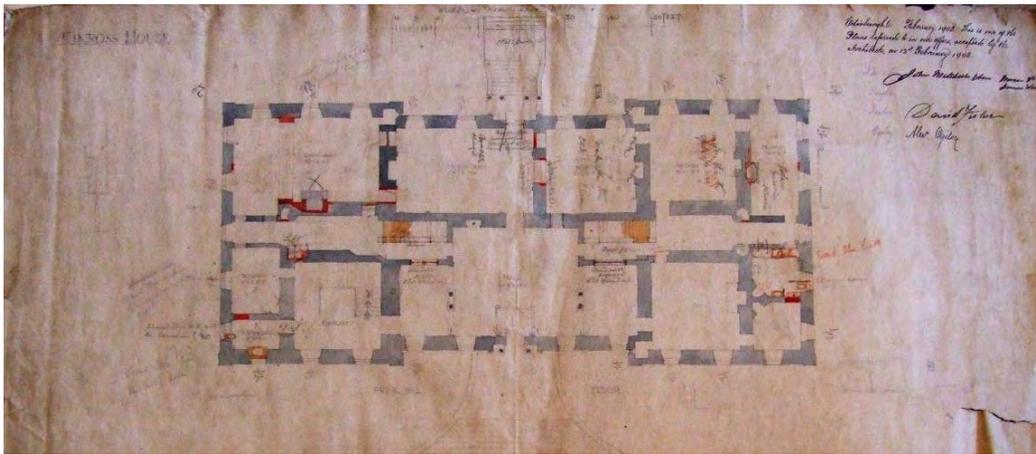
It is clear that the major work done to the house was by the firm of MacGibbon & Ross after the parting of Sir Basil with Lorimer & Matthew. Around fifty MacGibbon & Ross office drawings are in the possession of the Montgomerys, a large proportion relating to the varying schemes for the gates and lodges, and the rest relating to the reorganisation of the spaces in the house itself. These drawings were in the possession of the Montgomery family at Kinross House until October 2010 and at time of writing, the drawings were to be sent to the National Archives of Scotland. These drawings are not catalogued. However, of the two drawings lodged in the Ross papers in the National Library of Scotland (NLS), one of them is a working copy of a contract drawing dated February 1906 in the Kinross House collection and this drawing gives the most accurate depiction of the extent of the MacGibbon & Ross works at Kinross (Fig. 60).¹⁰²

Figure 60 Kinross House entrance storey plan. MacGibbon & Ross, 1906. *Kinross House*

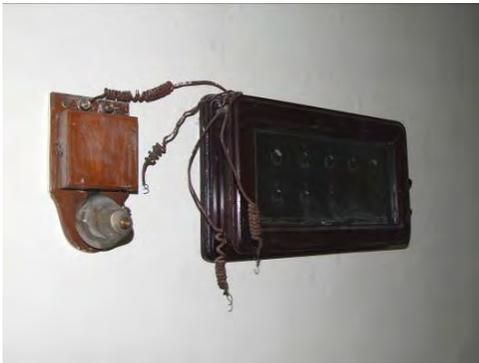
Figure 61 Kinross House, bell repeater board, chamber storey, north stair. *S&B*

These changes in social practices are reflected at Kinross in the changes in the use of the rooms. All bedchambers were banished from the entrance storey. On the former state storey, Bruce's withdrawing room became the principal bedchamber, with a pair of electric bells that would have flanked the bed, and the anteroom another.¹¹⁰ The chamber storey was rationalised and divided into servants rooms in the north and guest bedchambers to the south, with a connecting door installed. Two electric bell-repeater boards

were mounted on the wall above the north stair, and the newly created hallway, indicating that these rooms were occupied by servants expected to attend to their duties at any time of day (Fig. 61).

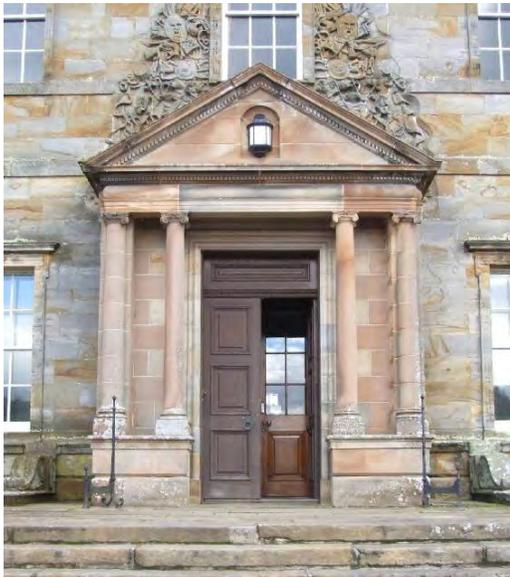
Figure 69 Kinross House, west porch. S&B

through several modifications, the built design reuses some of the stones from the jambs of Bruce's front door, merely moving them forward (Fig. 69).

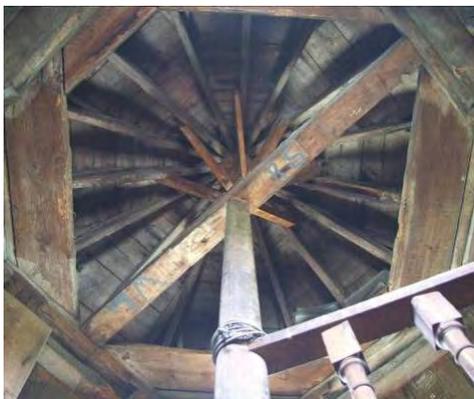
Figure 74 Kinross House, cupola structure. S&B

Some of the copper surface is damaged. It can be repaired in the short term but should be replaced with lead, the probable original material, in the medium term.

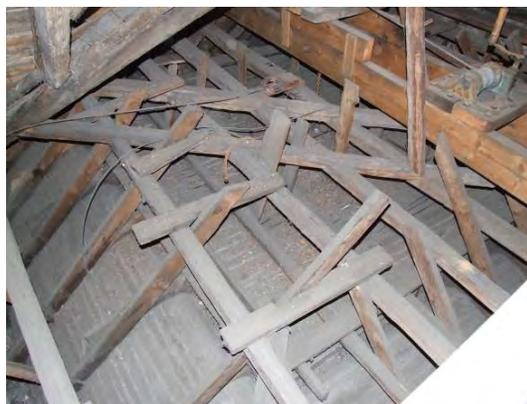
Figure 75 Kinross House, 17th century timbers over state stair. S&B

The cupola retains 18th century joinery with the timbers pit sawn rather than mechanically sawn. At the head of the stair are turned balusters. There is a lot of flashband. One of the chimneys has been rebuilt and has no recessed panel, the chimney to the north of the centre line on the west side. The leadwork around the cupola is original. The finial is squint and should be straightened up.

The entire roof structure of the central part – between the two end pavilions of the main house – has clearly been replaced. The roof structure has been renewed to a design that is different from the original. The character of the joinery is mid 19th century.

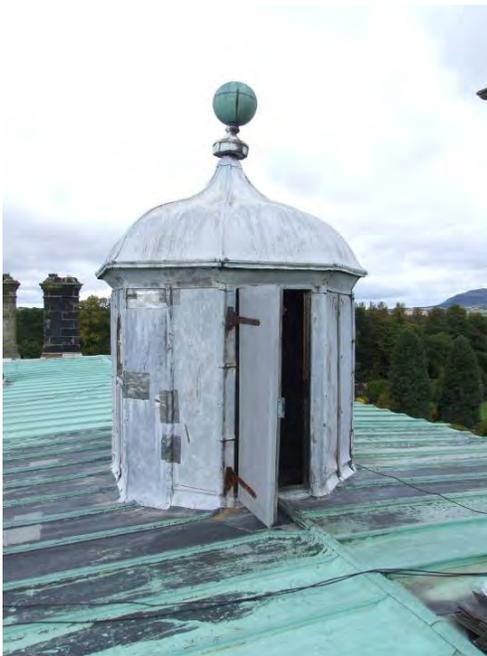
Figure 76 Kinross House, cupola. *S&B*

Although the cupola structure appears to be original, the supporting structure is made of later sawn timbers. This indicates that the cupola has been taken down as a complete unit for the rebuilding of the roof over the

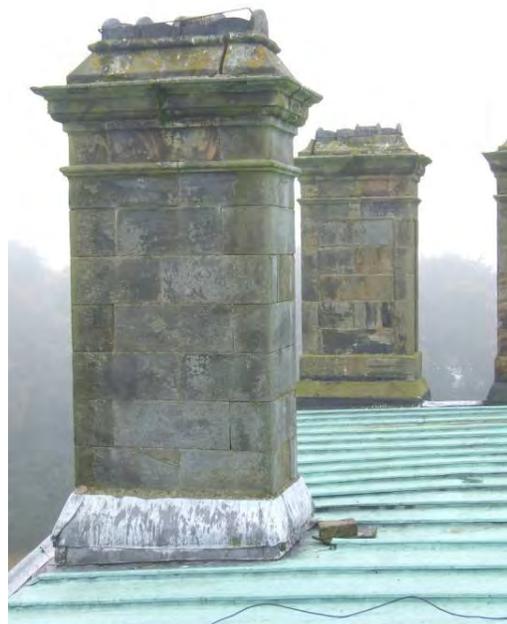
Figure 77 Kinross House, north east chimneys. *S&B*

central part and then built back into position. Two chimneys lack recessed panels. One above the cross wall between the central block and the north pavilion block near to the western edge, and the other above the cross wall between the central block and the south pavilion block near to the eastern edge. These were rebuilt in the nineteenth century re-roofing.

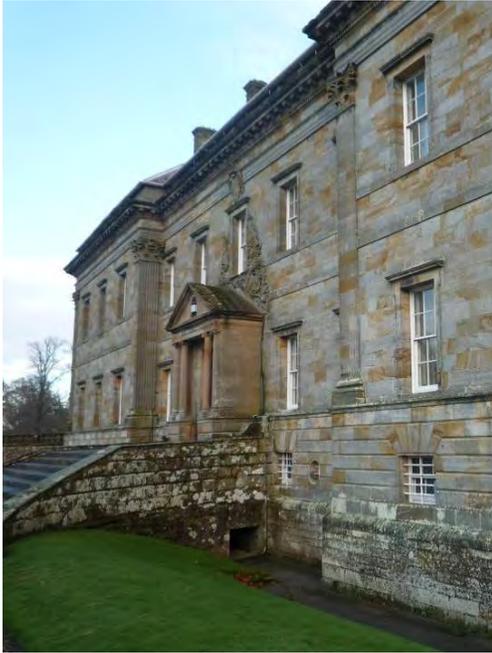
Figure 78 Kinross House, west façade, dropped ground level. *S&B*

The ground level in front of the building has been reduced and a concrete-finished area made in front of the wall. Previous repairs are evident. Some lintels appear to be in different stone and the first floor lintel over the porch has been cut out and inset with an indent. The same work has been carried out to both ground floor and first floor windows in the bay to the north of the porch. Also the central ground floor window in the northern block.

The condition of the masonry is remarkably good. There are some easings and cracks between columns of windows, notably in the first and second bays from the north, above the first floor windows in the fourth and fifth bays from the north, and a more minor easings in the two southernmost bays. In each case the repair can be lime mortar pointing into joints.

Some lintels are cracked but appear to be secure and do not need to be indented. There are no stones that are so decayed that require indents. This is a remarkable testament to the quality of specification of stone. It might also reflect high quality of the repairs undertaken at the time of the 1902 alterations. There are other open joints which should be repointed. These are particularly noticeable in string and cornice courses.

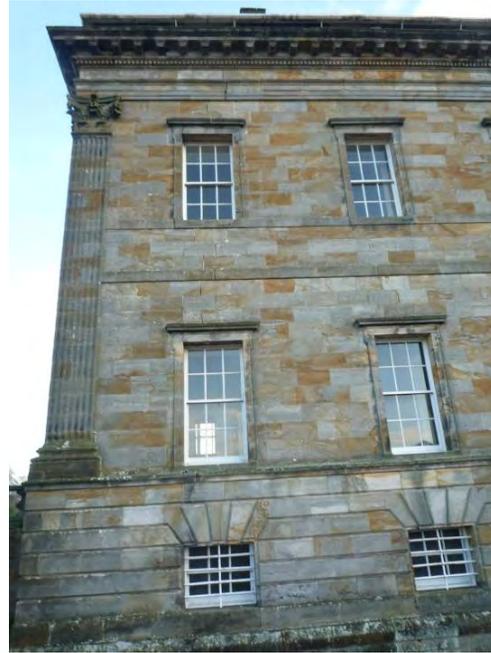
Figure 79 Kinross House, west façade north bays, showing easing. *S&B*

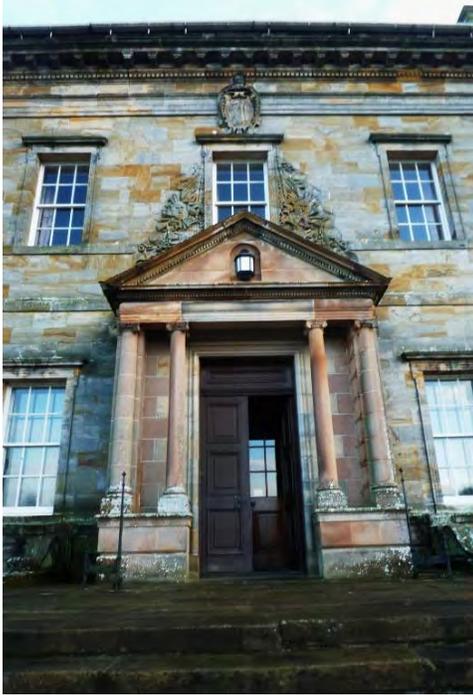
Figure 80 Kinross House, west porch. *S&B*

The stone chosen for the porch is generally fair but it copes with wetting and drying less well than the stone on the main front of the house. One stone to the north of the entablature has surface erosion and one of the capitals is badly eroded. However, it is not necessary to replace either of these stones

because the decay does not detract from the original design or appearance of the building.

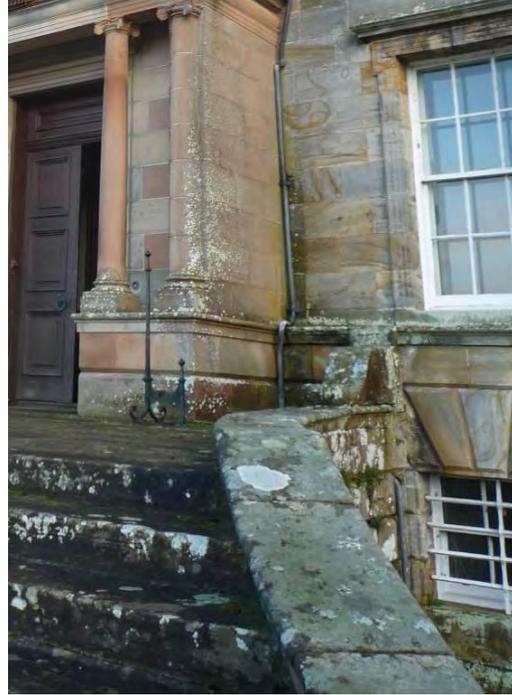
Figure 81 Kinross House, west porch, showing broken pipe. *S&B*

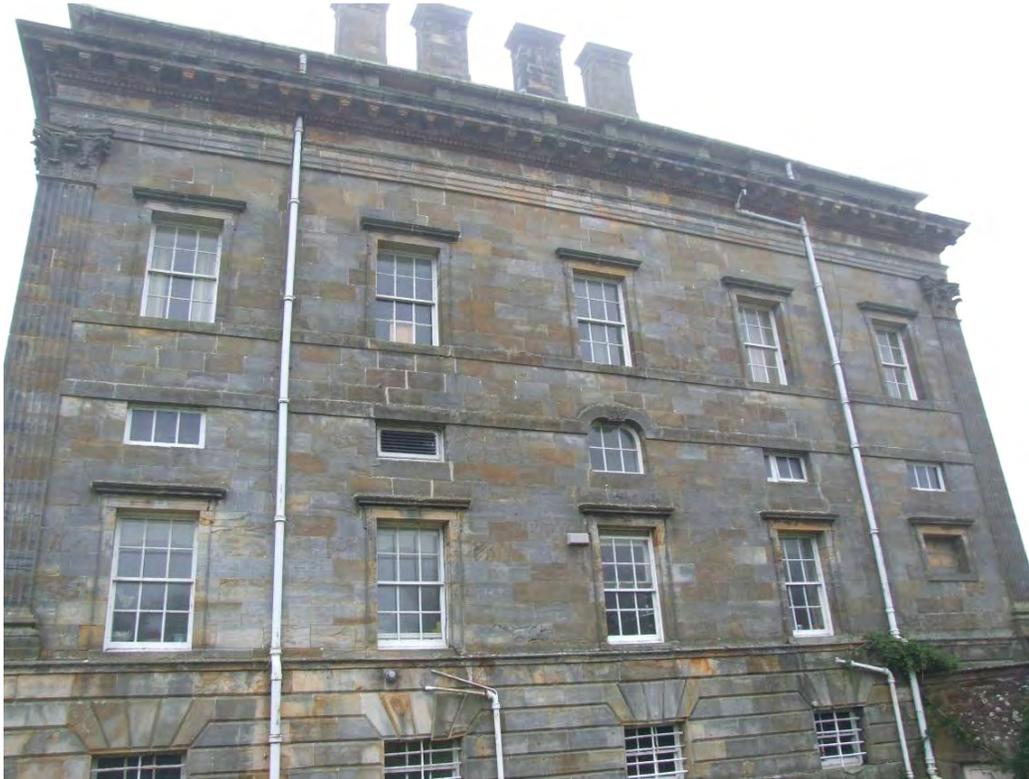
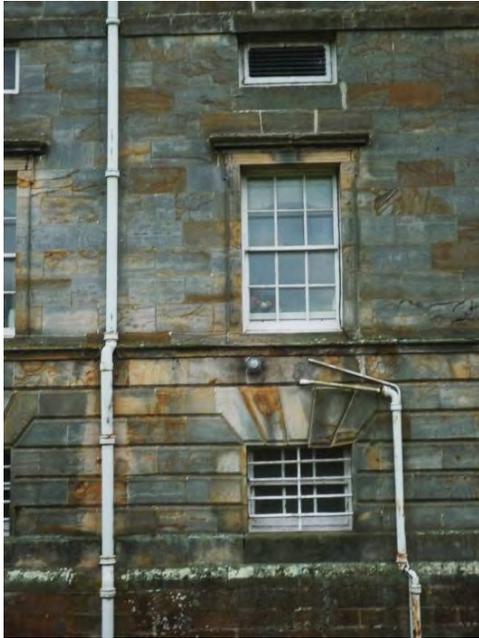
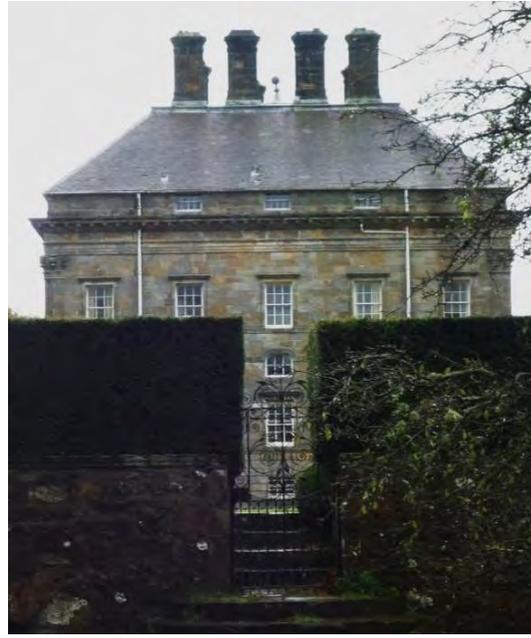
Figure 82 Kinross House, north facade. S&B

This elevation is not the show front of the east and west elevations. It contains some aesthetic compromises, such as the windows of the mezzanine level and prominent downpipes. The attic windows are centrally aligned with three central bays, maintaining their symmetrical disposition, without unnecessarily lighting the corner rooms with windows in two facades.

On the first floor, the bay closest to the north west corner is a blind window with a raised sill. This was intended to complete the symmetry of the façade without actually giving access to the charter room within. The condition of this elevation is fair. Some repointing has been carried out at open joints. There are vertical structural easings, particularly in the second bay from the west.

From the attitude of various owners, this wall has been treated as being the least important of the elevation – the one which has been most appropriate to change.

Repainting of timber is needed. The vent at mezzanine level off the kitchen is unsightly and should be replaced with a vent which respects the original astragal arrangement.

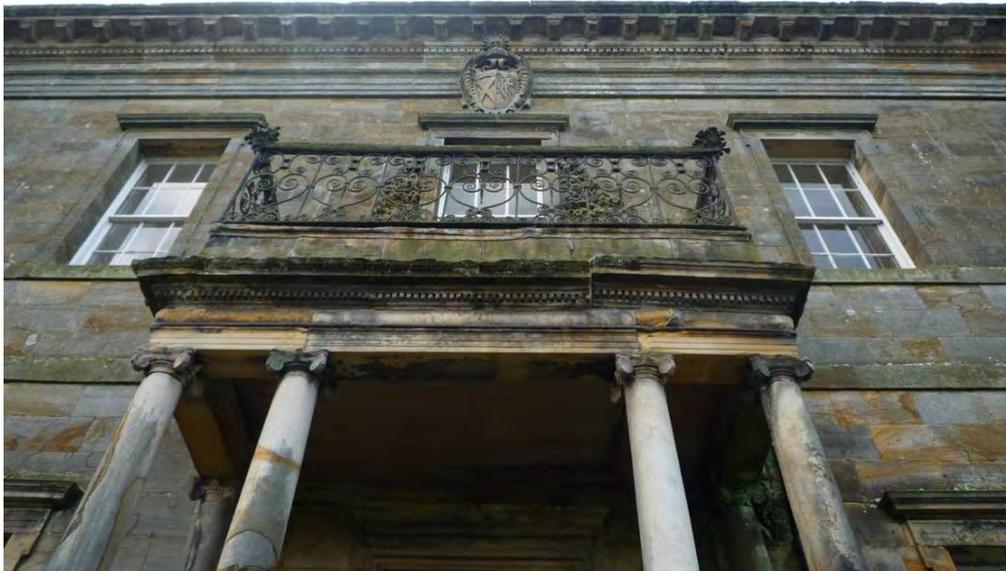
Figure 85 Kinross House, east porch. *S&B*

The design is very similar to the west side. The main difference is in the porch, which is a portico without pediment, forming a balcony. The carved elements are floral rather than military and occupy a smaller area. Above the porch are railings which have the character of original seventeenth or early

The masonry generally is in remarkably good condition. Some repairs have been made at lintels, particularly on the ground floor of the southern pavilion. The central ground floor element of the north pavilion is split and bowing downwards. This is a repair which has split. This lintel should be cut out and indented.

The central arrangement of porch and stairs is in poor condition. There is severe distortion on the porch and it would be best to take this down and rebuild it. Most of the original stones can be reused. The porch roof deck is probably leaking.

The inside ceiling of the porch has been covered in board. This ceiling may have originally been timber with a bead moulding around it. Alternatively, it could have been lime plaster. A plaster ceiling should be reinstated.

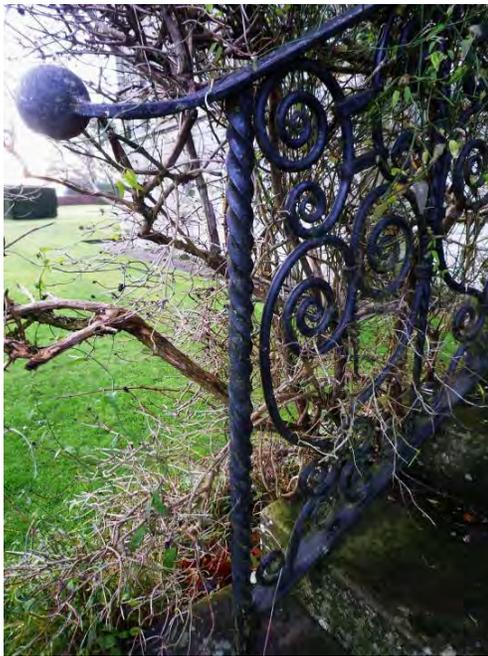
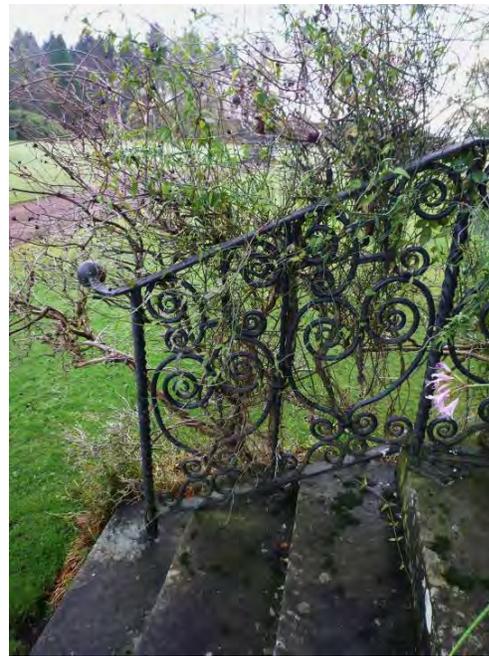
Figure 87 Kinross House, east porch railings and steps. S&B

The northern lintel of the porch and the pilaster where it meets the wall is saturated, possibly due to leaking pipe outlet. There are ferns growing at this point. It is important to take action to ensure that this wall dries.

Some of the balusters on the southern balustrade are cracked and are unsteady. It is probable that the best course of action would be to lift and rebbed the steps and balustrade so that it is all even and secure. Lichen and

Ironwork should be repaired by a blacksmith and repainted.

moss should be power washed off the face of the steps so that they are not slippery. The central door is an Edwardian replacement.
