KINROSS HOUSE
Kinross

Conservation Plan
Simpson & Brown Architects
November 2010

Contents	Page
1.0 Executive Summary	3
2.0 Introduction	4
2.1 Objectives of the Conservation Management Plan	4
2.2 Study Area	5
2.3 Heritage Designations	6
2.4 Structure of the Report	7

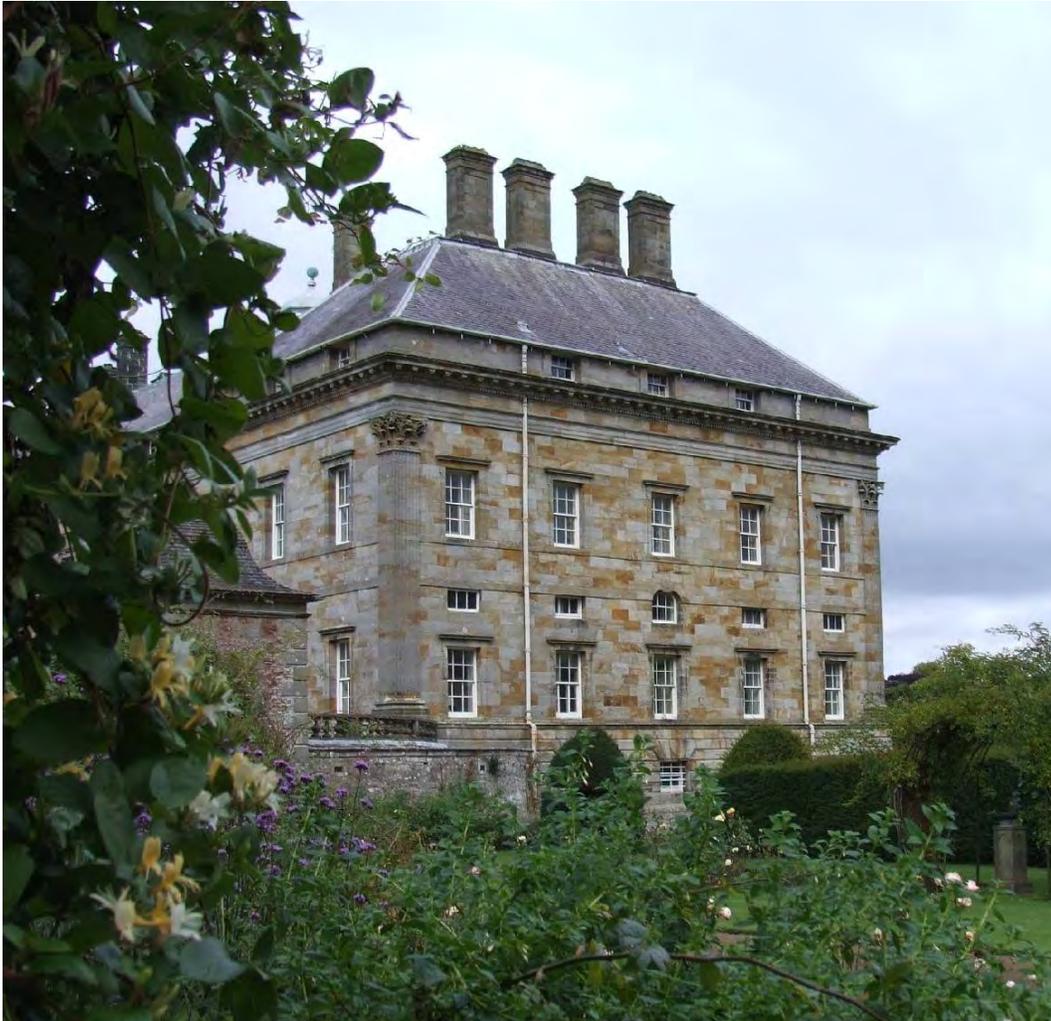
Figure 88 Kinross House, south elevation. *S&B*

The south elevation is to the same design as the north elevation. This elevation has been treated with more care than the arrangement to the north. Only cables detract from this front and some vents in the second ground floor window from the western corner.

The condition of this elevation is fair with no stones requiring indenting and relatively little structural easing. There have been few previous repairs. As with all of the external metalwork, the downpipes need to be repainted. Originally they would have been lead. The sockets for the brackets of lead pipes are visible. There is an odd cut in the masonry at mid height of the window on both sides which might have been the chase cut for an addition. This chase may have been cut in connection with an upper level to the quadrant, but there is no repetition on the north elevation.

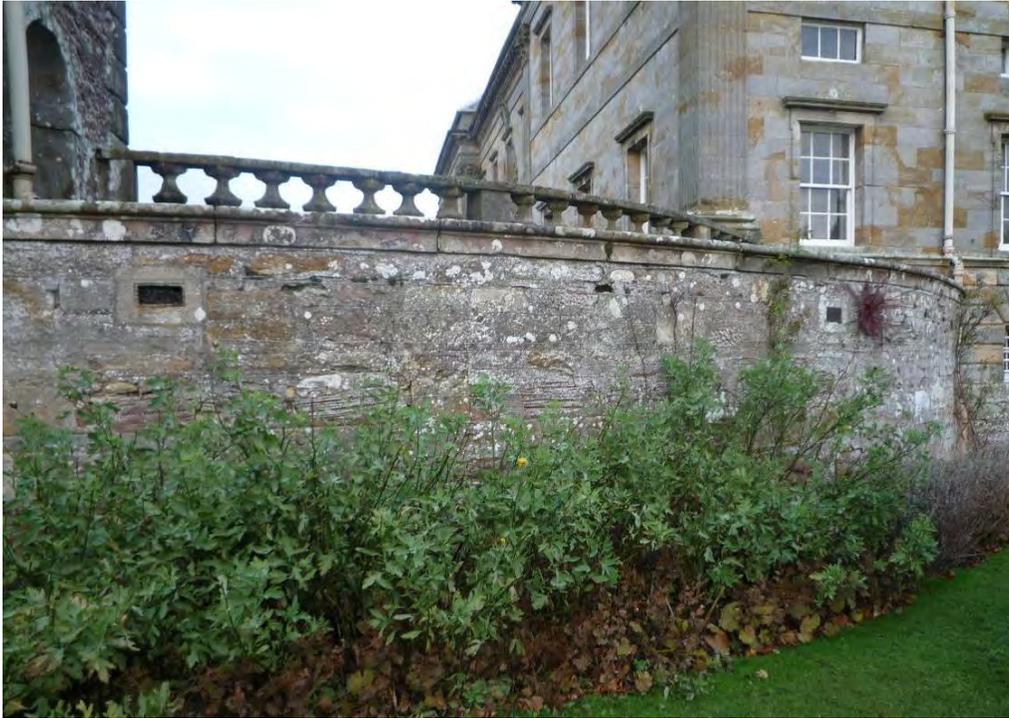
Figure 89 Kinross House, south quadrant. *S&B*

The south east facing, convex side of this quadrant is built of rubble stones of various colours with the mortar brought flush and lined. There is a row of ashlar stones at mid height which is in line with the top rybat stone around the doorway. Below this course the rubble is a strong pink sandstone. The door is nineteenth or early twentieth century. The door surround has a simple chamfer which is not consistent with the architecture of the rest of the building and so this door might be an insertion. The position of this door possibly suggests that it is contemporary with the work to lower the ground levels around the house.

The concave side is not a pure quarter circle. There is a string course running across its sill level and then simple pilasters rising on the same line as blocks on the balustrade. The masonry on this side is red rubble and this colour has been increased by red lichen on this wall. It is probable that this wall was intended to be harled in the three panels around and above each of the three windows. This wall requires repointing and possibly some taking down and rebuilding of the balustrade if it is found to be insecure.

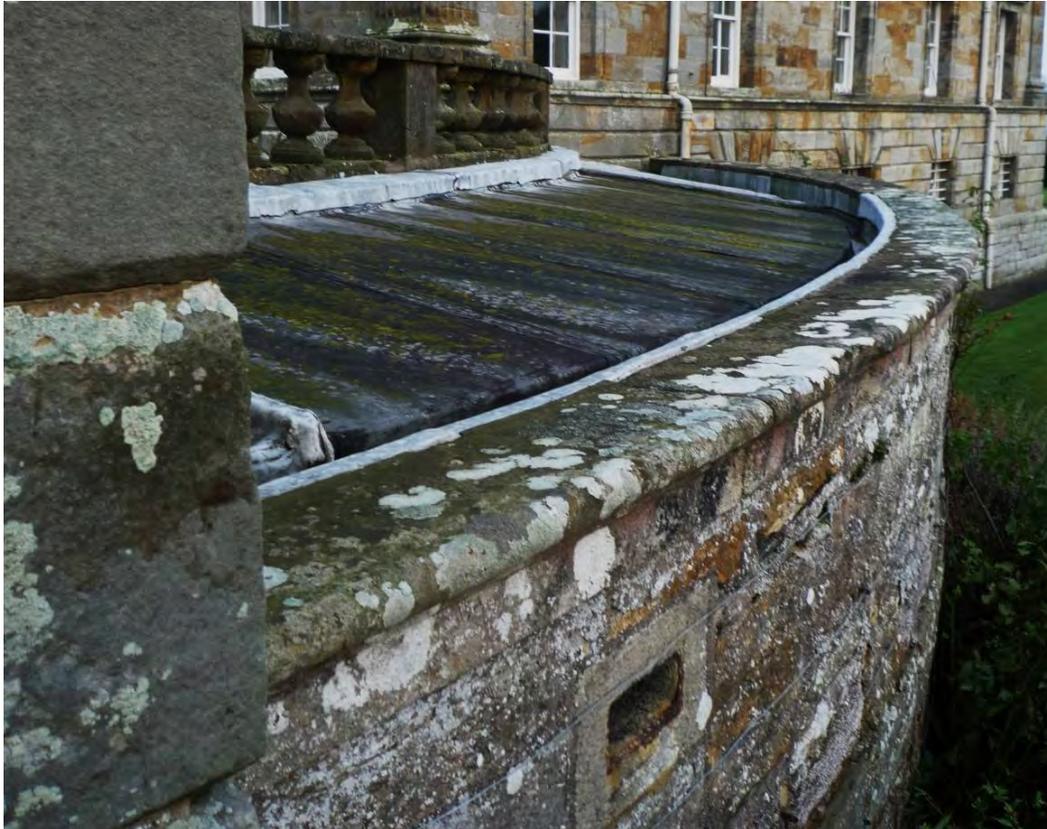
Figure 90 Kinross House, south quadrant roof. *S&B*

The roof is covered with lead which looks in fairly poor condition. There is a sloping roof running down towards the convex side with a gutter immediately inside the copes.

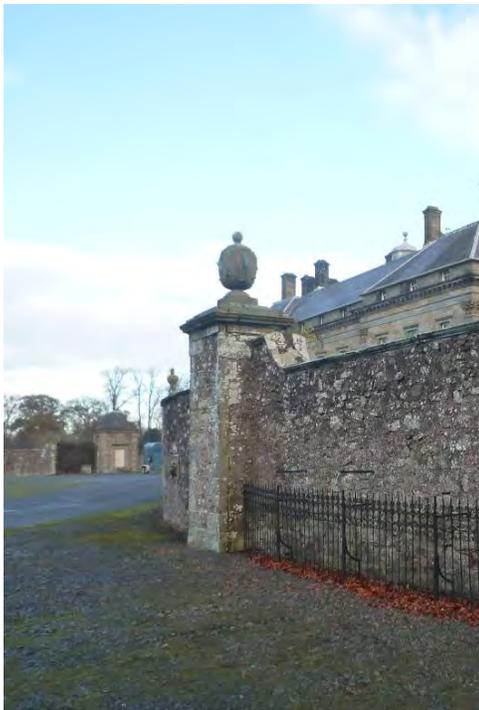
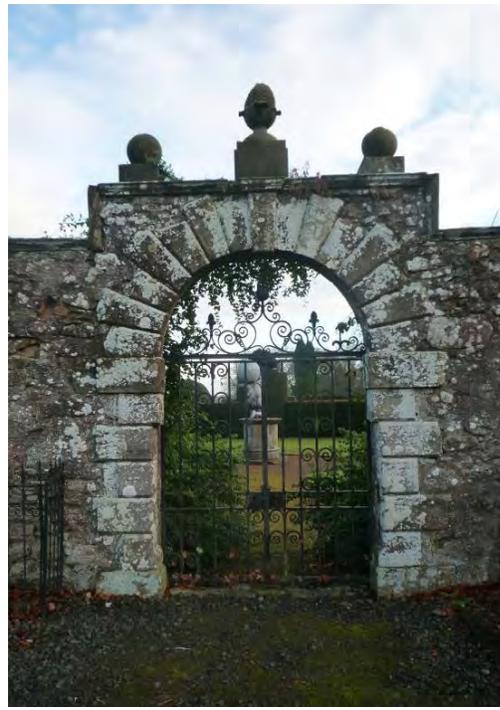
Figure 92 Kinross House, south west screen wall archway. *S&B*

This is a rubble wall which is part retaining. It has a flat cope. It is a decorative wall in that there is an arch surmounted by three finials. This is

The condition of this wall is fair. There are some copes which need to be rebeked. In the quadrant section close to the pavilion there are areas of open joints and loose rubble which requires packing out and repointing.

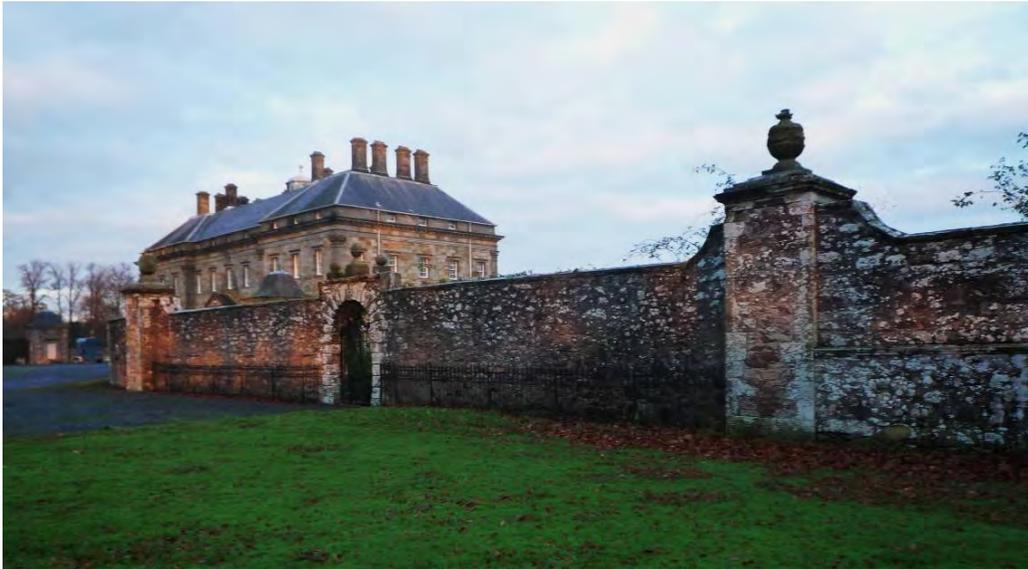
Figure 93 Kinross House, south west screen wall. *S&B*

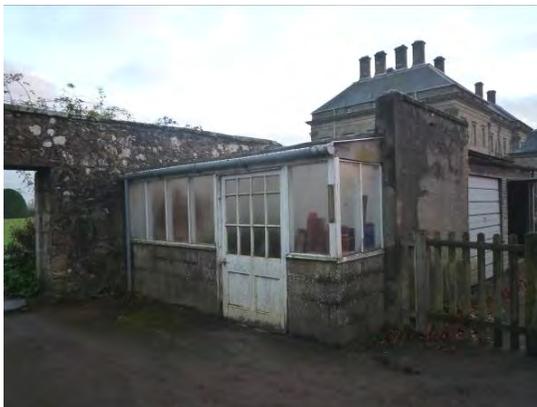
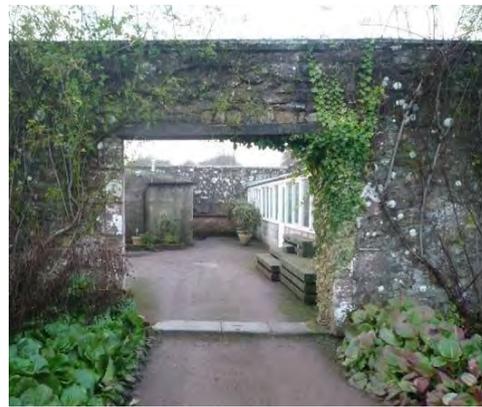
Figure 96 Kinross House, north enclosure wall.
S&B

This wall runs due north from the pavilion and forms a rectangular enclosure with its northern wall running to meet the northerly pier of the flanking wall. There is a ball finial at the north eastern corner. This eastern wall is in two parts. The northern part is about 13m long and appears to have had a door placed centrally. The rybats used to make this door have been taken down

The eastern part of the wall checks out by about 500mm and has rusticated quoins at the corner. This is a blank wall apart from two small circular openings which appear to retain their original yett like ironwork. This wall is in reasonable condition and requires some repointing. The north wall is plain. The southern face is covered by a green house and is largely obscured by plants. The north face of this wall is also obscured by vegetation. It faces onto a small formal space created by walls to the south, west and north, and by a yew hedge to the east.

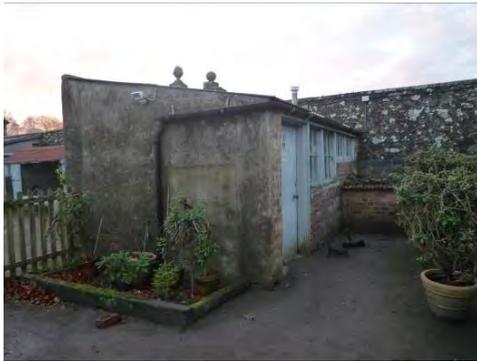
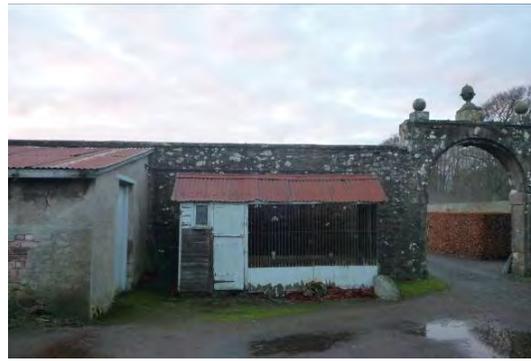
Figure 98 Kinross House, buildings in north enclosure. S&B

To the north is a modern greenhouse with proprietary timber windows and a blockwork riser. The greenhouse is generally hidden but, in architectural terms, has negative significance.

To the south of this are two blocks, possibly intended to be game larders. They are separate so that the maximum amount of ventilation could be provided through louvered windows. They are built of brick with cement render faces lined out to look like stone and with a concrete flat roof which has had corrugated sheeting added on a timber structure built on top of the concrete roof at a later date. These two game larders are used for storage with the southern one being the wood store. The joinery of the louvers and frames

has been a green colour, possibly originally. Although of interest, and worth recording, the appearance of these structures is negative.

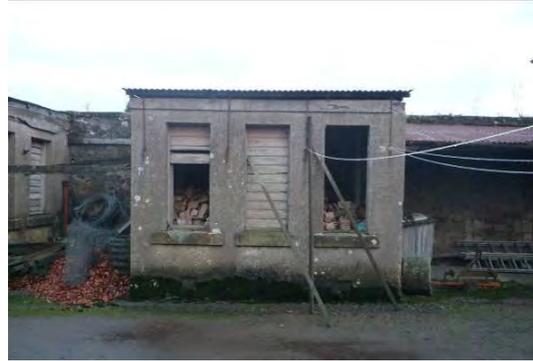
Figure 101 Kinross House, buildings in north enclosure. *S&B*

Further south is an open shed which has its roof supported by two iron columns which have cast capitals. This shed is in very poor condition but the columns could be recycled. The wall behind has some blocked areas which suggest an arch headed opening.

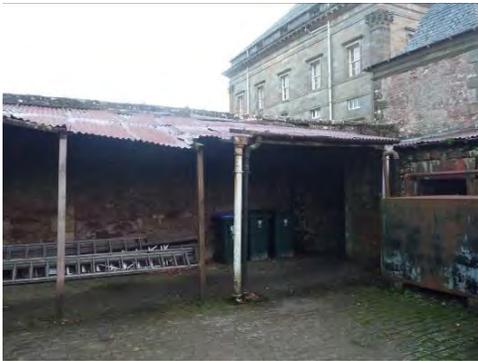
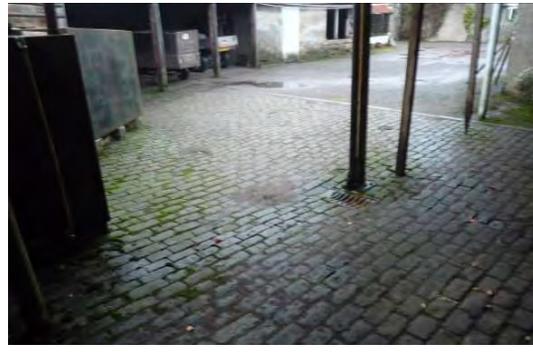
Figure 102 Kinross House, buildings in north enclosure. *S&B*

The setted pavements towards the southern end of the yard are attractive. The rest of the yard is finished with gravel.

Further north is a block built of brick and covered in cement render which is now used as a woodshed. Its roof is covered with corrugated sheeting. It has negative significance.

To the north of this, next to the gateway into the yard, is a timber kennels building with a corrugated sheeting roof. This should be recorded but has no significance.

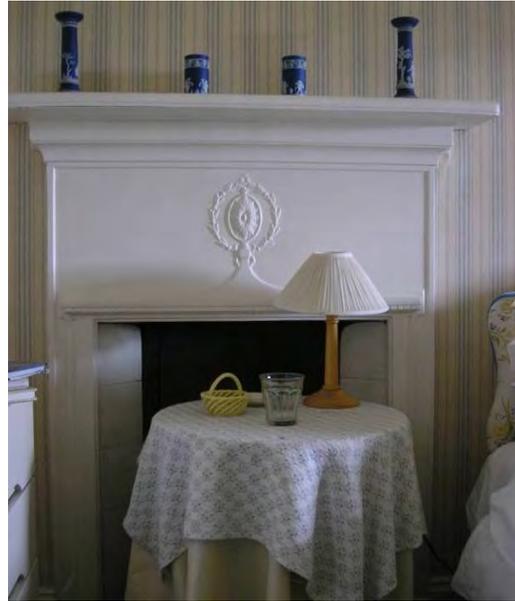
Figure 106 Kinross House, second floor, fireplace room 11. *S&B*

The finishes on the second floor have old doors but much more recent joinery on architraves, blocks and skirtings. All of this is Edwardian, as is the fireplace in room 9, the linen cupboard at the centre of the corridor and the fireplace in room 11. This is consistent with the evidence of inserted brick flues in the attic/roofspace. Rooms 8 and 9 are beyond a partition door across the corridor and are plainer than rooms 11 and 12. This suggests that 8 and 9 were servants' rooms but 11 and 12 were family or guest rooms. 11 and 12 have picture rails. They appear to be Edwardian rooms. The picture rail might be recycled from elsewhere. It is thicker, apparently to accommodate wall hangings, possibly material stretched on frames rather than wallpaper. The fireplace in room 12 does not allow for such hangings. Neither do the skirtings or architraves.

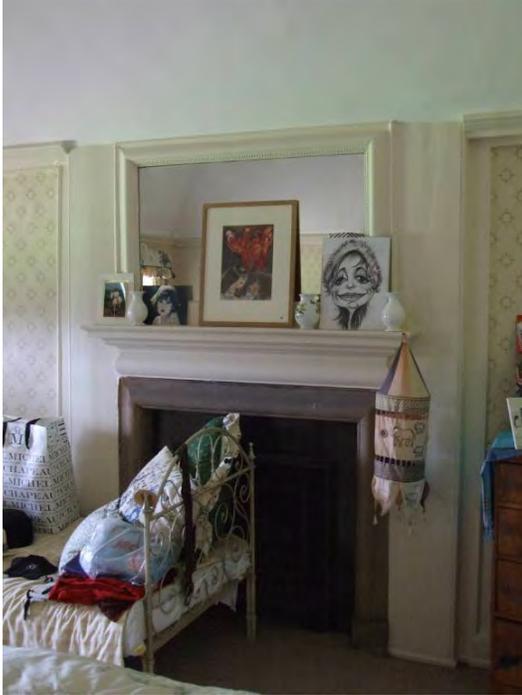
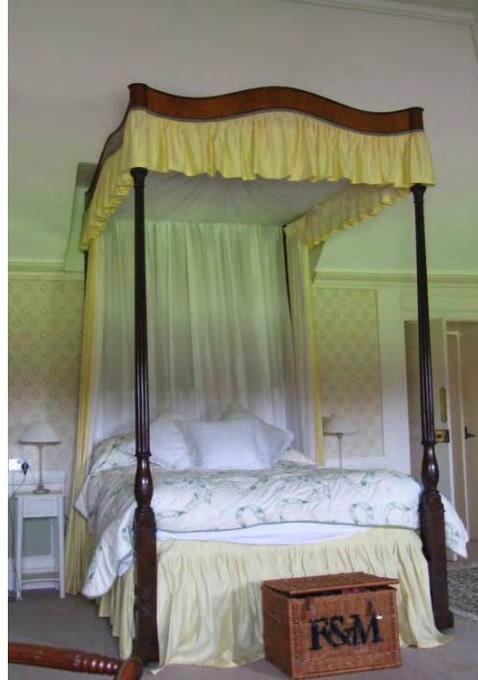
Figure 108 Kinross House, second floor, room 14. Check in coomb for tester bed. S&B

Room 14 has been two rooms of similar planning to the rooms opposite on the other corners of this floor but with the wall between them removed to form one room, presumably also in the early 20th century.

In room 13 both the panelling and cornice is interrupted for the position of a bed placed centrally on the west wall. The bed clearly had a canopy over it which needed to cut into the coom. Above the fireplace is a painting of Glasgow, from what became the Necropolis with the cathedral in the right foreground.

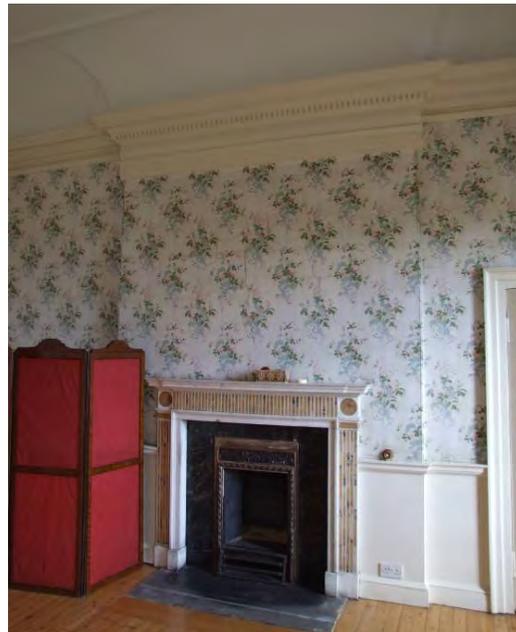
Figure 110 Kinross House, first floor, room 7. S&B

Room 7 is now the games room. The fireplace on the northern end is late 18th century in character. A similar fireplace has been used in the bedroom to the south (room 6) which was one originally the state anteroom. In room 6, the fireplace has inlaid yellow marble into a white marble and an apparently consistent mirror above it. The upper part of the mirror is damaged. This

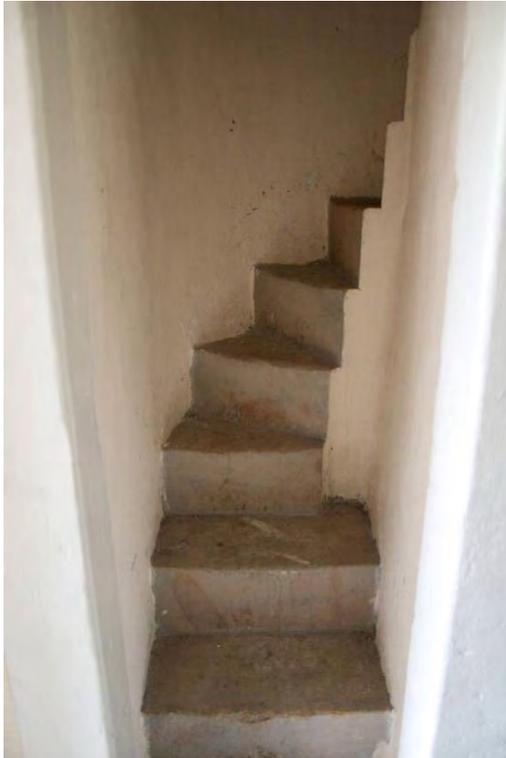
Figure 113 Kinross House, south mezzanine, pages stair. *S&B*

To the north is a part mezzanine. The rooms are quite low and of variable height. All of this work, with the possible exception of the door which has been inserted across the landing, looks to be original work. There is an odd curving cupboard behind a partition in the room to the west of the landing. This appears to mark the position of the former pages stair. As in the room above, the end of the corridor has been separated off with a wide doorway and it is possible that the floor beyond it is a replacement. The cornice stops at this doorway. In the mezzanine room there is a shaft down into the laundry room below. On the ground floor the door from room 4 to the oak staircase is 19th century in quality.

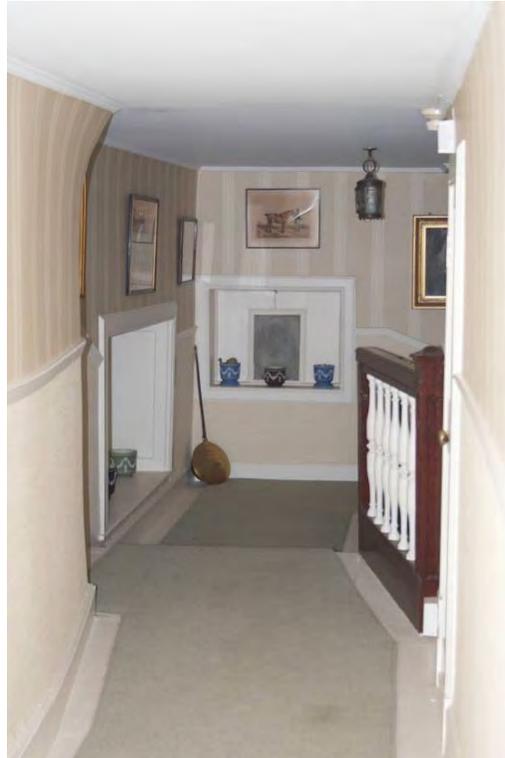
Figure 114 Kinross House, south mezzanine stair landing, looking north. *S&B*

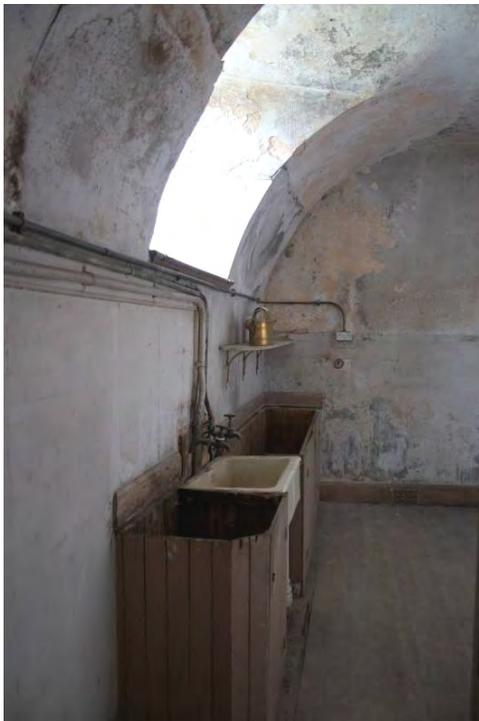
In the lower ground, the floor south east room is a vault but there is a fireplace surviving. The overmantle is presumably Edwardian. On the inner face of the outside wall, and some distance up the vault, later linings have been introduced. In the former butler's room to the west, the joinery of sink and units to either side are of some significance. The range is also significant.

Figure 117 Kinross House, butler's room.
S&B

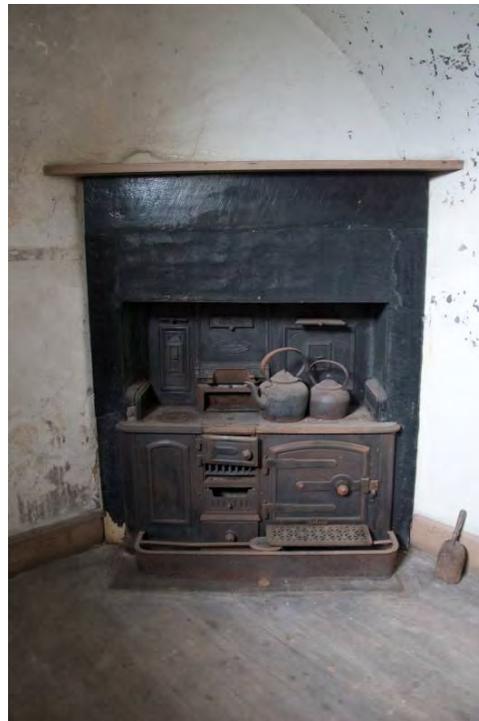
Figure 118 Kinross House, butler's room range.
S&B

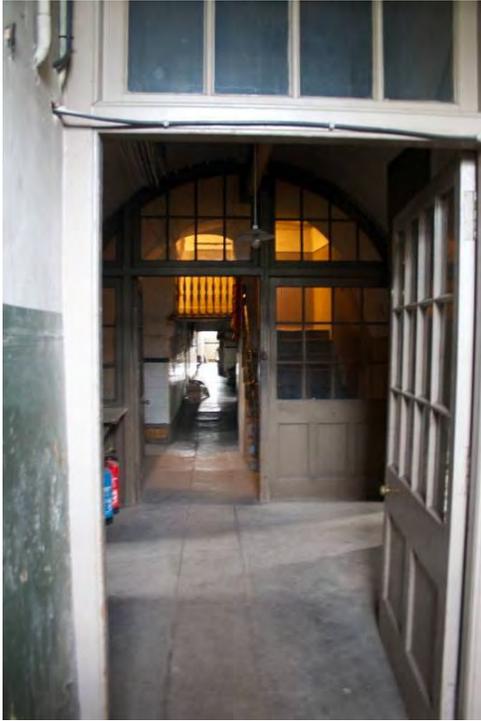
store room (former butler's room and former housekeeper's room). Within the lower hall is a beautiful blacksmith handrail which is probably of late 17th century date.

Figure 119 Kinross House, basement, north hall, looking south. *S&B*

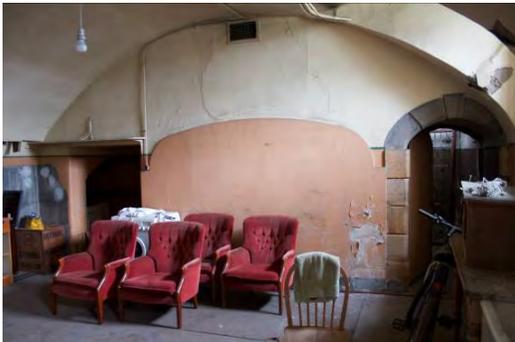
In the former servants' hall there are various joinery elements, such as pilasters, which are stacked up here in storage. They came out when the kitchen was formed on the ground floor. The scullery was an original kitchen with two fireplaces visible across the north wall, now covered by 1902 partitions.

Figure 121 Kinross House, old kitchen, showing blocked-up fireplace, and space for corner stair, removed after 1902. *S&B*

In the south eastern corner of the old kitchen there is a possible position for a spiral stair rising to the entrance hall. The dumb waiter is in the north east corner of this room.

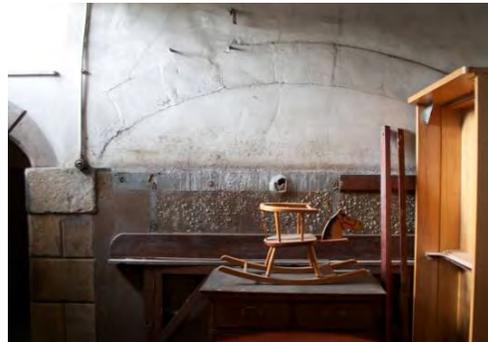
Figure 122 Kinross House, old scullery, showing blocked-up fireplace. *S&B*

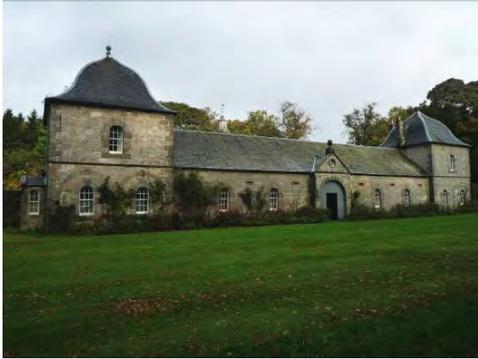
Figure 123 Kinross House, stable courtyard south façade. *S&B*

This is a quadrangle group with its main front facing south. The front of the stable block does not address the main formal area to the west of the house but a separate area to the north west. This main front of the stable block is strongly visible from the west garden, however, and is an important component. The south front of the stable block is the most important. It is characterised by a central arch with a pediment above, rising to a ball finial. To either side of the arch are two bays of strongly rusticated arch headed windows. At either end are broad two storey pavilions which have their eaves height close to the ridge of the main central block. The pavilions have distinctive ogee roofs. At the south side of each of the pavilions were two arches. These have been filled with rubble and with arch headed windows which match the design and detailing of the later windows on the upper floor of the pavilion blocks. All of the windows have been replaced with six over six sash windows in the mid to late nineteenth century.

On the south front there are six vents. These are made of a different colour of stone but it is probable that they are original because they tie in with the surrounding masonry. This change in stone colours, together with the general design of the building, which includes 10mm check between all dressed stones and rubble, suggests that the building was originally harled. This would be in accordance with masonry practice for eighteenth-century buildings in Scotland. It is probable that the harling was removed in the nineteenth century. The blocking masonry was not intended to be harled and was brought flush with the arched stones above, about 10mm in front of the earlier masonry in the upper part of the building. Hinge crooks survive for the doors which infilled these arches in all four of the original openings.

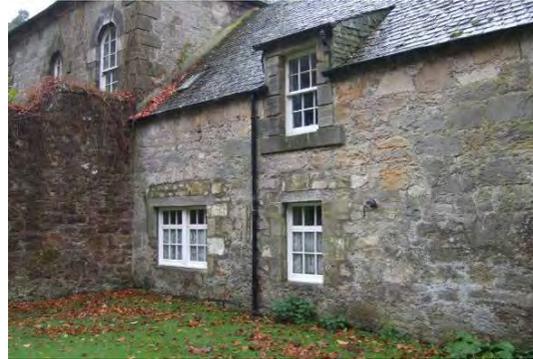
Figure 124 Kinross House, stable courtyard, east façade. *S&B*

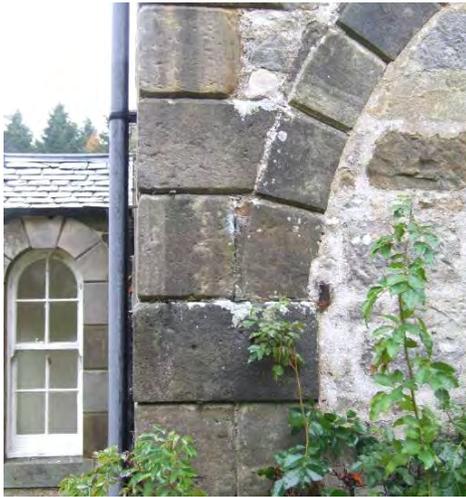
Figure 125 Kinross House, stable courtyard south façade, showing later arch cut into quoins. *S&B*

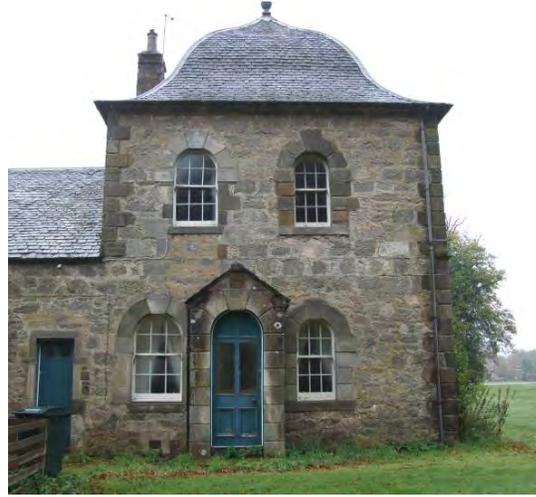
The east and west ends of the pavilions both have stone porches at the centre of the outer faces of the pavilions.

Figure 126 Kinross House, stable courtyard, east pavilion east façade, showing added porch and altered windows. *S&B*

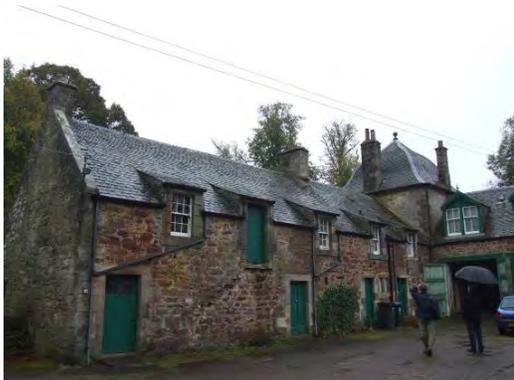
The eastern block looks to be 18th century at least. There is a greater amount of red sandstone on the courtyard elevations and this appears to have been less expensive stone than the stone used to the south. Some rusticated surrounds have been built or recycled into the wallhead of the courtyard side of the east block to form dormers. An outside stair reaching to a door at the northern end has been removed.

Figure 127 Kinross House, stable courtyard east range, showing alterations. *S&B*

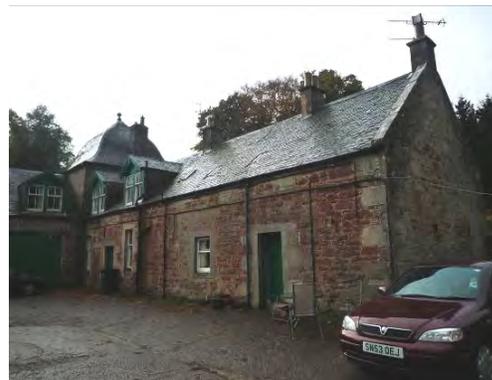
Figure 128 Kinross House, stable courtyard, west range, showing alterations. *S&B*

The western block looks generally nineteenth century. It has been altered in several places to remove or infill windows and doors. It is now in domestic

The condition of these blocks is not good. Even though the buildings are generally in domestic and storage use, there are several places where the roof slating is in poor condition. A significant amount of reslating is required to return these buildings to good condition.

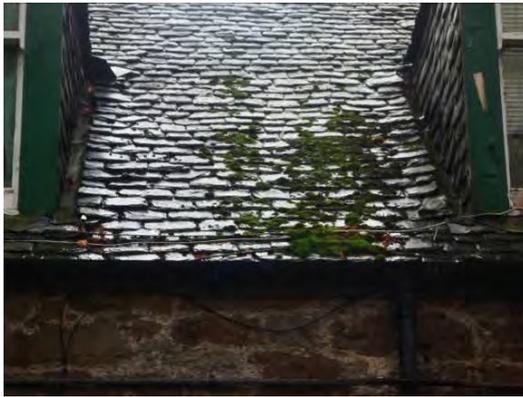
Figure 129 Kinross House, stable courtyard south range roof. *S&B*

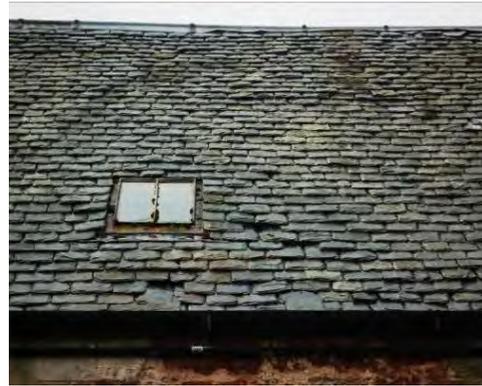
Figure 130 Kinross House, stable courtyard, north range roof. *S&B*

The condition of this block is fairly poor. The slates are uneven and are leaking in many places. There are many signs of stains in the sarking. The rafter ends are enclosed by masonry which will hold moisture against them and encourage dry and wet rot.

The rhones and conductors are UPVC and have failed in many positions. There are active leaks with water running down the face of the wall.

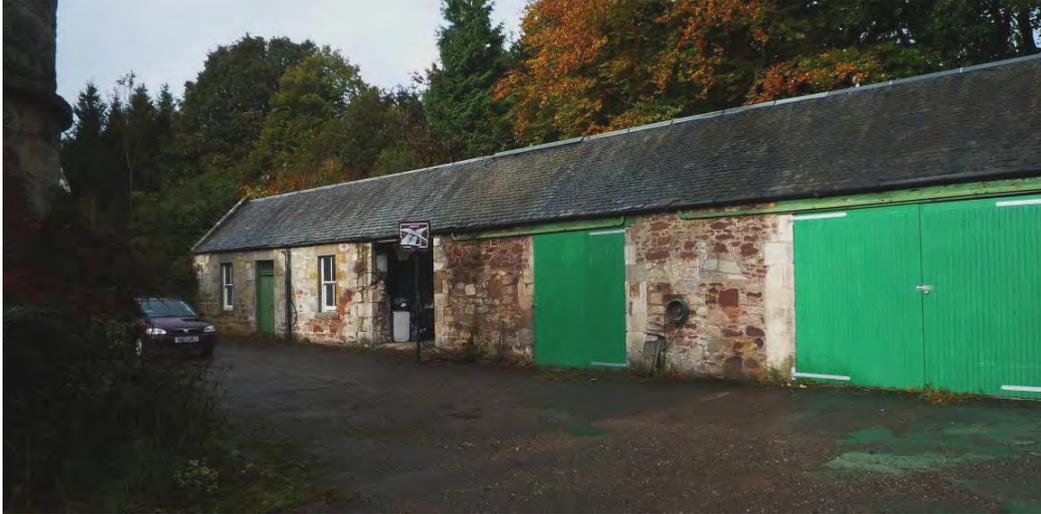
Figure 131 Kinross House, stable courtyard north range, showing alterations. *S&B*

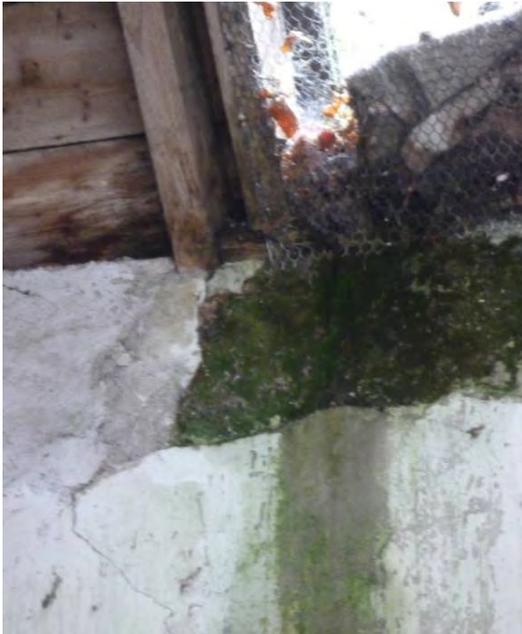
Figure 132 Kinross House, stable courtyard north range, interior. *S&B*

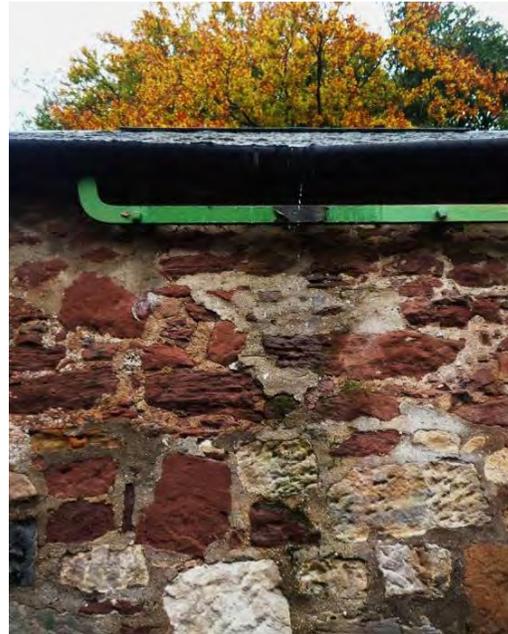
Figure 133 Kinross House, stable courtyard north range, damaged rhone. *S&B*

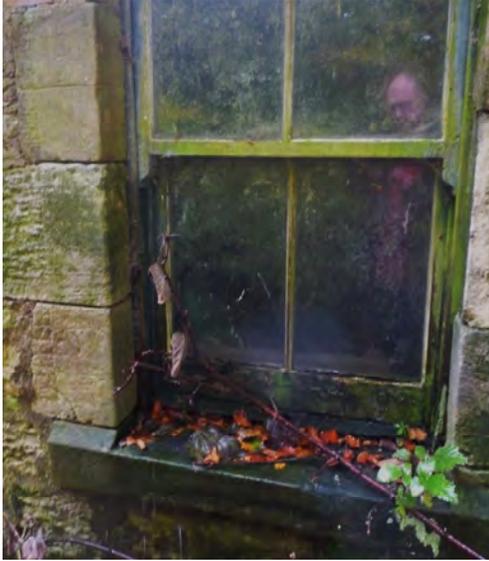
Towards the western end of the southern wall are full height structural cracks in the masonry.

Figure 134 Kinross House, stable courtyard north range. *S&B*

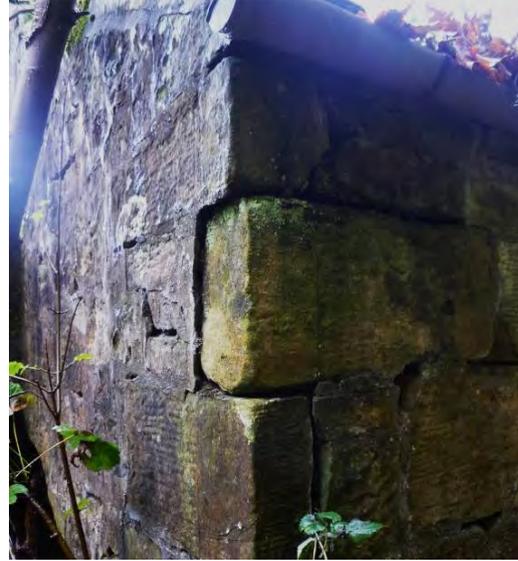
Figure 135 Kinross House, stable courtyard north range, north east corner. *S&B*

The lean-to blocks to the north are a subsequent addition. On the eastern gable, tree roots have become established at the base of the wall and in the masonry of the attached flanking wall. There is some structural failure at the north east corner with the quoin stones separating.

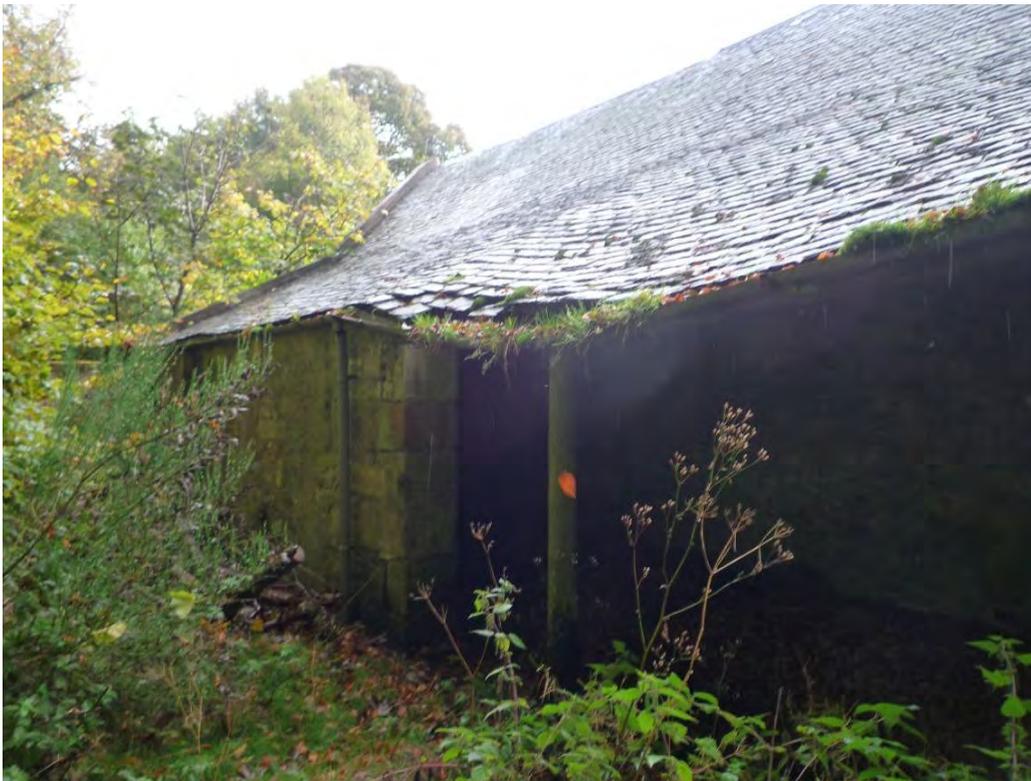
Figure 136 Kinross House, stable courtyard north range, lean-to. *S&B*

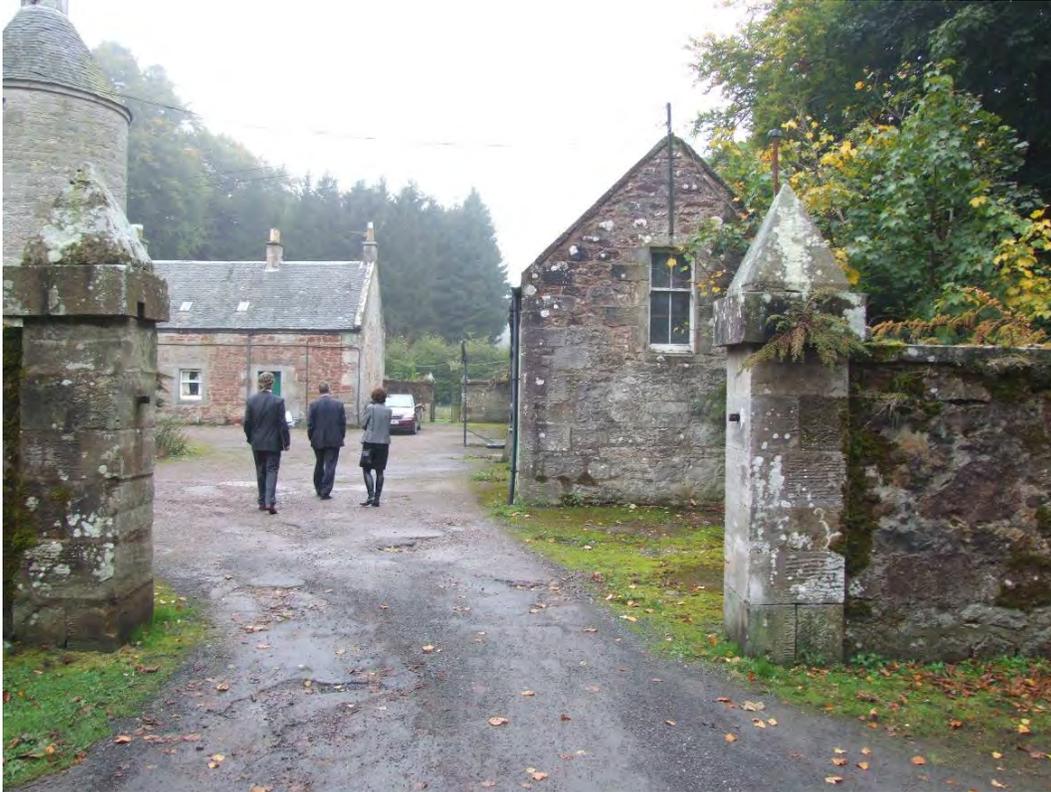
To the east of the north block is an enclosure wall which has pyramid topped gate piers and corner piers. This wall is fair but has some vegetation growing in it. It requires repointing and the removal of moss. The copes should be rebedded.

The gates are missing.

Figure 137 Kinross House, stable courtyard east gateway, showing end of north range. *S&B*

This gateway is on axis with one of the east-west drives within the north woodland.

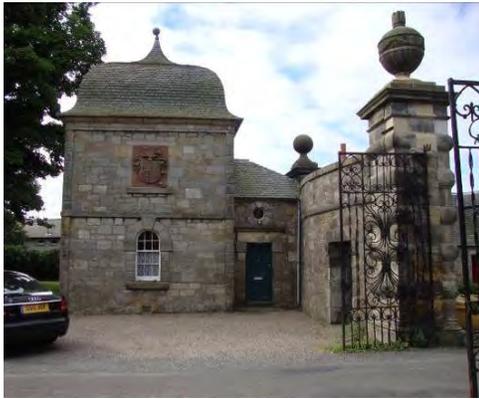
Figure 138 Kinross House, south gate lodge and gate pier. *S&B*

The gatepiers are massive with bull nosed Gibbs rustication rising to large urns. The polished masonry is consistent with the seventeenth-century work on the house and may have been reused. The gates themselves are Edwardian and not sufficiently elaborate for their context. The arrangement of quadrant walls to either side is not symmetrical in plan because it is intended to address the approach road from Kinross High Street which approaches the main axis from an angle to the south west. This means that the gates and gate piers are axially aligned but the pavilion blocks are not.

The condition of the pavilions is fair. The roofs appear to have been well maintained and there are only a few places where the slates are out of position or where Welsh slates have been used.

Some repointing and resetting of stones is needed on the chimney of the south pavilion and there is an area of out of position slates immediately to the east of the chimney. The sash and case windows are generally in fair condition but will need to be repainted. Some of the sills look rotten. It is common conservation practice to replace rotten sills with a part indent for the front face only using a hardwood such as oak.

The gates are in fair condition but require significant overhaul by a specialist. Rusted surfaces need to be thoroughly brushed back, repaired and repainted.

On the main gates there are some missing elements to be replaced.

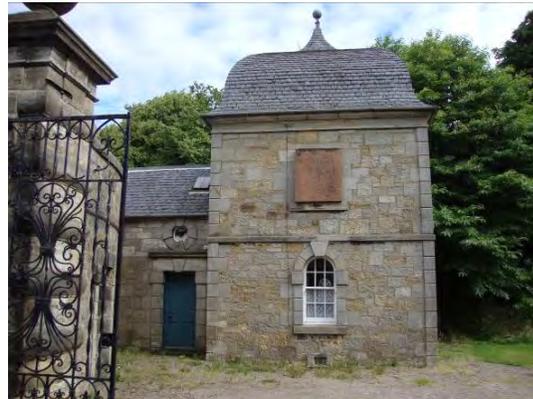
Figure 139 Kinross House, north gate lodge and gate pier. *S&B*

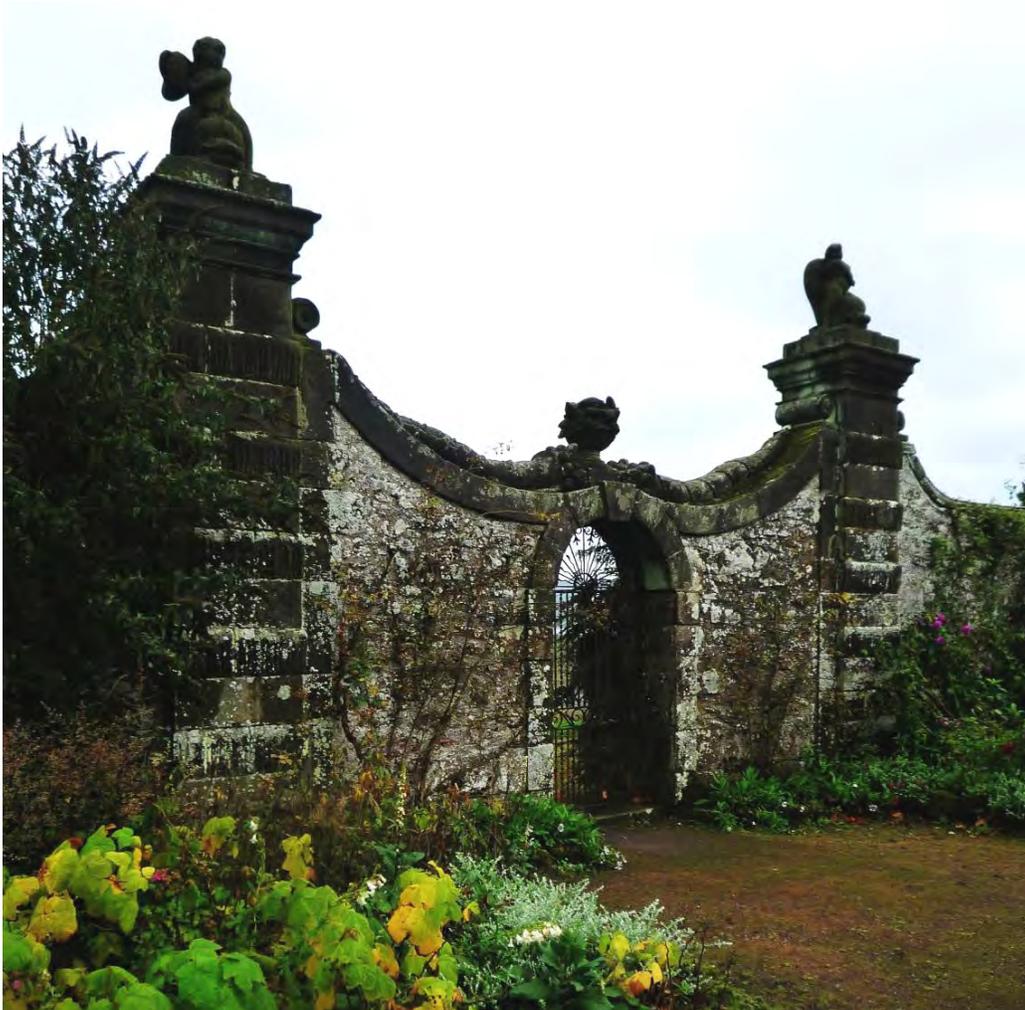
Across the central part of the wall are a number of yew buttresses with flower planting between. The arrangement is a symmetrical response to the east front of Kinross House but much wider. At the centre are rusticated piers

with dolphin finials to either side of an inventive composition involving curved walls with cornucopia on the top rising to a basket finial, overflowing

Figure 144 Kinross House, fish gates. *S&B*

with fish. A round headed arch projects slightly upwards into it. The curving copes rise to scrolls against the piers which have finials of fat cherubs riding dolphins. This carving has a naive quality which is characteristic of Scottish seventeenth and early eighteenth-century carving. At the centre is an Edwardian gate which needs overhauling and repainting but with most of the iron intact.

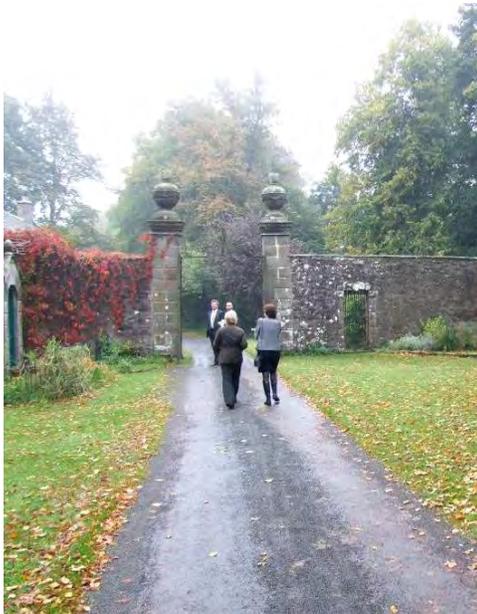
Figure 147 Kinross House, west end of the north wall gate piers. *S&B*

The walls are generally in fair condition but contain some areas of masonry in poor condition. Copes should be repointed. Some vegetation and small trees should be raked out from the masonry.

The ironwork of the gates is in poor condition and needs a comprehensive overhaul, replacement of missing elements and repainting. This applies to the main gates in particular. The side gate and the gate in the arched opening are in better condition but still need repair.

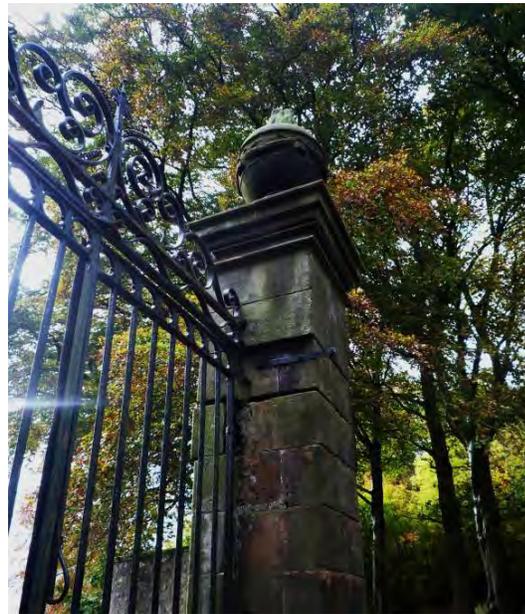
Figure 148 Kinross House, west end of the south wall gate piers. *S&B*

At the western end of the south wall are a pair of gate piers which match the gate opposite to the north, next to the stable block. These piers also have Edwardian iron gates within. These gates are in fair condition and should be repainted. The piers are also in reasonable condition apart from the upper courses of the west pier which has severe jacking from the iron crooks from a previous gate (fig).

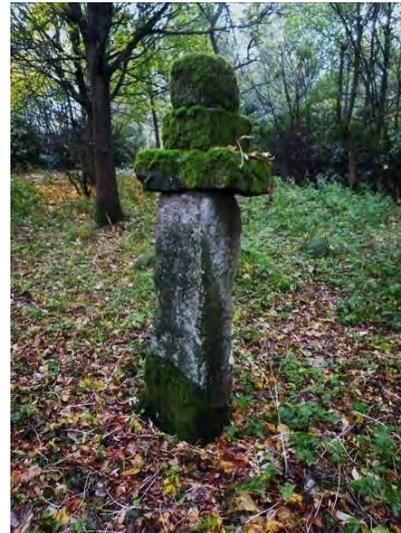
Figure 152 Kinross House, marker stone for Newhouse. S&B

To the south of the northern path is a rustic monument marking the position of Newhouse, built up of a stone post with three stones above. This is in fair condition though covered in moss.

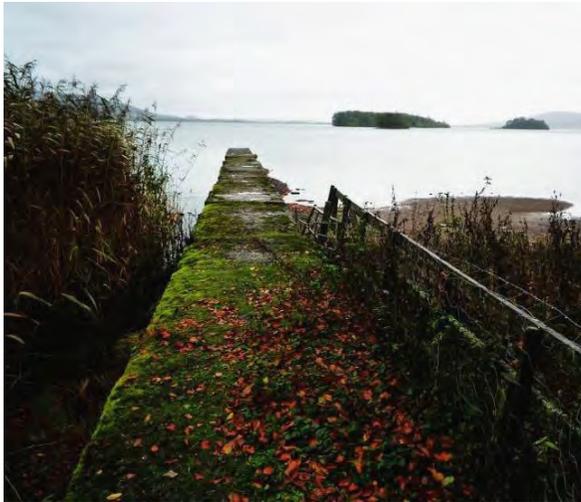
At the northern end of the Loch Leven shore is a concrete jetty. Next to the northern face of this jetty is rubble and concrete which is the remains of a demolished building which has been tumbled into the shore of the loch. About 20m back from this pile of rubble is a concrete base for a building which has now been removed, and also a rubble estate wall running along the line of the shore of Loch Leven to the north.

Figure 153 Kinross House, jetty. *S&B*

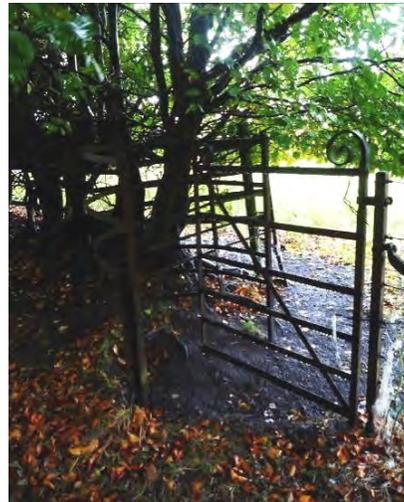
Figure 154 Kinross House, estate fencing. *S&B*
