KINROSS HOUSE
Kinross

Conservation Plan
Simpson & Brown Architects
November 2010

Contents	Page
1.0 Executive Summary	3
2.0 Introduction	4
2.1 Objectives of the Conservation Management Plan	4
2.2 Study Area	5
2.3 Heritage Designations	6
2.4 Structure of the Report	7

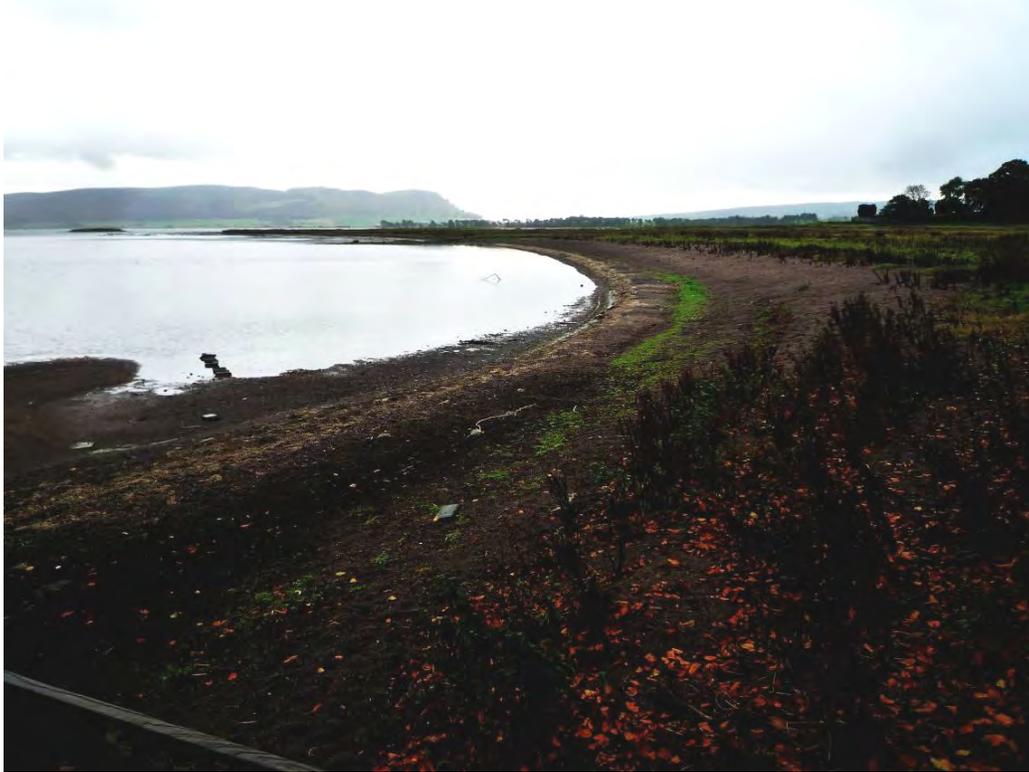
Figure 155 Kinross House, east shoreline. *S&B*

This is an area to the east of the east garden wall. There is a tennis court, a path running north-south and then an open area running down to the shore of Loch Leven. There is a path running parallel with the eastern wall set about 4m east of it. The tennis court is not in playable condition. It is surrounded by a metal post and chain link wire fence. This derelict tennis court is a negative component within the landscape.

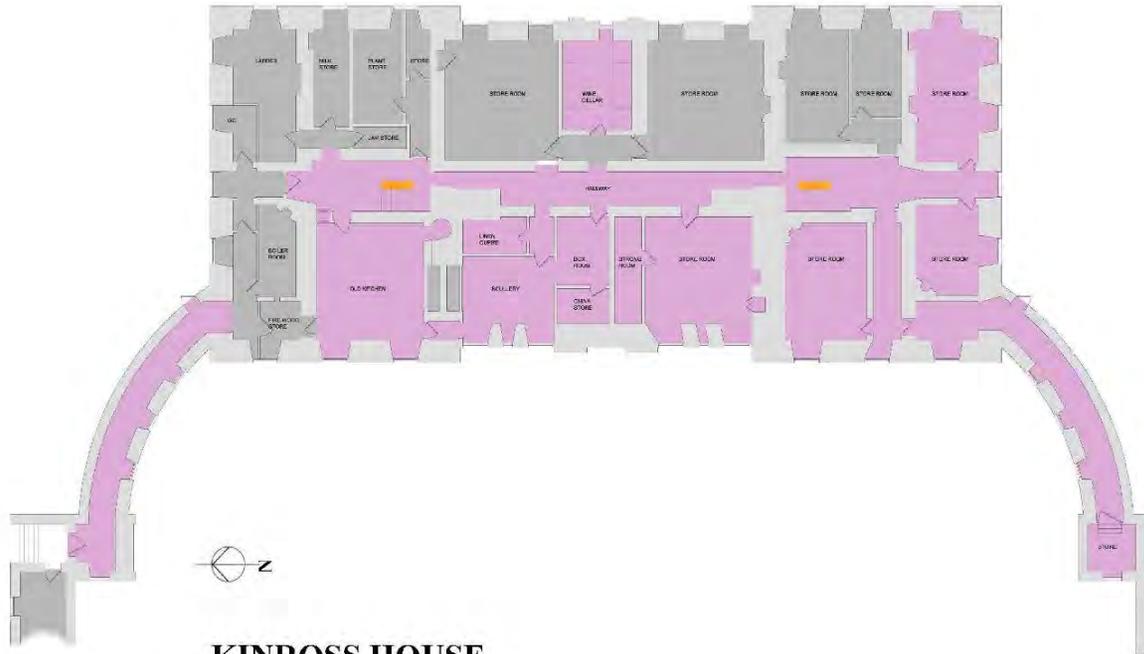
Lower Ground Floor Plan: Significance

- Outstanding significance
- Considerable significance
- Moderate significance
- Neutral
- Negative significance

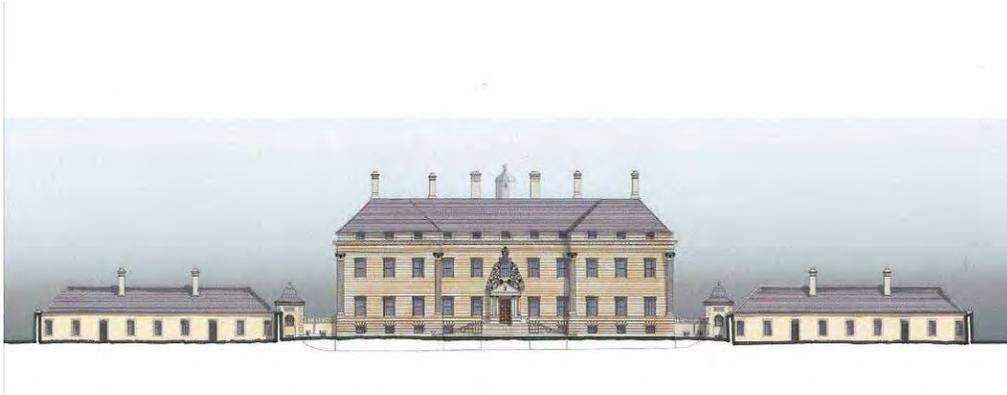
Figure 156 Kinross House, reconstruction of west elevation, c.1685. Section through court walls, showing elevations of wings. *3DReid/S&B*

Restoration also applies to the possible reinstatement of the wings. It is clear from historic accounts and map evidence that these wings were constructed by William Bruce. They fell into disrepair and were demolished. Drawn records, combined with physical evidence, give a reliable indication of the design of these buildings. There is enough common practice across Scottish architecture of that date to make a reliable judgement about the materials and construction methods that influenced the exact appearance of these buildings.

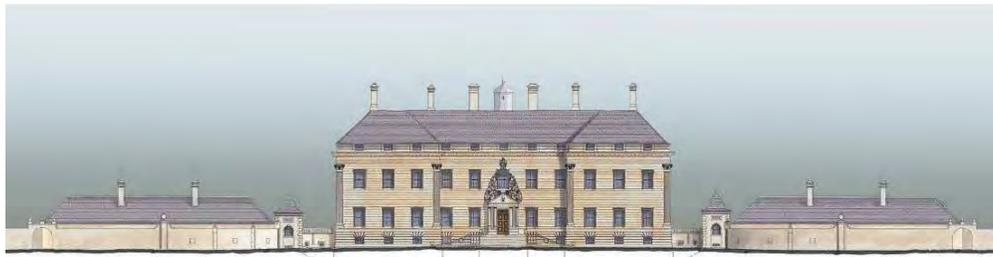
Figure 157 Kinross House, reconstruction of west elevation, c.1730. Screen walls as existing, showing roofs of wings. *3DReid/S&B*
