# LIGHT AGEING OF DISCOLOURED MANGANESE STAINED GLASS FROM UPPSALA CATHEDRAL

During the recent conservation work on Sweden's largest church window, The Son's window from 1892 in Uppsala Cathedral, questions were raised about the type of protective glass that should be installed. Some of the stained glass was noticeably discoloured and the concern was that the process of discolouration would continue if not appropriately protected from sunlight.

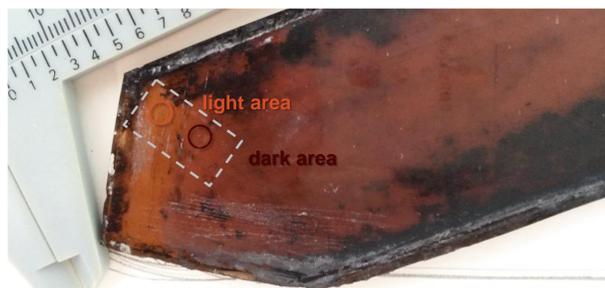
Pink-brown stained glass piece showing the area that was exposed to accelerated light ageing (grey) and the "light" and "dark" areas used for colour measurements.

At the Swedish National Heritage Board a small area (2 cm<sup>2</sup>) with both original "light" and discoloured "dark" stained glass was exposed to accelerated light ageing under a high UV metal halide lamp. The exterior side of the glass piece was directed towards the light source.

The discolouration process was followed spectrophotometrically through regular reflectance measurements of the "light" and "dark" areas from both the interior and the exterior sides of the glass piece.
