SUMBURGH HEAD LIGHTHOUSE RESTORATION AND DEVELOPMENT PROJECT  
CONSERVATION MANAGEMENT PLAN

March 2009

Conservation Management Plan

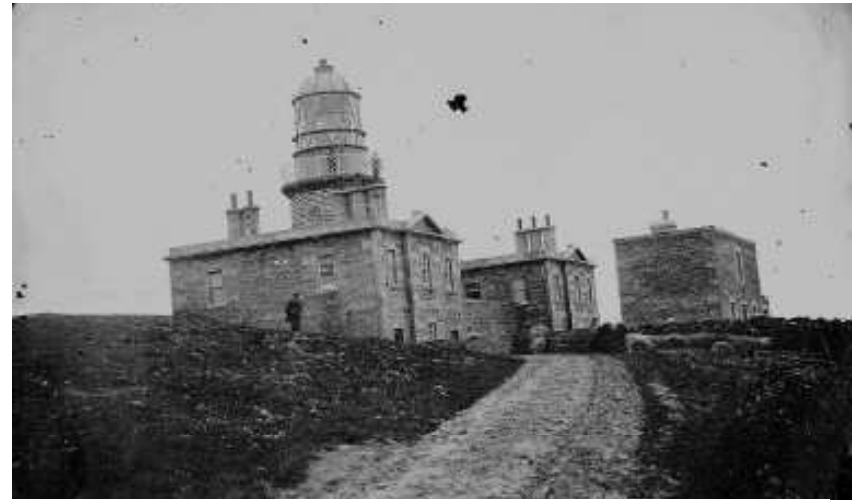
Fig. 2.6 Early photograph of Sumburgh from c. 1870 showing the first phase of development by Robert Stevenson

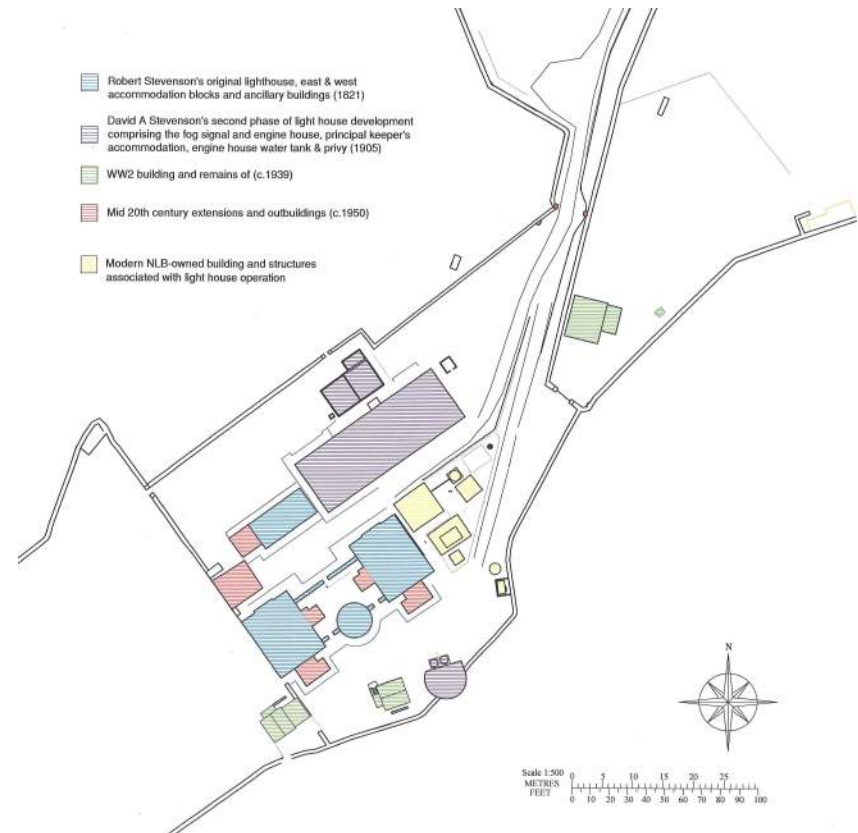
Fig. 2.7 Plan showing phases of work at Sumburgh

As may be seen from the phasing plan (see fig. 2.7), Robert Stevenson's first phase of building work at Sumburgh Head comprised the light tower (building 1) and two flanking pavilions (buildings 2 and 3), both of which provided accommodation for the lighthouse keepers and their families, and the building opposite, which formed the smithy and further accommodation for occasional keepers (building 8). In addition, it also included a stores building at Grutness (approx 2km from Sumburgh Head and under separate ownership) that is still extant and largely in its original form (see fig. 2.8).

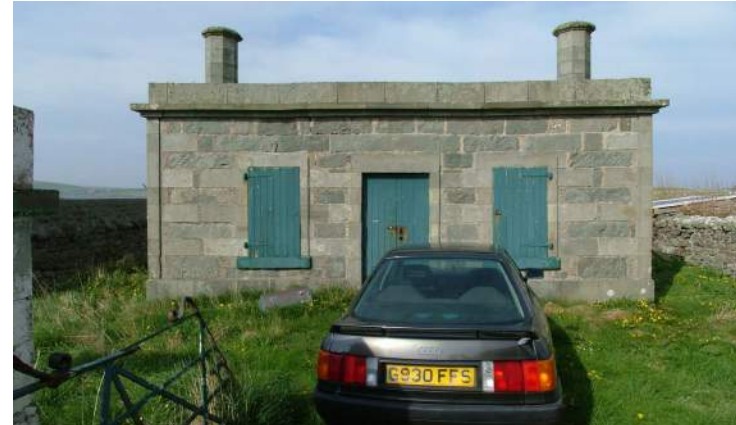
Fig. 2.8 Store Building at Grutness

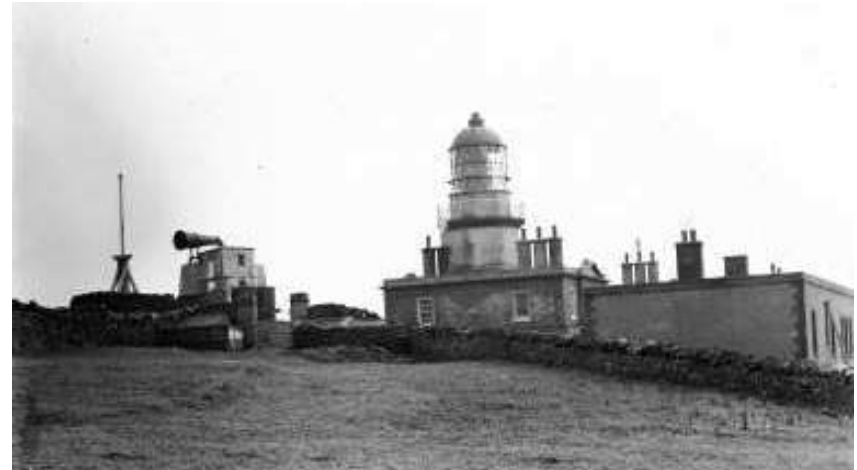
*Fig. 2.9 Sumburgh lighthouse and surrounding buildings in 1905*

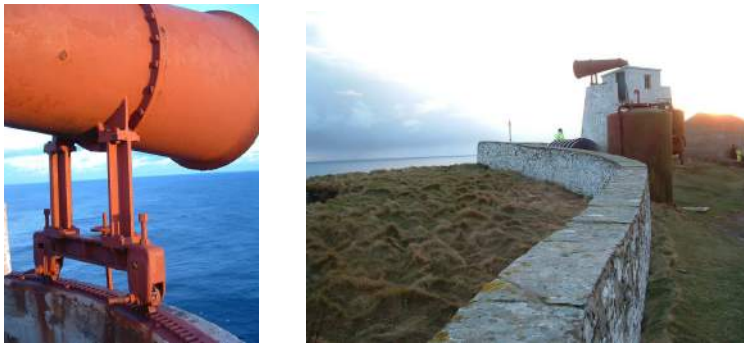
The fog signal was 1 blast every 90s from the horn which operated using compressed air from the three Kelvin engine compressors located in the engine house to vibrate the diaphragm. The installation of the foghorn required an increase in the number of lightkeepers from 2 to 3 and thus Sumburgh needed to have an additional dwelling house built along with the engine room to house the engine/compressor sets. This traditionally was combined in a single building block with the engine room at one end and the additional house at the other with

Fig. 2.10 and 2.11 The Foghorn building and detail

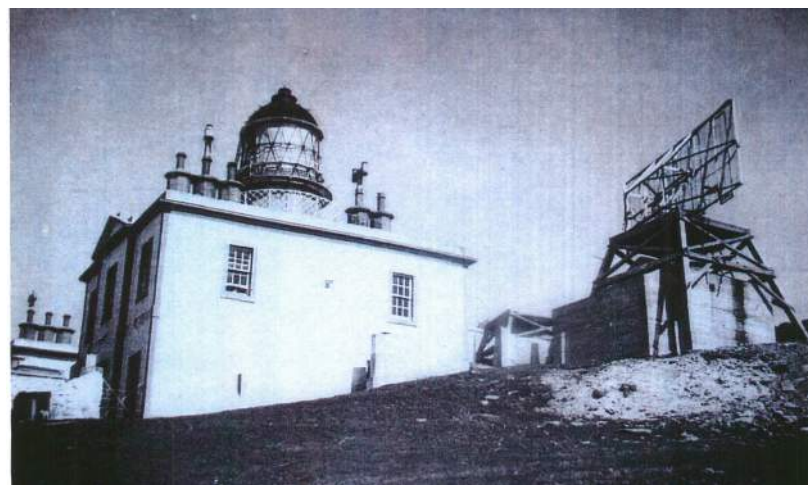
*Fig. 2.12 Radar Building 2 and the West Pavilion during wartime*

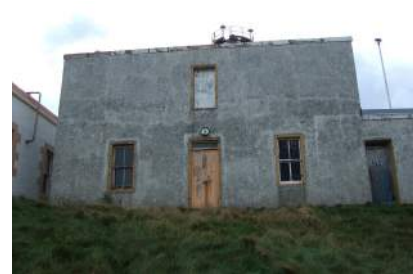
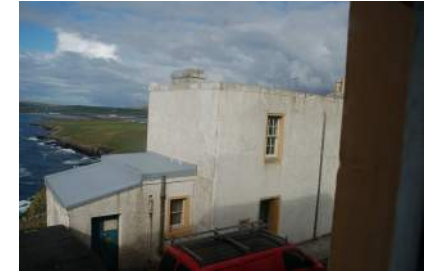
This two-storey building is constructed of coursed granite rubble with a painted cement render finish. The roof is flat and is of timber construction covered originally with sheet lead that has since been replaced with a modern synthetic membrane. The ground floors are solid and partly retain the original granite setts while the upper floors are of timber boarded construction.

Fig. 2.16 and 2.17 The Smithy/Occasional Keeper's Block

The building measures 14m by 5m and has two rooms on each floor. The ground floor rooms have their own entrance doors on the front (east) elevation while the upper floor rooms are accessed via a single-flight timber staircase from an entrance door in the rear (west) elevation. According to historical photographs this building is contemporary with the construction of the lighthouse and accommodation blocks. The ground floor rooms include a smithy and byre. The smithy has a set of working bellows in the fireplace. The byre has retained its original cobble floor. On the upper floor there is accommodation for an assistant (or occasional) keeper and next to this there is a storeroom. A small annex building was added to the south elevation, probably in the 1950s, and this includes a fuel store and a toilet. The keepers' accommodation still contains a 'time-capsule' of fixtures and fittings including wooden bunk beds, carpeted floors, sink, and electric fire and cooker. The room is unchanged since it was no longer required by the NLB.

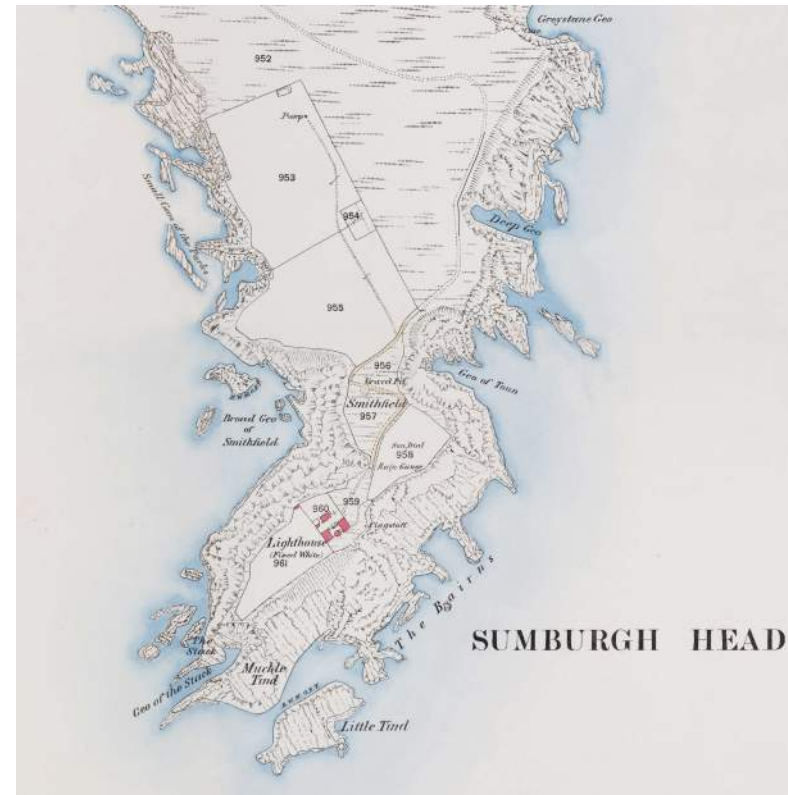
Fig. 2.18 OS Map of 1882 showing the original sundial location in the field to the north east of the lighthouse

A sundial plinth is situated to the south of Building 12, the auxiliary engine rooms. The plinth is made of cast-iron with fluted sides to a height of 1.2m. The sundial is missing. This style of plinth is a typical NLB feature and similar to those found at other comparable sites. The OS map of 1882 shows that the sundial was originally located in the field to the north east of the main site indicating that it was moved at some point after that year.

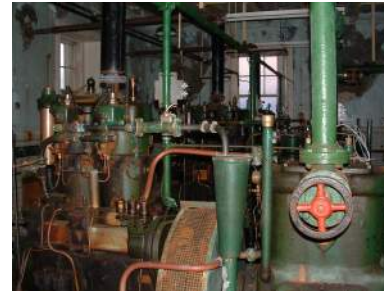
The engine room was completed in 1907 to provide compressed air to the foghorn tower. The engine room interior includes three Kelvin marine diesel engines that supplied compressed air to three iron receiver tanks situated on the north wall. These tanks were manufactured in 1906 by James Dove & Co,

Engineering Contractor, Edinburgh. The three engines are K2 Series engines linked to air compressors.

*Fig. 2.19 The Engine Room interior*

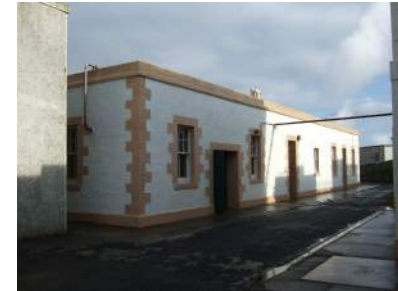
*Fig. 2.20 The Engine Room exterior*

The engines now have electric starter motors fitted requiring the use of paired 15 volt batteries. These were charged by battery chargers powered by direct mains current and also by a Lister diesel engine. The chargers are situated on the west wall of the engine room.

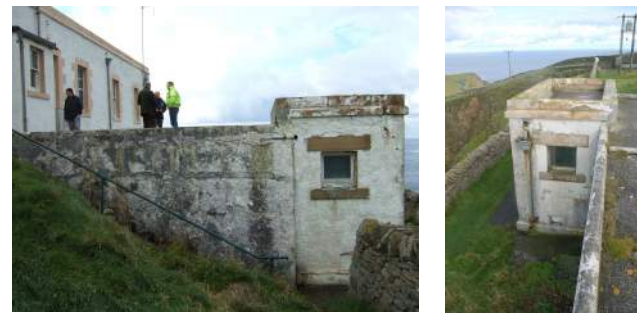
Fig 2.21 and 2.22 The Water Tanks and Toilet Block

A concrete part-subterranean water tank enclosure is situated to the west side of the SAT holiday-let/former principal keeper's accommodation. These water tanks were formerly used to collect and store rainwater used as coolant for the engines. The enclosure is brick built with a flat roof covered with mastic asphalt and measures c.8m by 4m. A set of steps descends on its northern end to a lower terrace level where two disused toilets exist. The toilets form a single

building block measuring 3.5m by 1.5m. All internal sanitary goods have been removed.

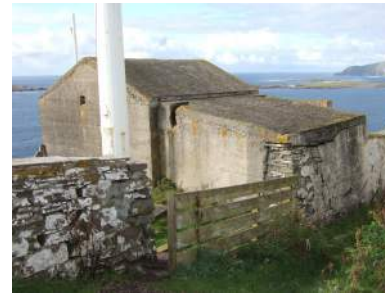
Fig. 2.23 Radar Building 2

The Radar 2 receiver building is situated on the south side of a boundary wall and is again constructed of unreinforced shuttered concrete which was used to encase a timber-framed wooden hut. A blast wall protects the main entrance which is situated on the north-west side of the building. The building measures 6.2m long and 3.6m wide. The ridge of the roof stands 3.3m above the floor. The north wall of the building has been contrasts with the smooth face of the concrete. The wall carries concrete to a further height of c.1.5m. The east wall exhibits the impressions of the long decayed timber planks of the sheds cladding. At the south end of the wall there is an impression of a shuttered window measuring 1.1m by 1m; the south elevation has a window opening with the same dimensions. On the inside of the roof are the impressions of corrugated iron which was originally used to roof the timber hut. built over the drystone boundary dyke and

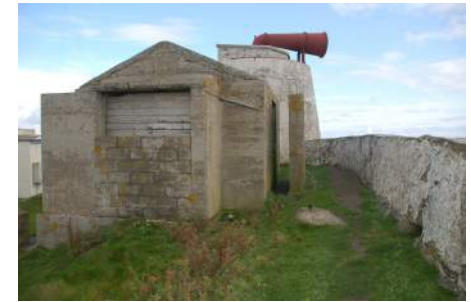
Fig 2.24 Radar Building 1

This single storey building is situated within a walled enclosure and is constructed of shuttered concrete with a flat roof, and has a small annex on its east side. The concrete building dates to World War II and is associated with the Radar buildings. The exact function of the building is not known but may have been an engine shed. The building is not owned by the SAT and no interior access was available.

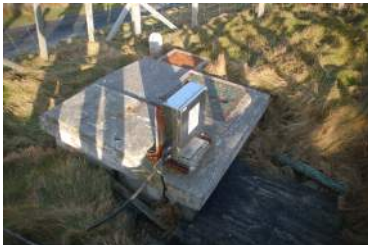
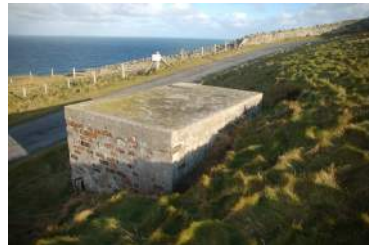
Fig. 2.25 and 2.26 Concrete Buildings at lower part of site

Situated 6m downslope from Building 15 and built into the hillside are the remains of a rectangular building measuring 10m long and 4.5m wide. A single course of concrete measuring c. 0.15m high can be seen enclosing the hard standing of a floor. Photographs taken in 1942 and 1948 are understood to show a building at this location which was possibly associated with a barrack block for army sentries who were known to guard the headland during its use as part of the Chain Home Low radar station which as highly secret defensive installations demanded the tightest security.

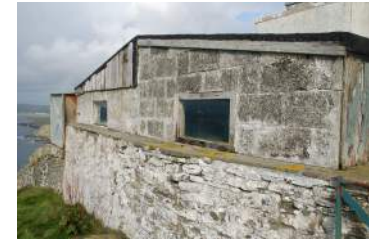
Fig 2.27 and 2.28 Disused Garages

A pair of derelict concrete and timber garages occupies the ground between the west accommodation block and the former smithy/occasional keepers accommodation block. The garages have been built against the drystone boundary wall. The garages measure c. 8m by 4m and have their main entrances facing the main drive.

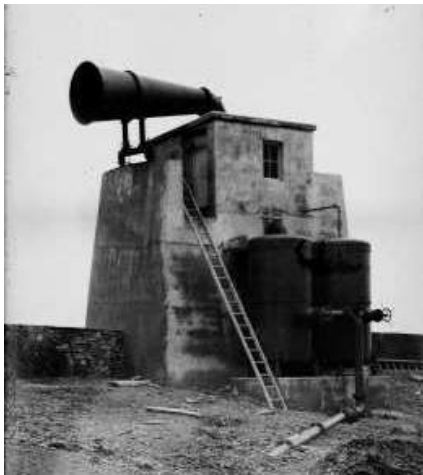
Fig. 3.3  
The newly built  
Foghorn in 1905

The introduction of foghorns in Scotland started around 1874 with Sumburgh Head installed by Robert Stevenson's grandson, David A Stevenson, around 1904. The last fog signal in Scotland was switched off in 2005 but all the original buildings and equipment at Sumburgh Head associated with the foghorn remain extant and are understood to be in working order.
